THE LAW SCHOOL
CLINICAL LAW CENTER

Press release concerning the living conditions at the Hoffman Hotel

March 19, 2026

NOTRE DAME LAW CLINIC PRESS RELEASE:

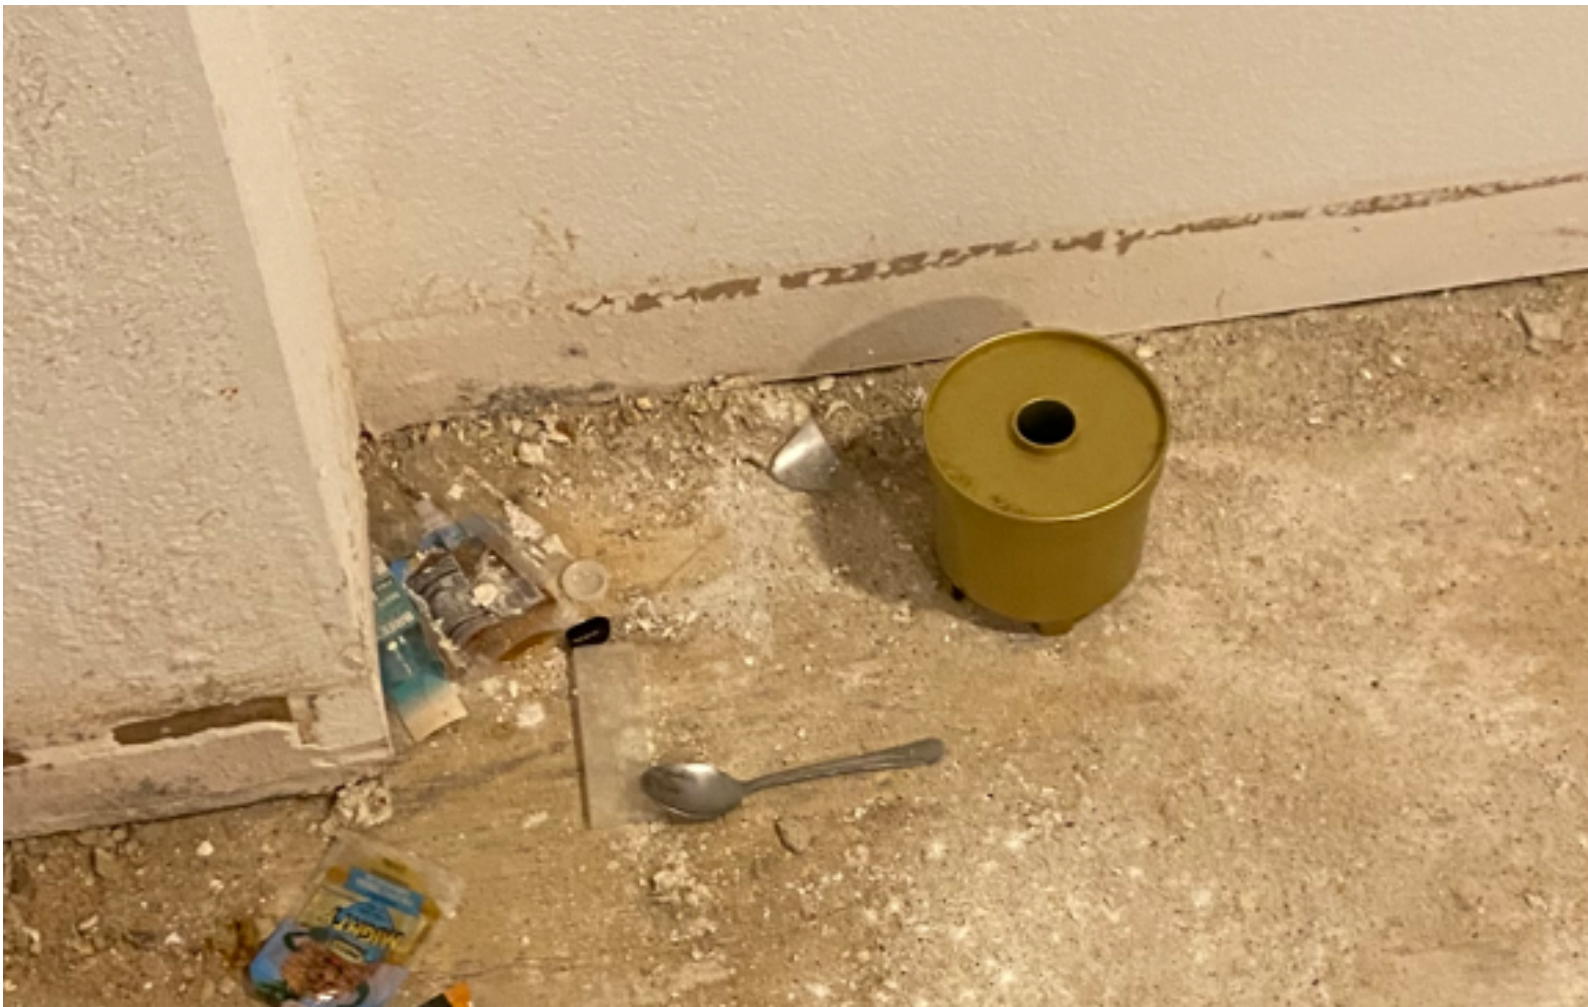
There is evidence to suggest that the common spaces at the Hoffman Hotel have been utilized as a space for non-residents to use illegal drugs. Below is a picture showing what seems to be a spoon and a hot pot of some kind that would be used to heat heroin before injection.

The image above was taken in the property's music room, a once soundproof room where musicians were free to practice their craft. Directly outside the music room, there were dried marks of an orange colored substance that appeared to be, and smelled like vomit. The music room has since been locked, but a small mattress and crumbs of animal crackers were found outside.

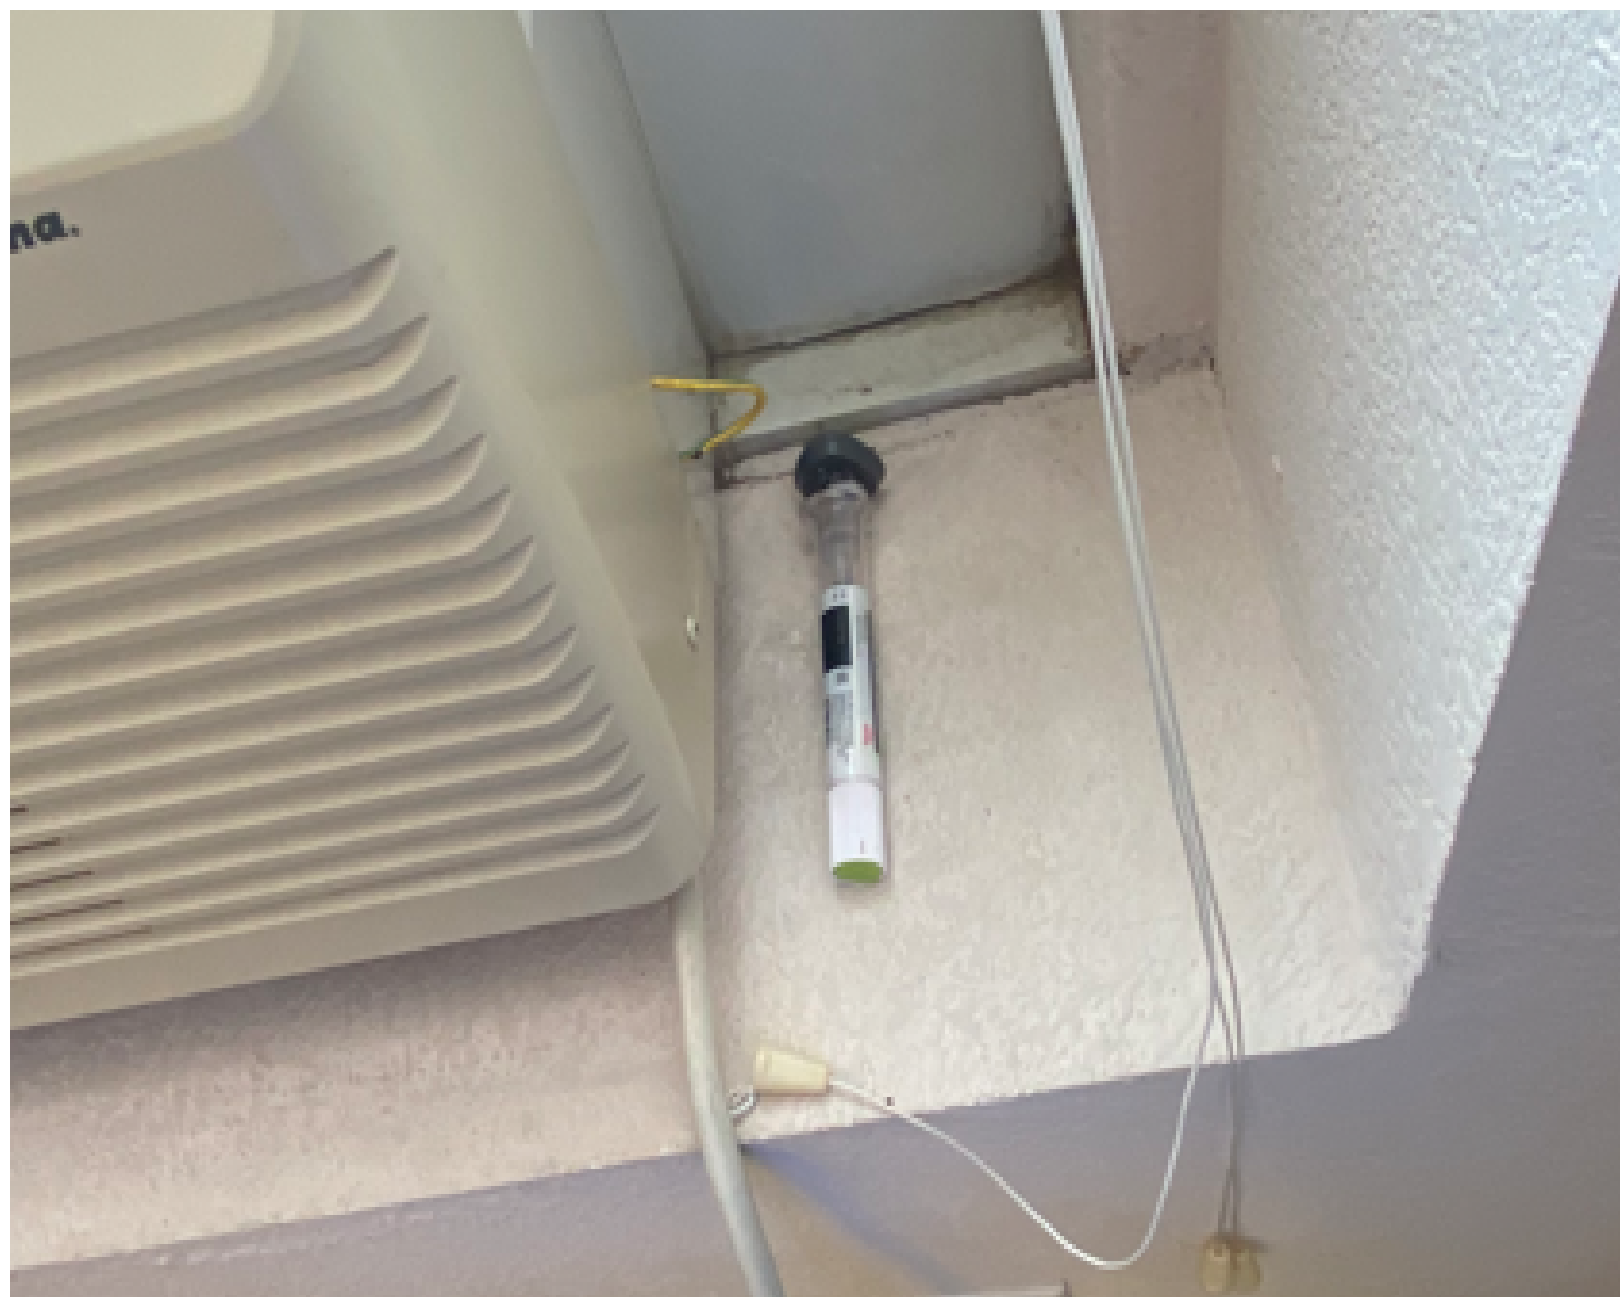
Not far from the music room, a stray insulin needle was found. In South Bend, it is common for drug users to repurpose medical needles for drug use.⁹

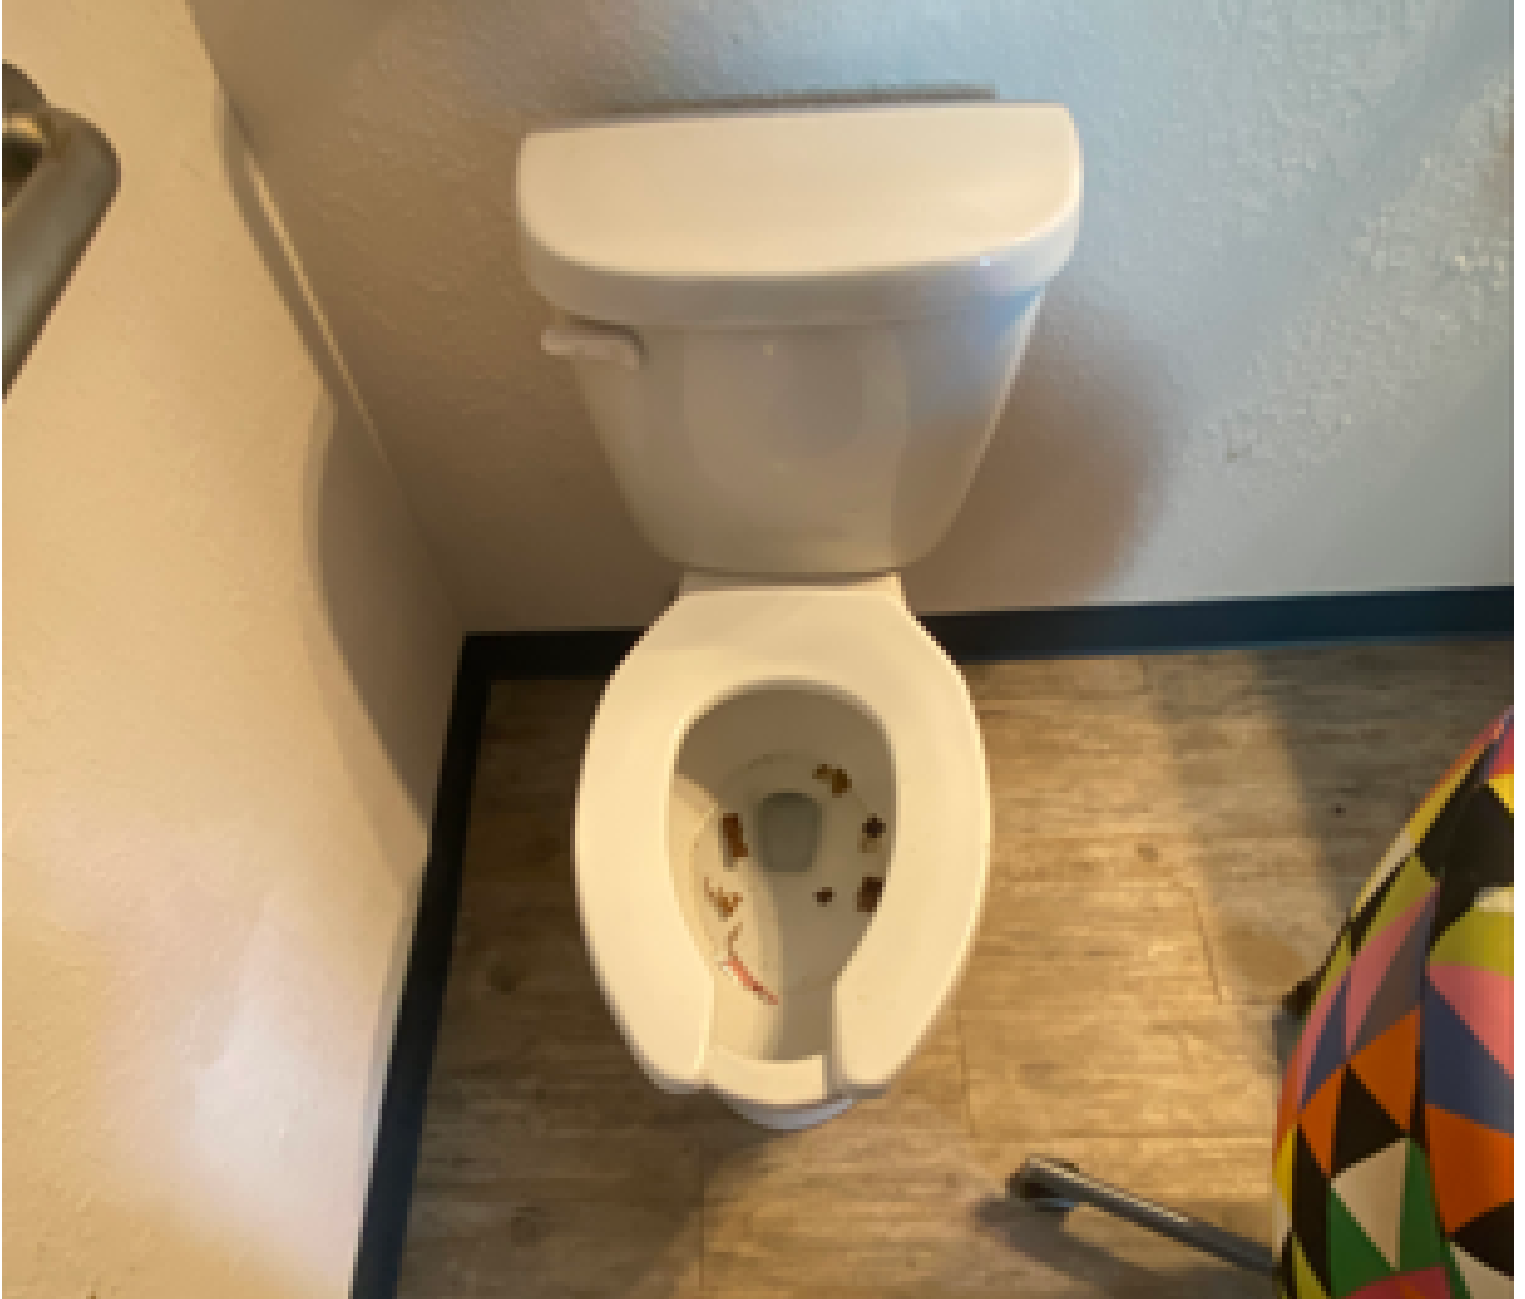
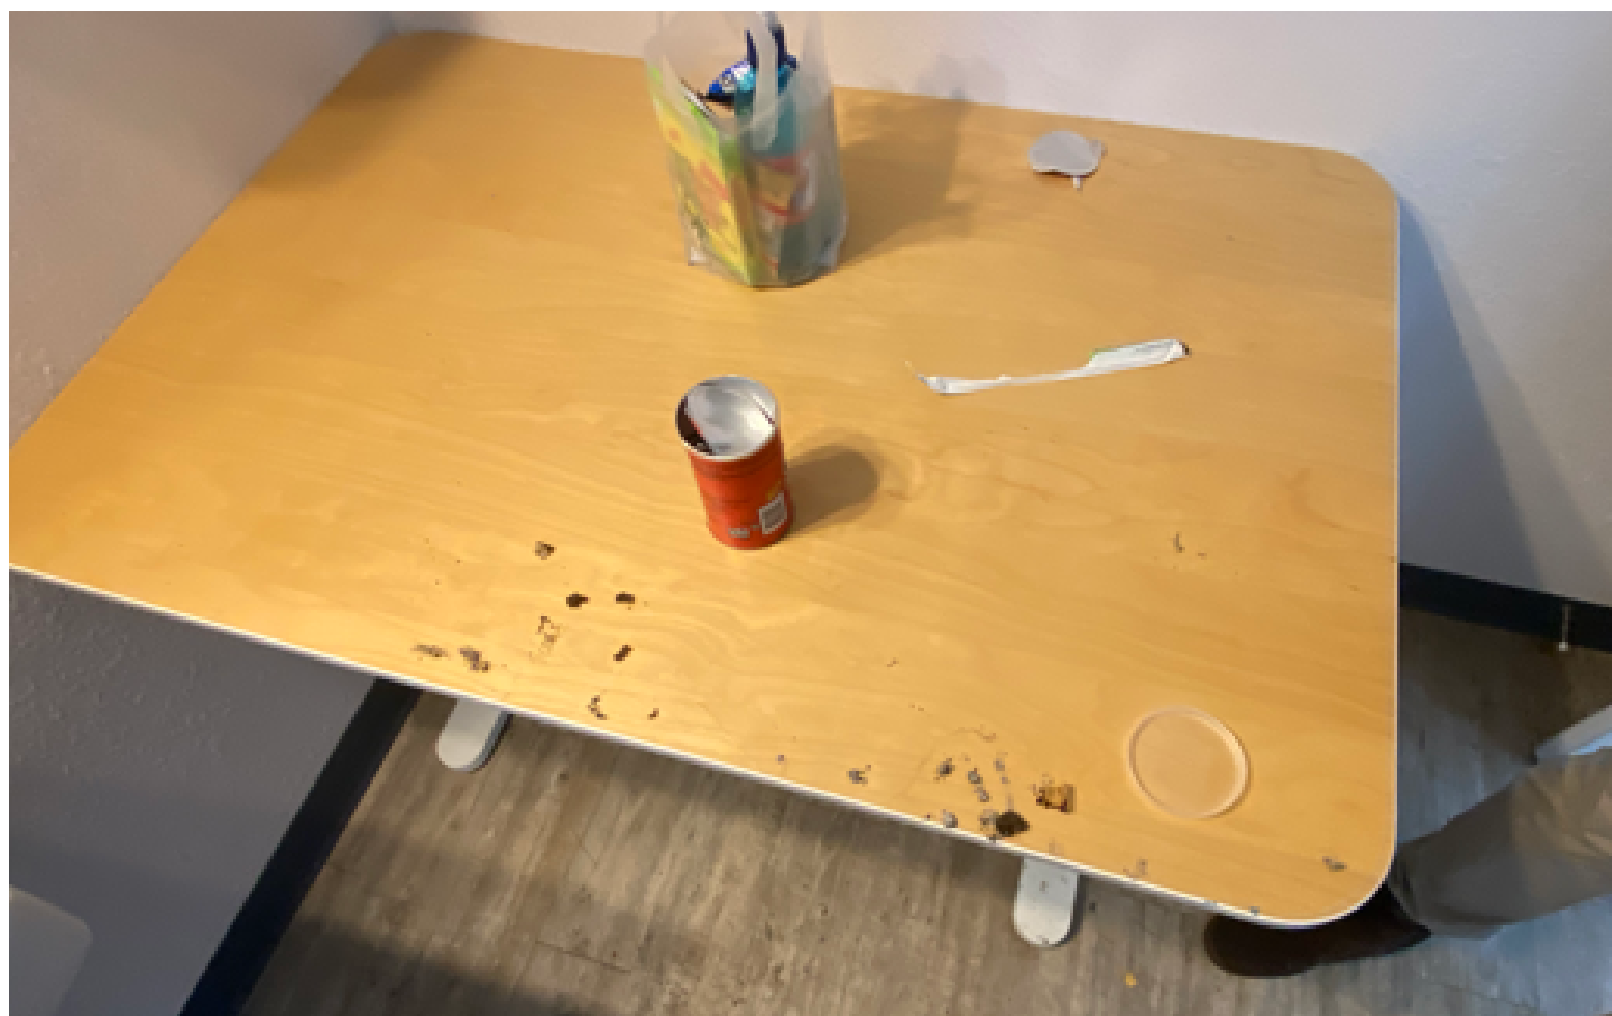
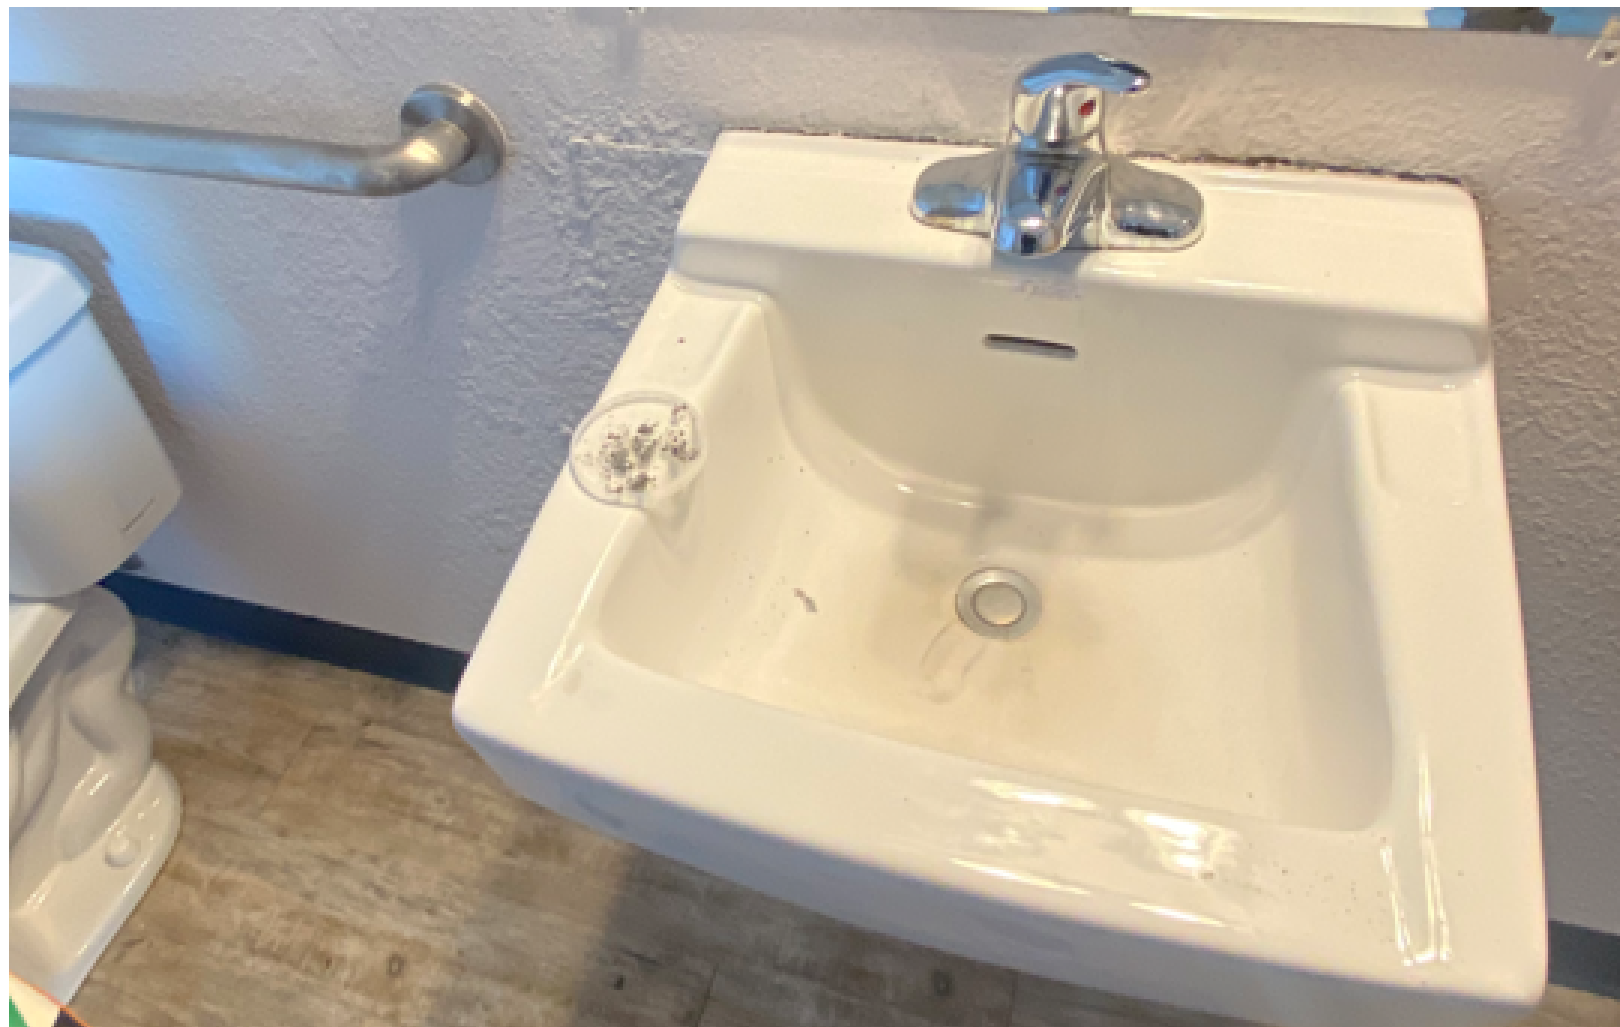
Hoffman's former lounge area, where residents could relax, paint, and socialize with other tenants, smelled of marijuana. The bathroom that directly leads to the lounge area is pictured below. Pieces of ash are located on the sink and on the table located directly next to it. There are pieces of rolling paper and ash in the toilet.

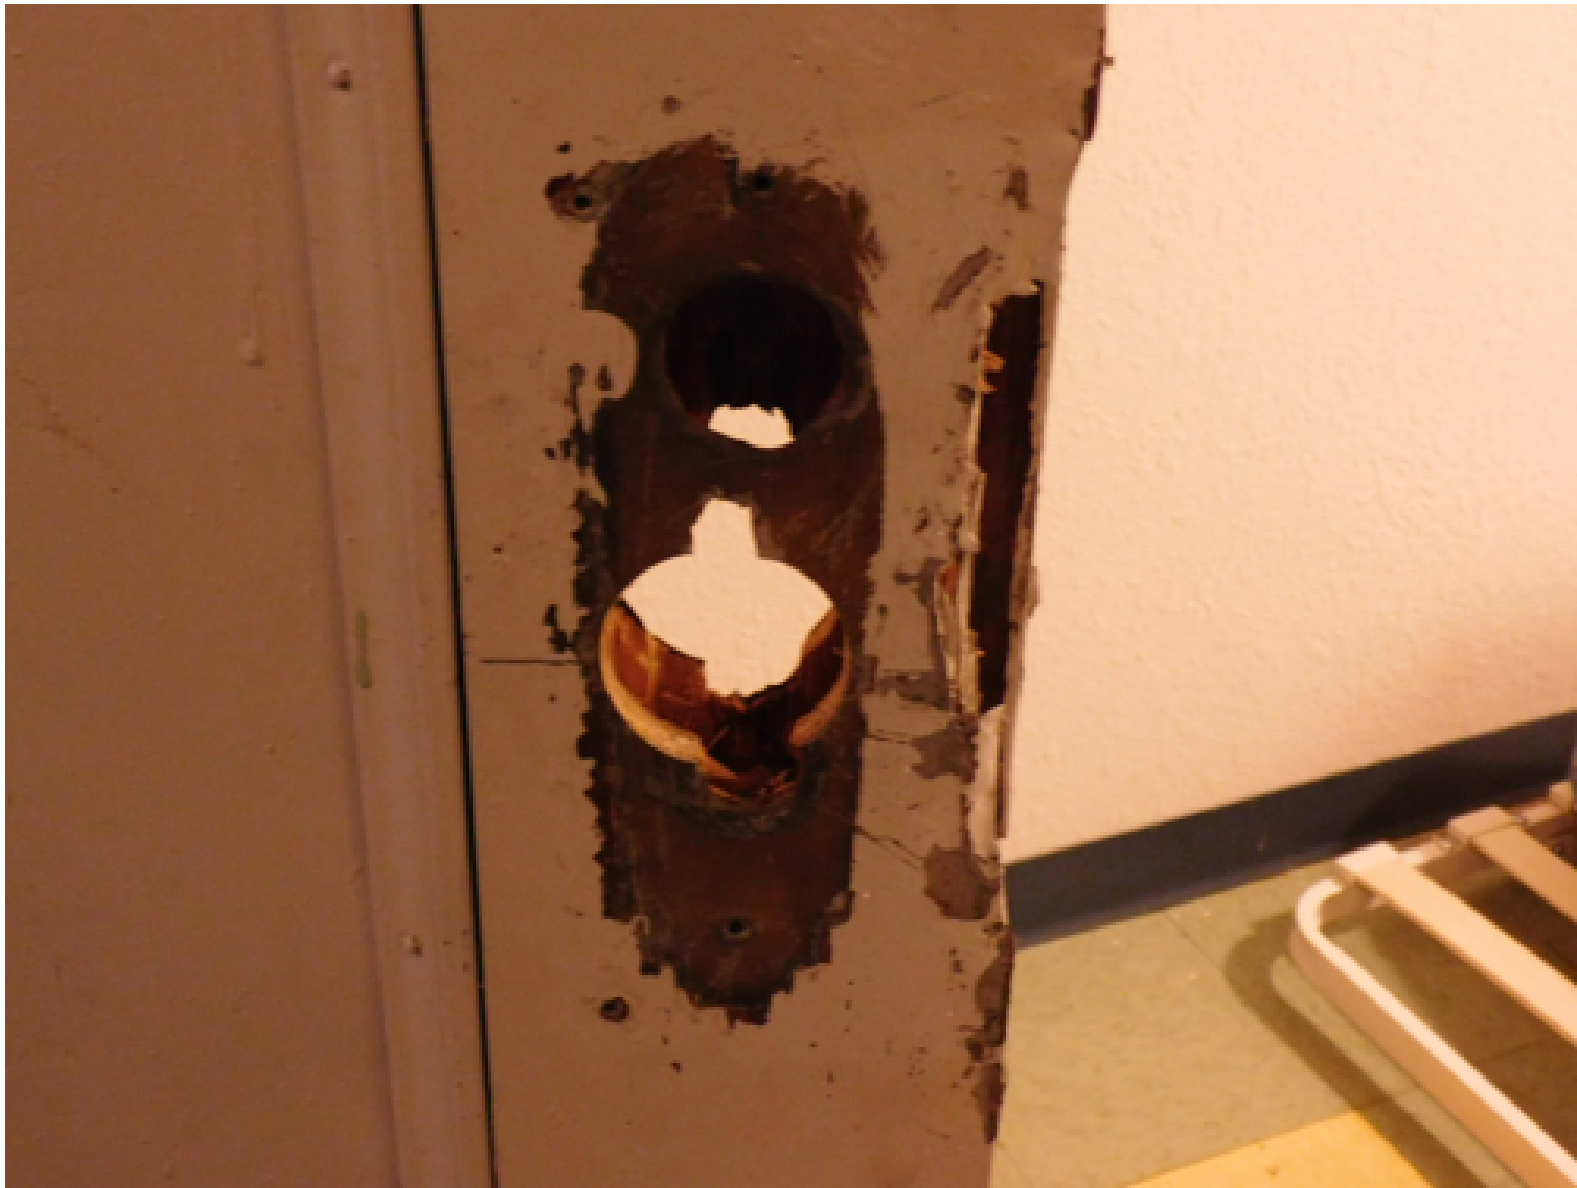
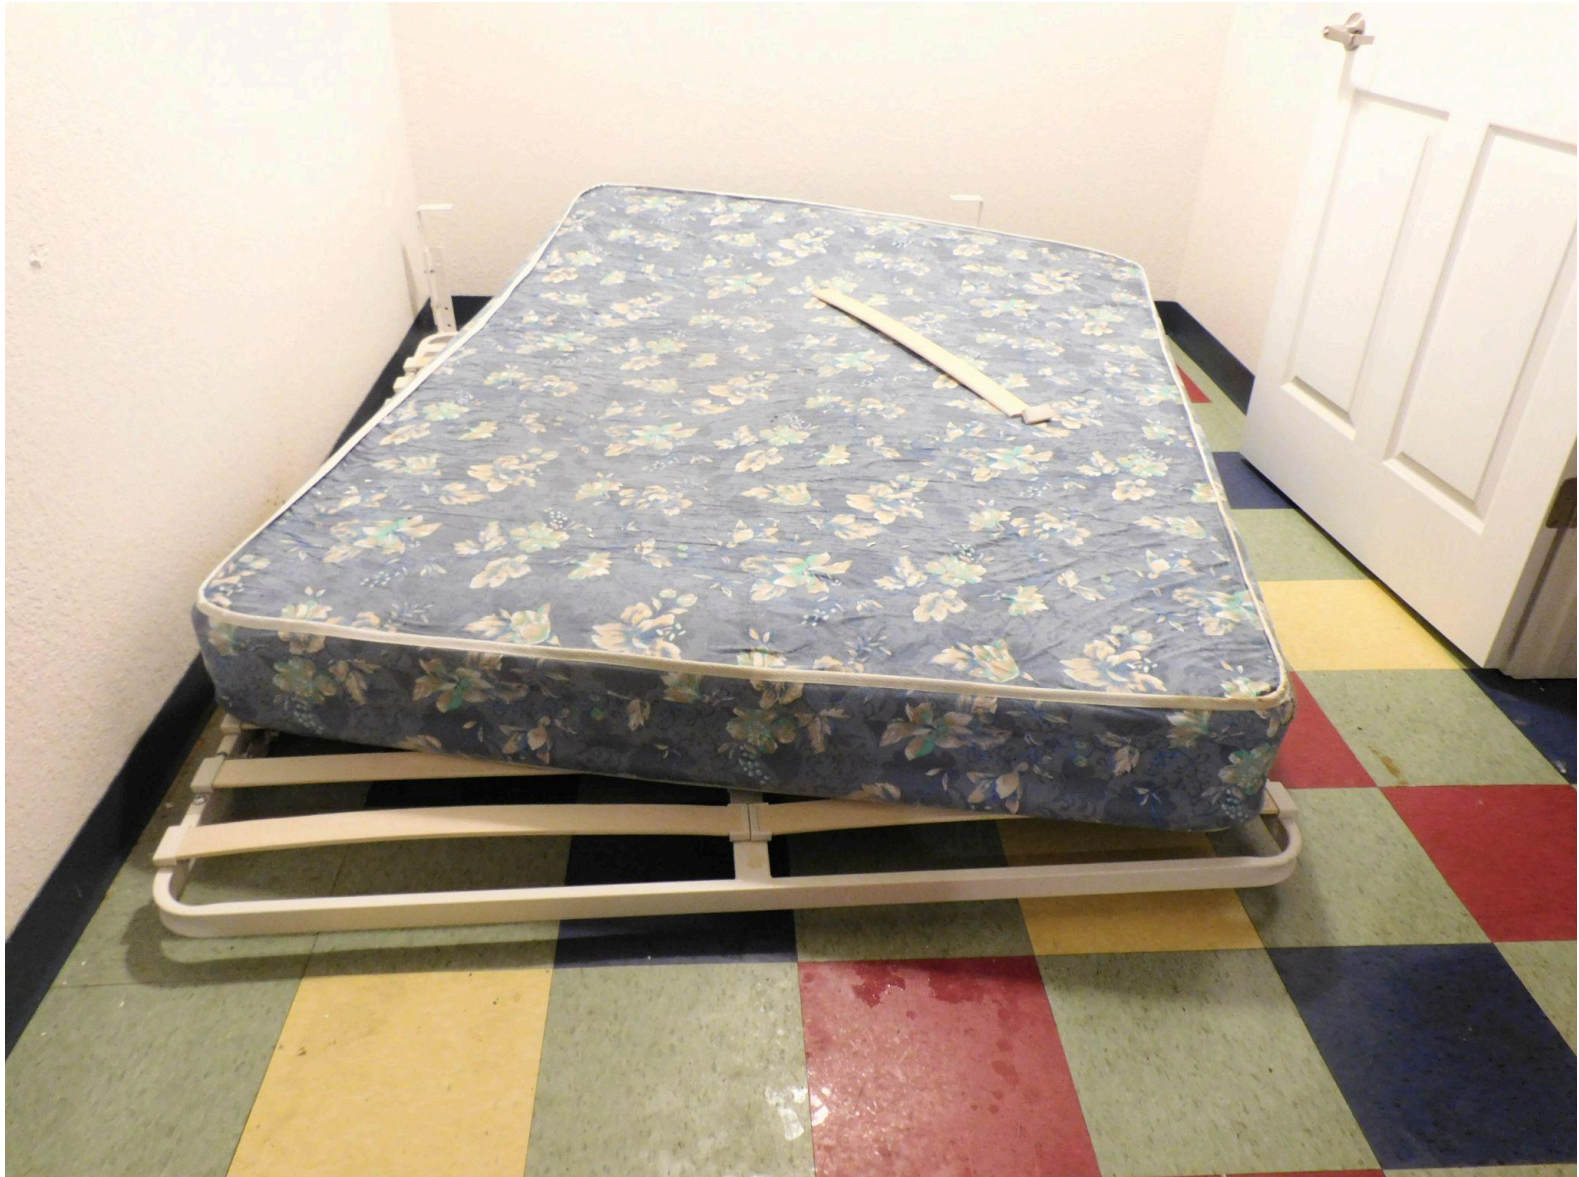
Aside from illegal drug use, there are concerns that non-residents have been able to access the building and sleep in the common areas. The Clinic has heard from residents of Hoffman that the former red light room, where photographers could develop their pictures, was seen with a mattress in it. The main door for the photography room is missing its handle. Food packaging and a cigar wrapper were found on the floor close to the mattress set on a metal mattress frame. Curiously, there was another metal frame located in the room directly outside the red light room. The photography room has since been locked.

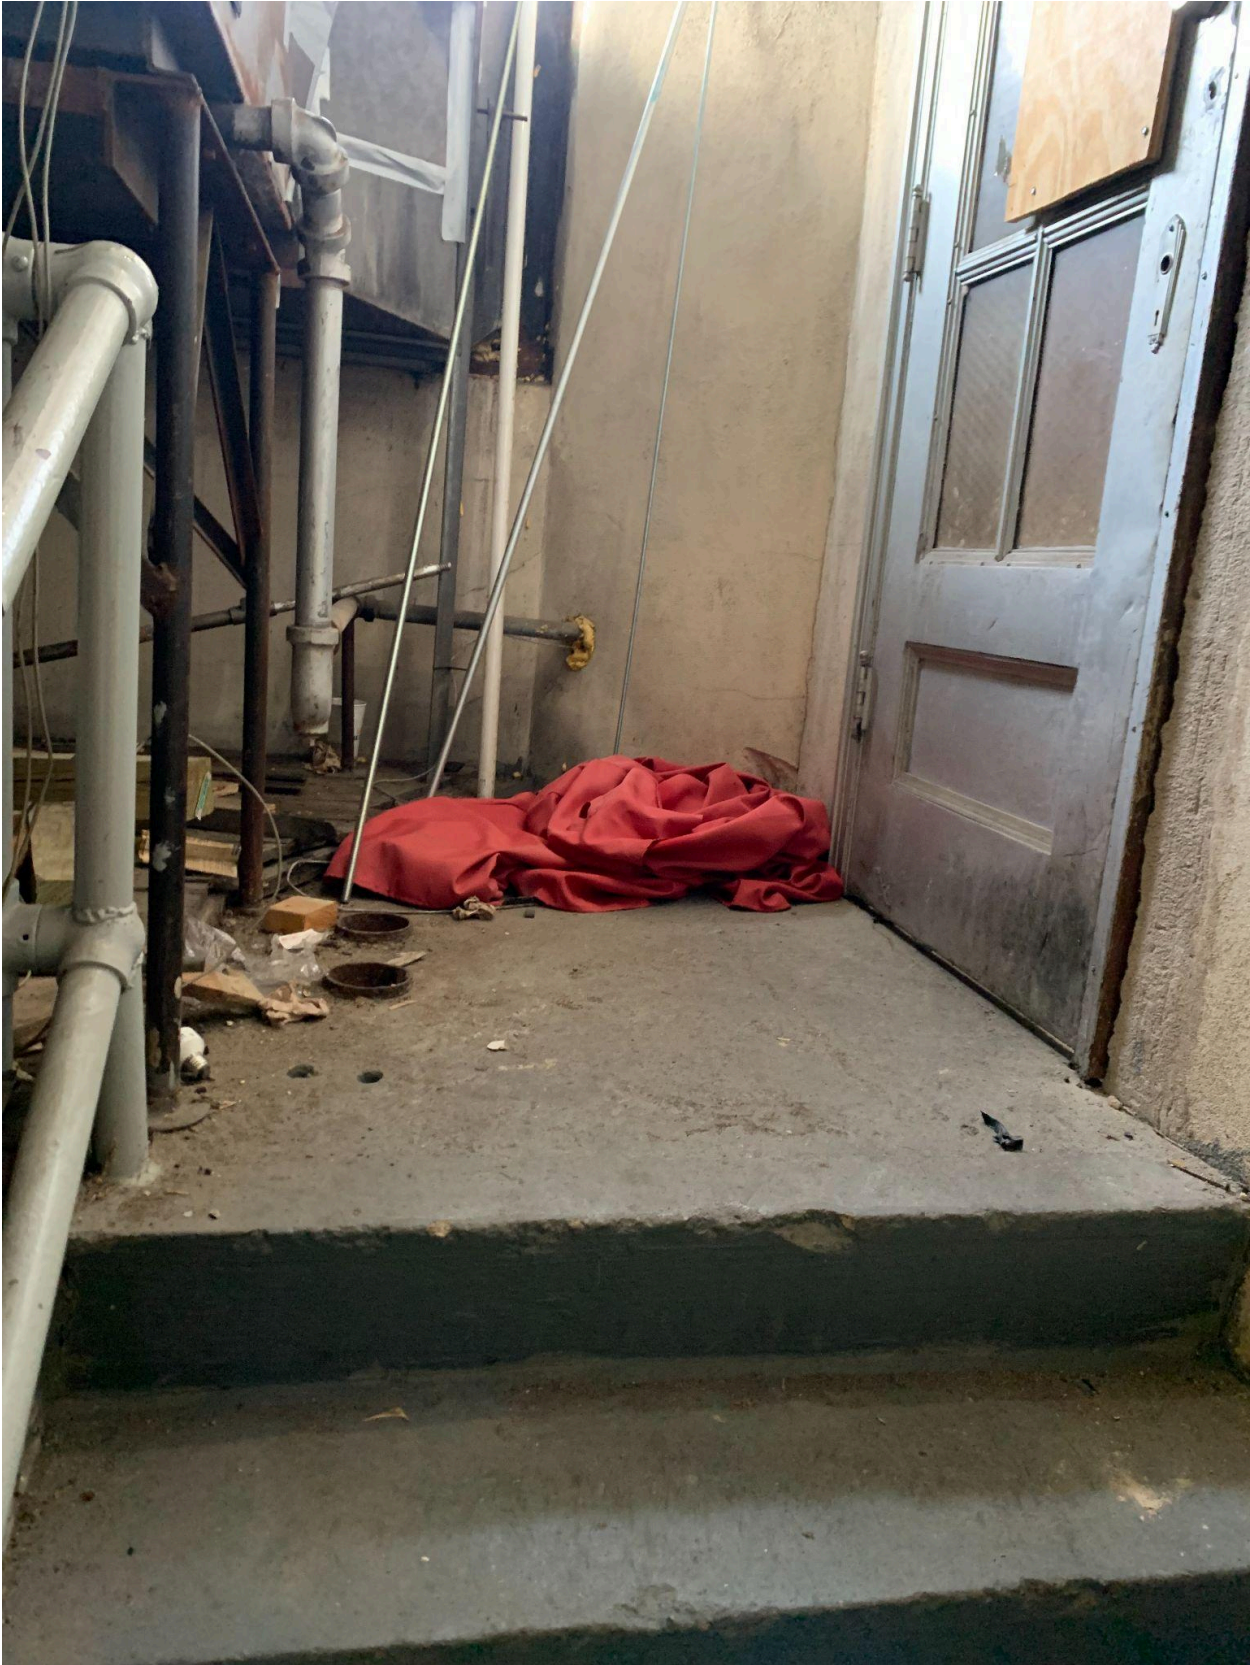
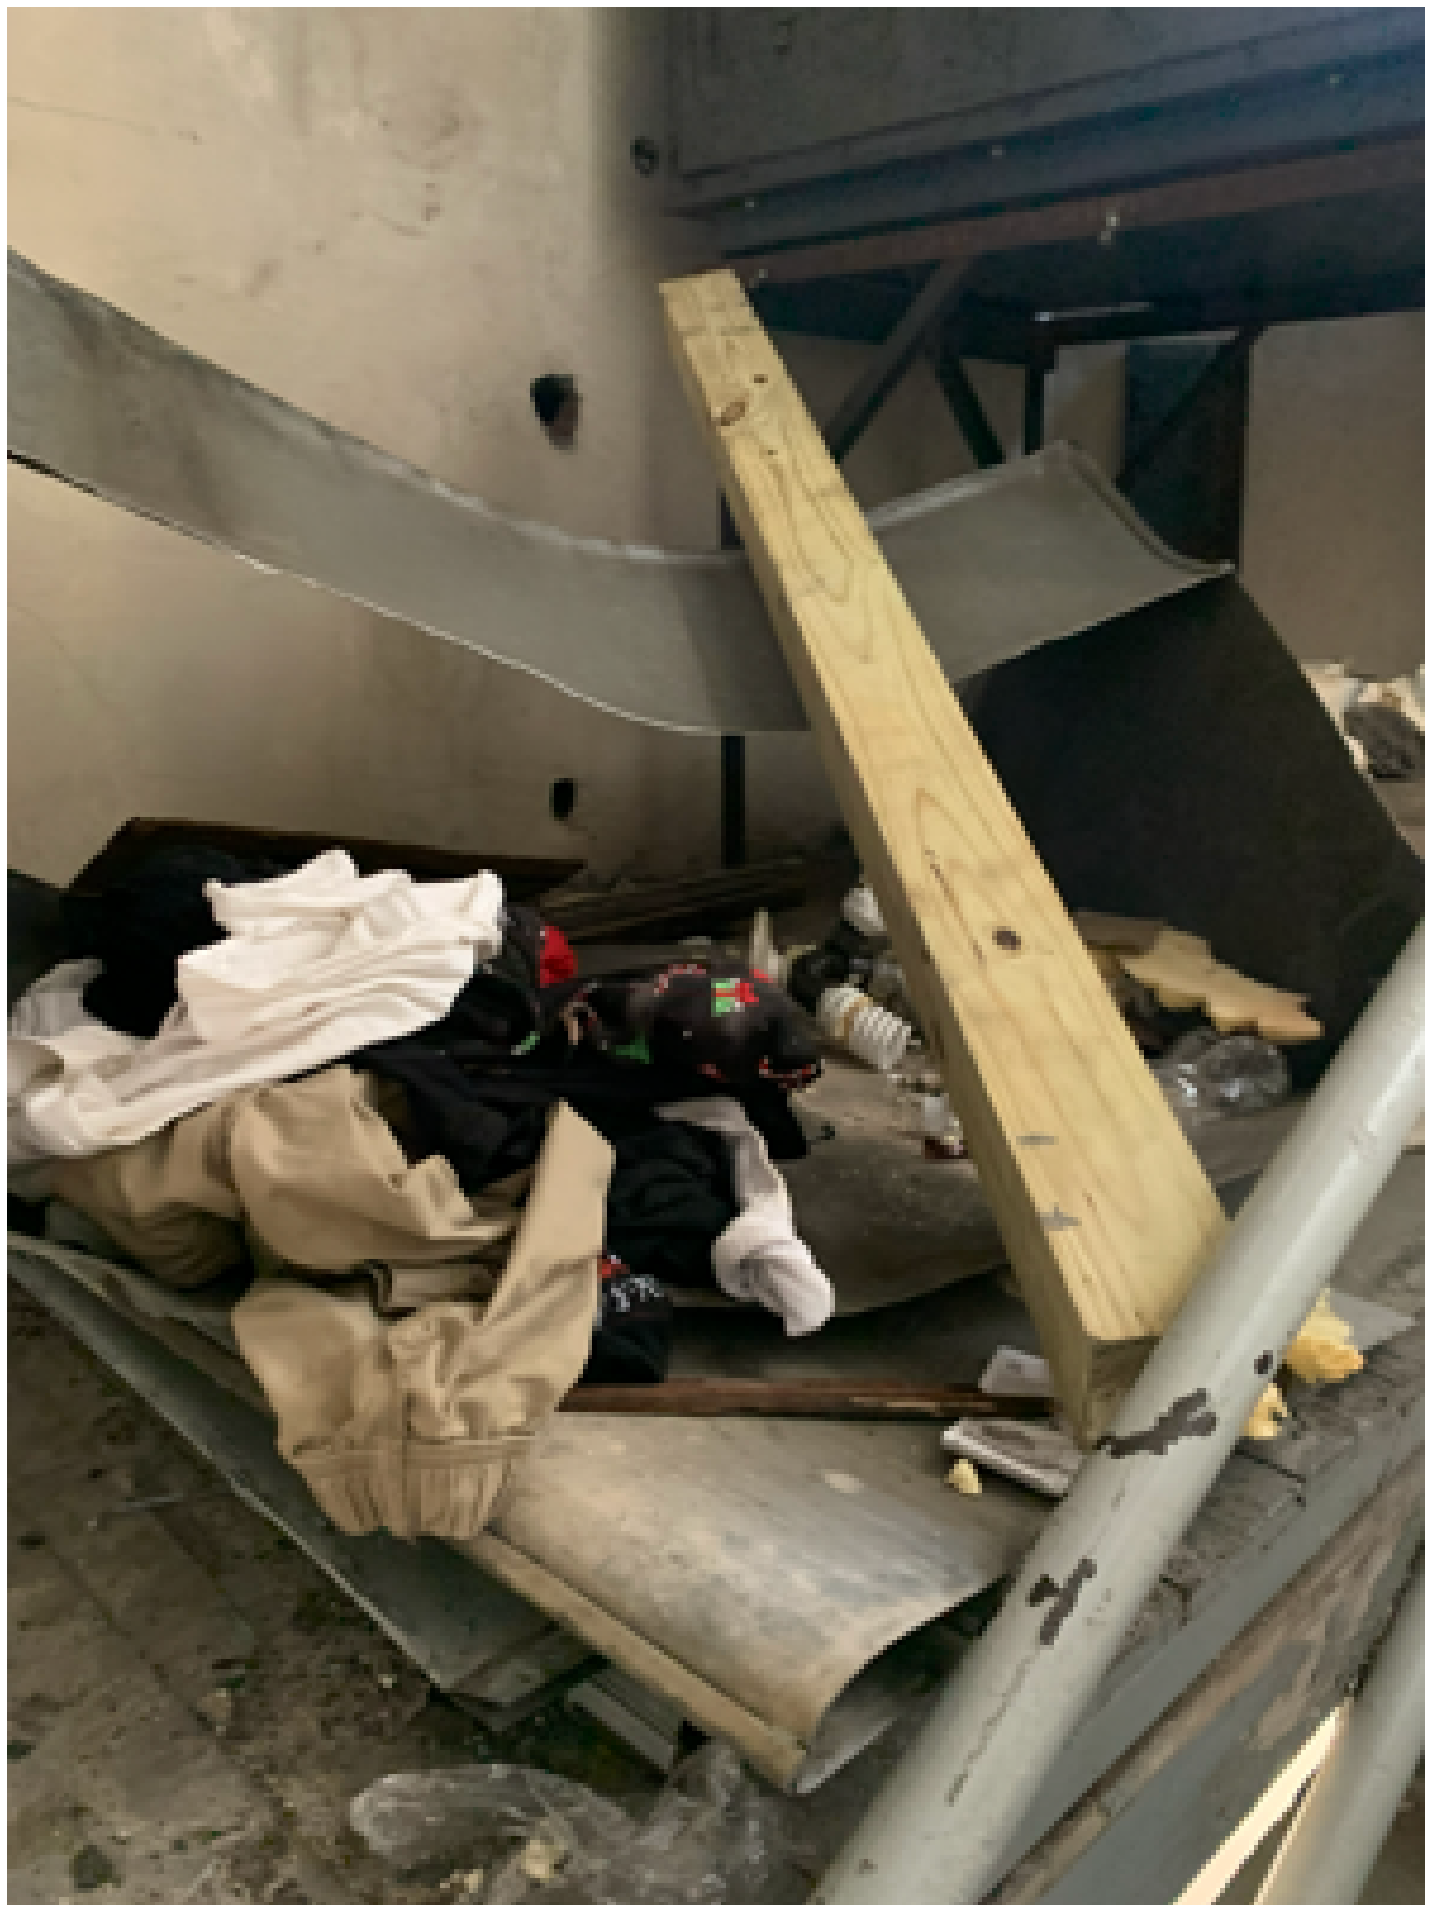
Dirty clothes, empty water bottles, used napkins, torn wrappers, and ashed cigarettes were found at the top of one of the stairwells.
