THE LAW SCHOOL
CLINICAL LAW CENTER

Press release concerning the living conditions at the Hoffman Hotel

March 19, 2026

NOTRE DAME LAW CLINIC PRESS RELEASE:

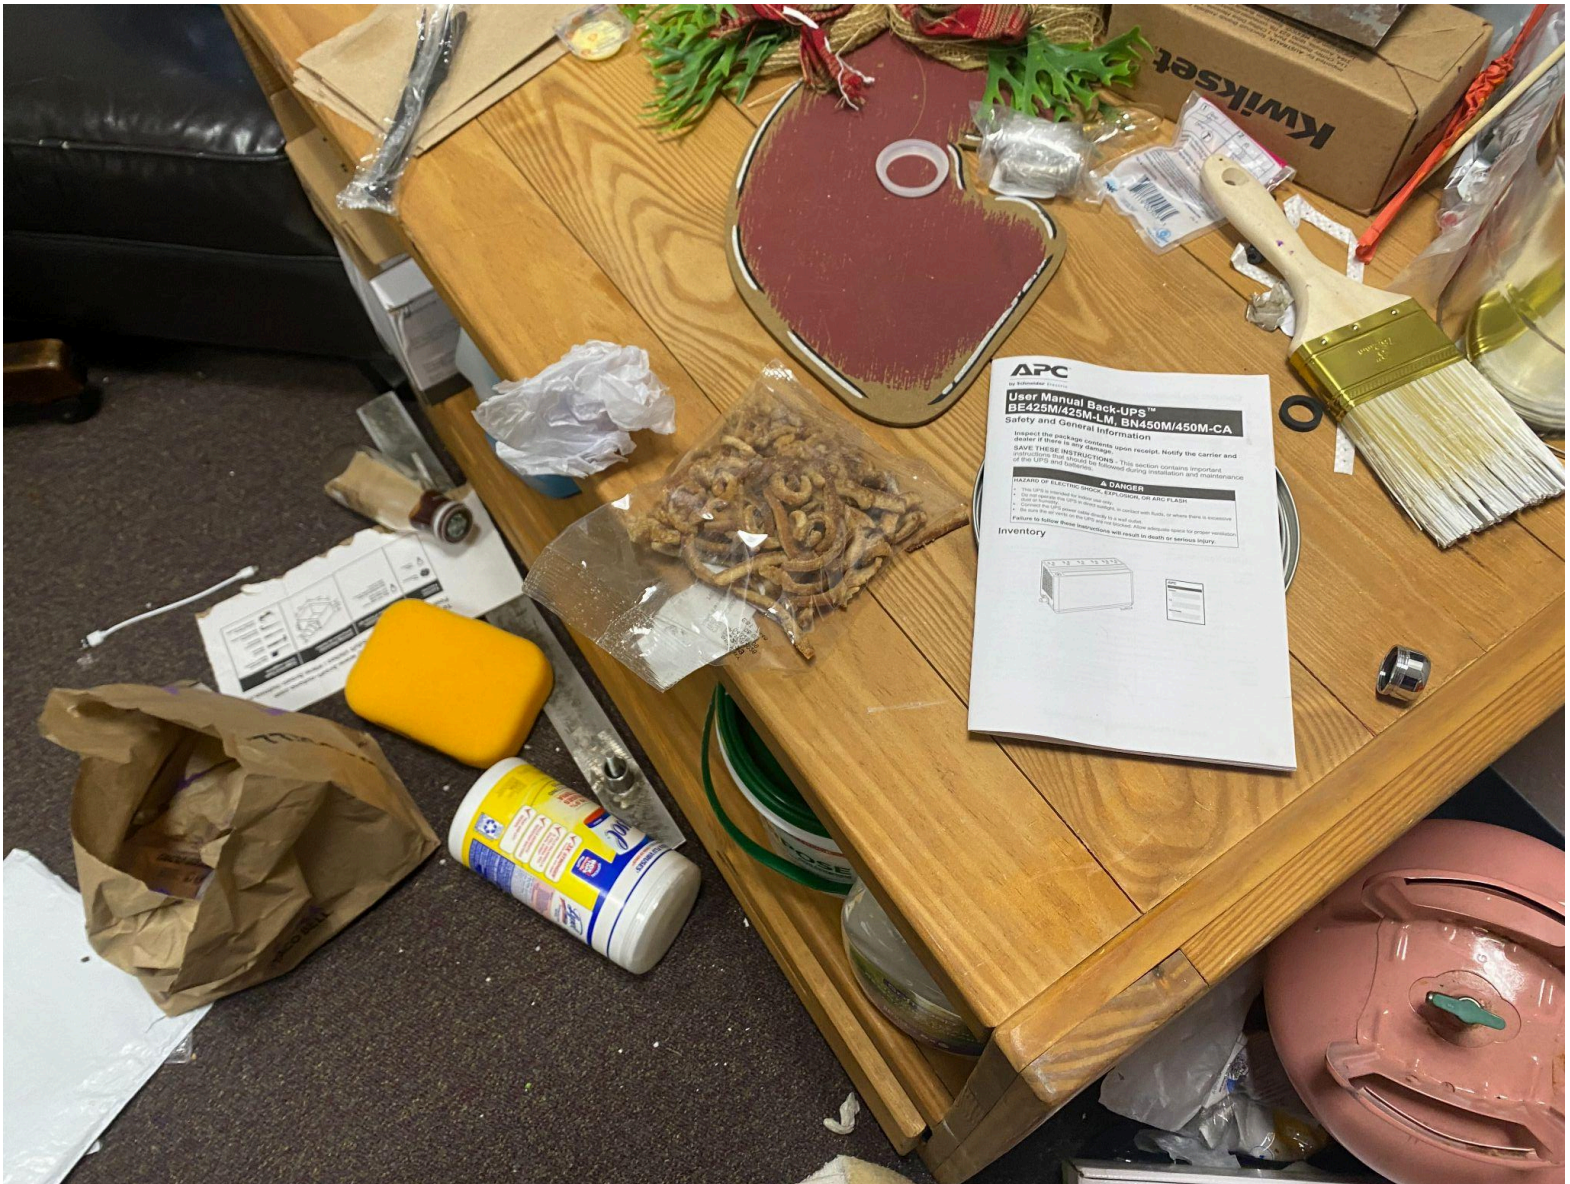
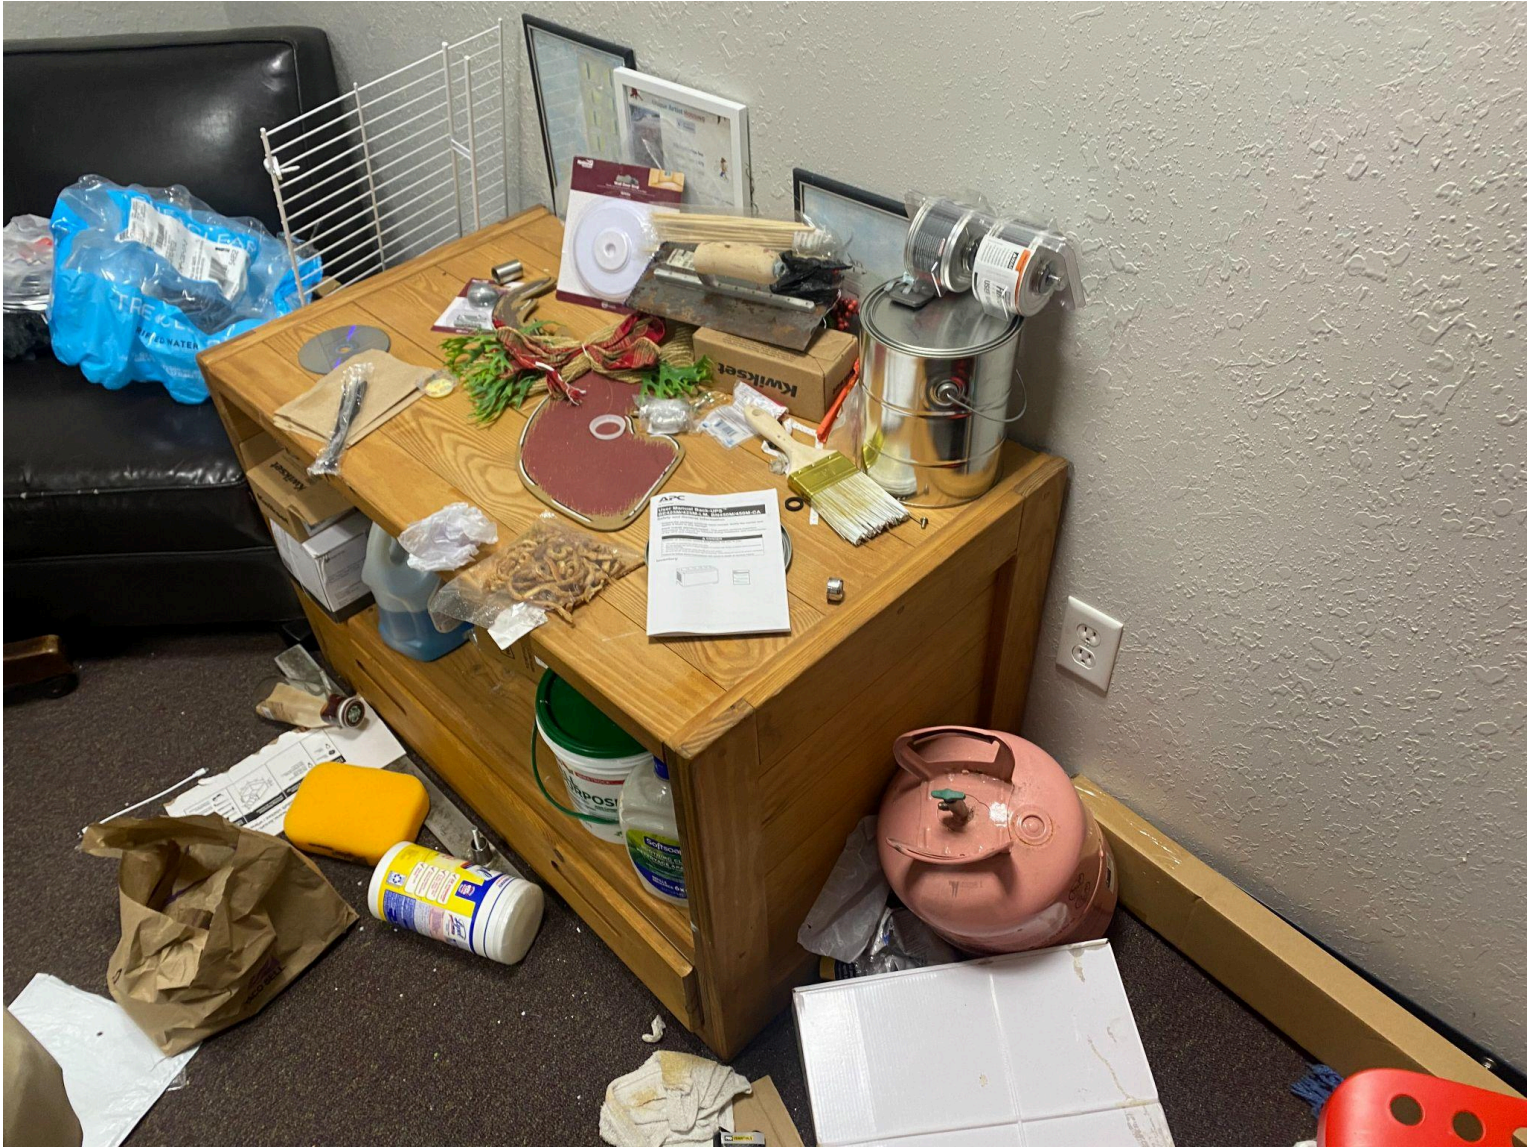
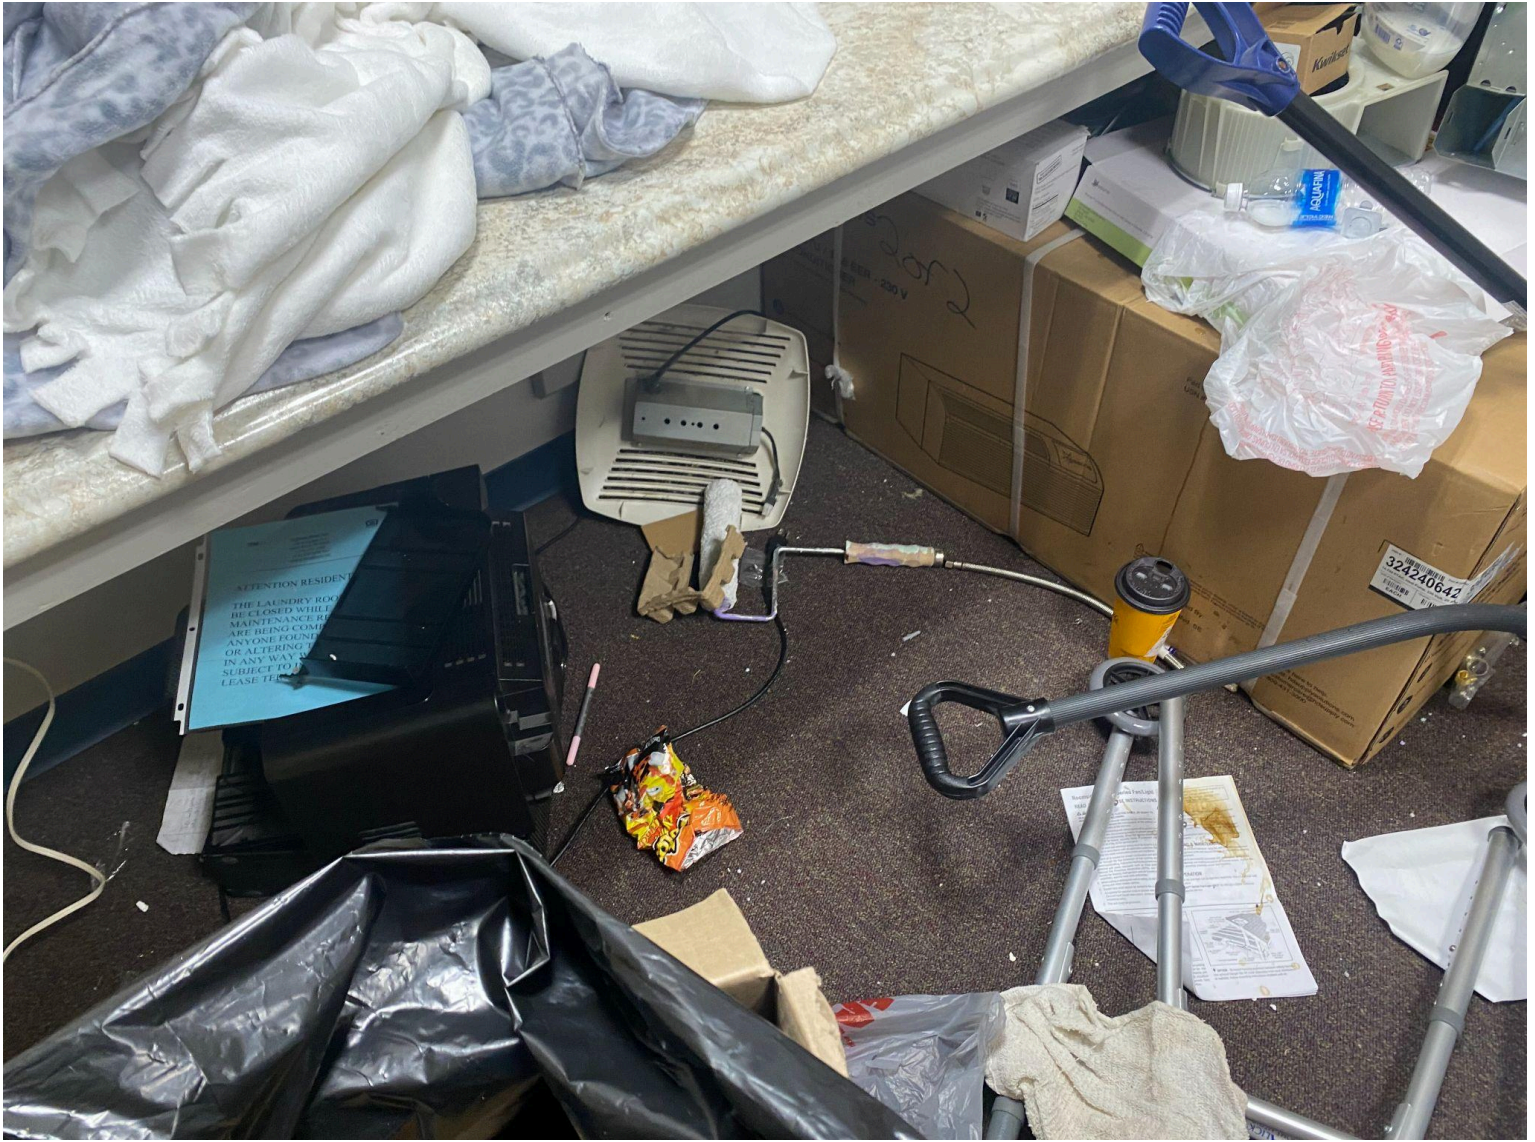
The Business Center, which once provided a set of computers that residents could use free of charge, is now full of garbage, including a propane tank that may have been used by a non-resident to heat the room while sleeping there.

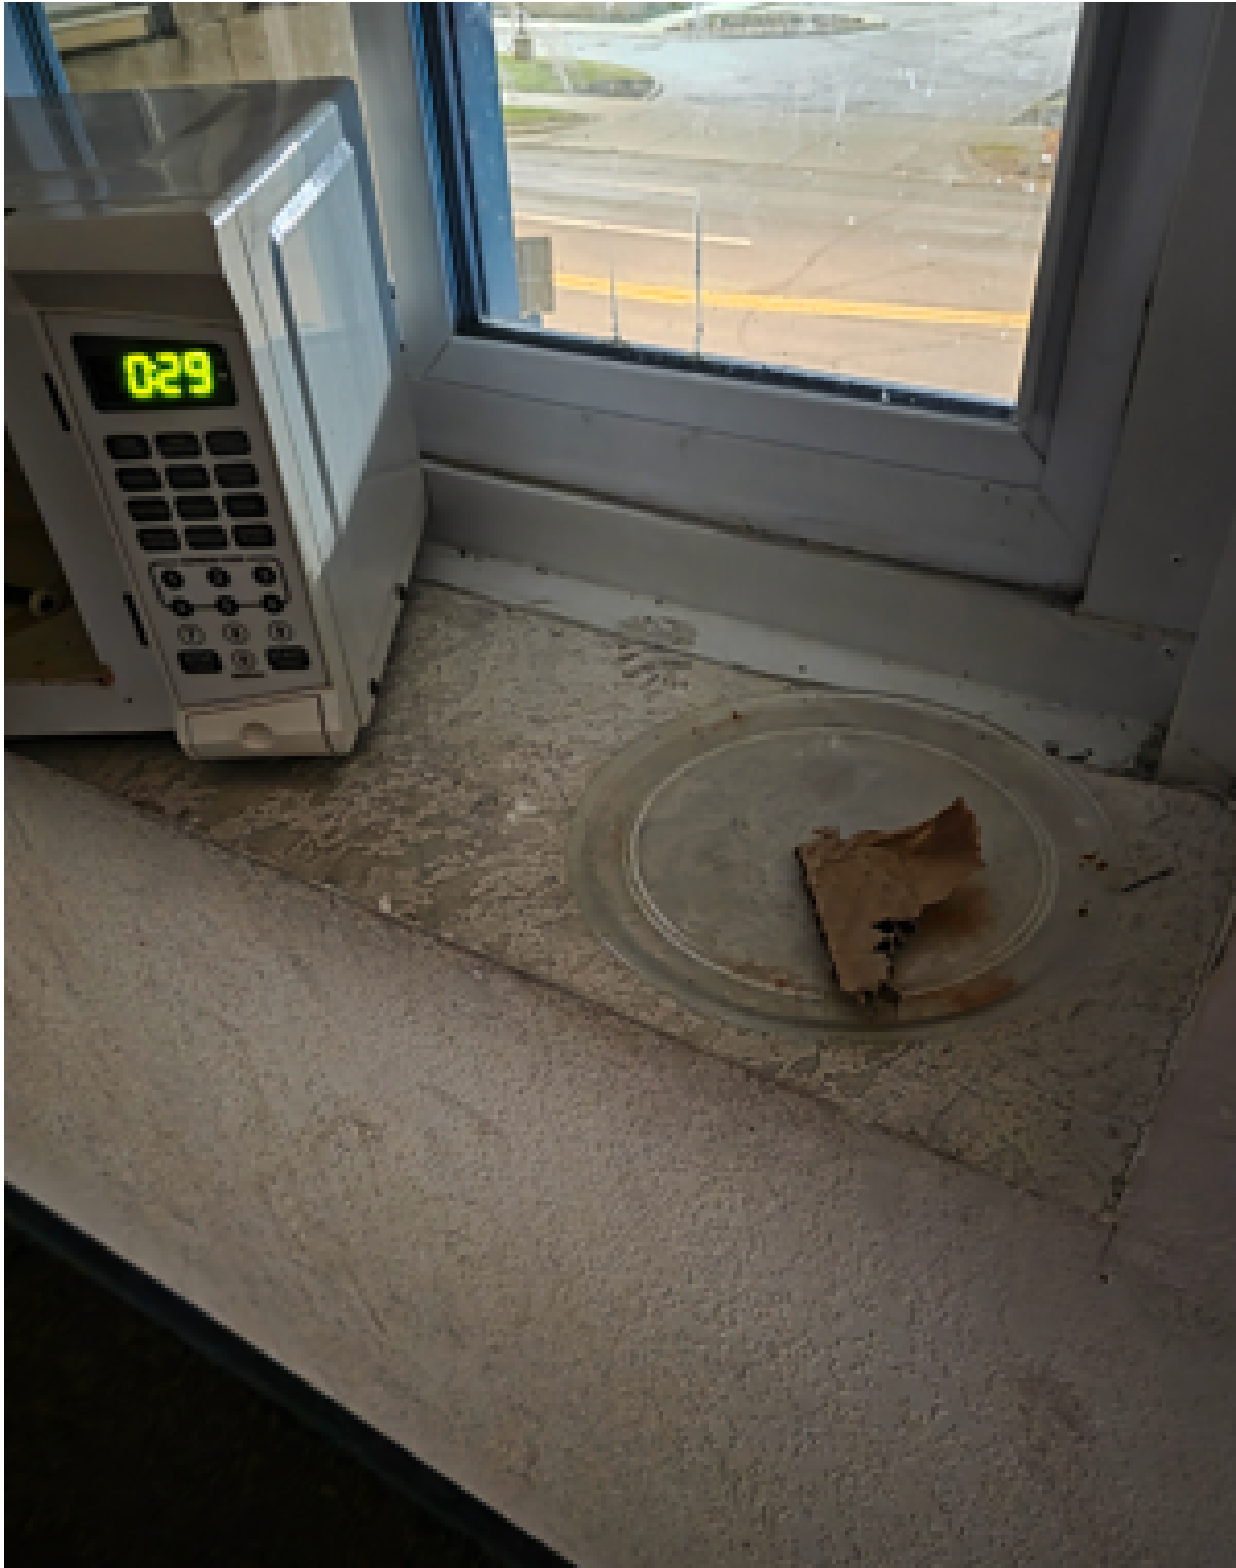
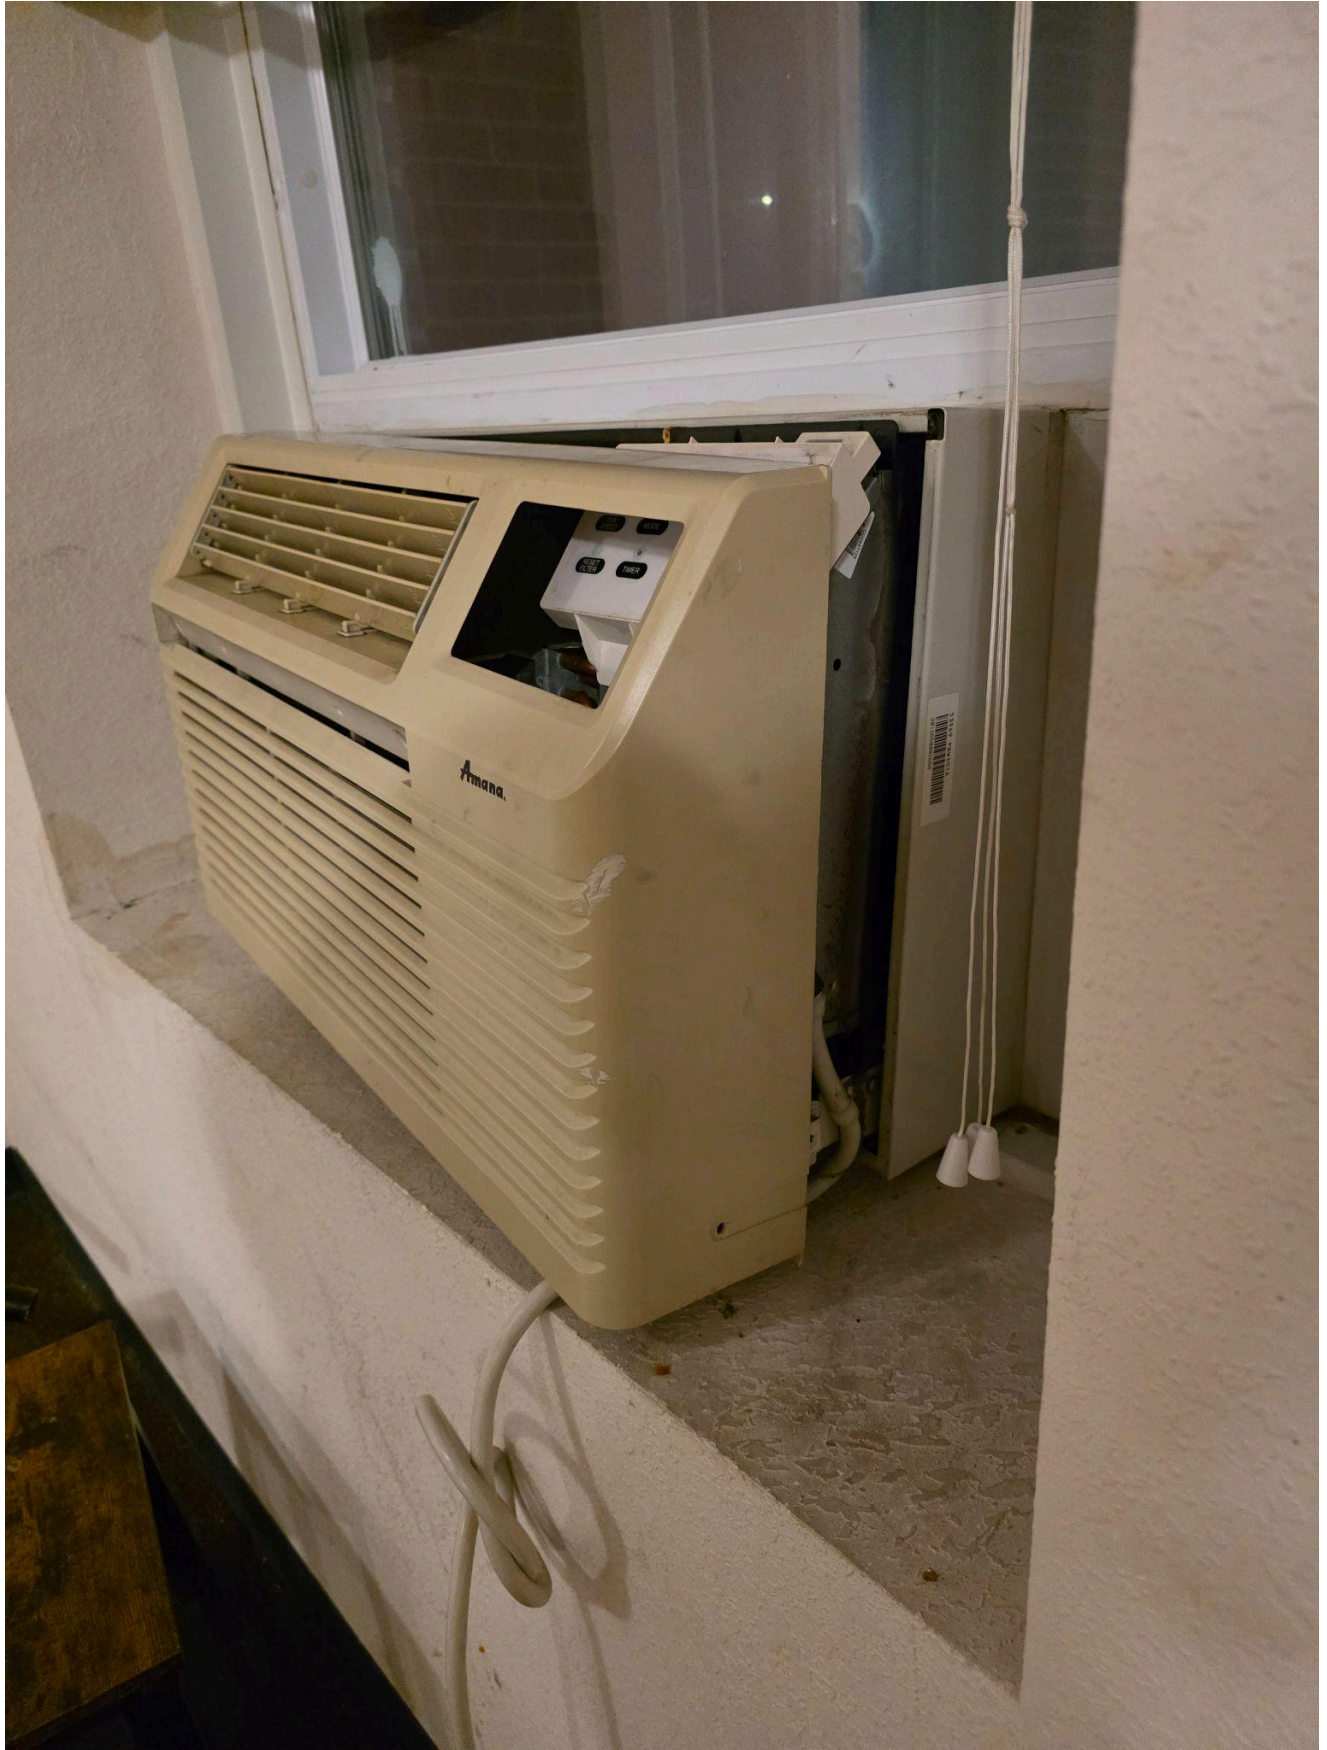
In the former fitness room, it appears that the window unit heating the room has been tampered with. There was a mini-mattress on the ground, and on the windowsill, a microwave was found next to a dish holding what seemed to be an unfinished and rotting Pop-Tart.

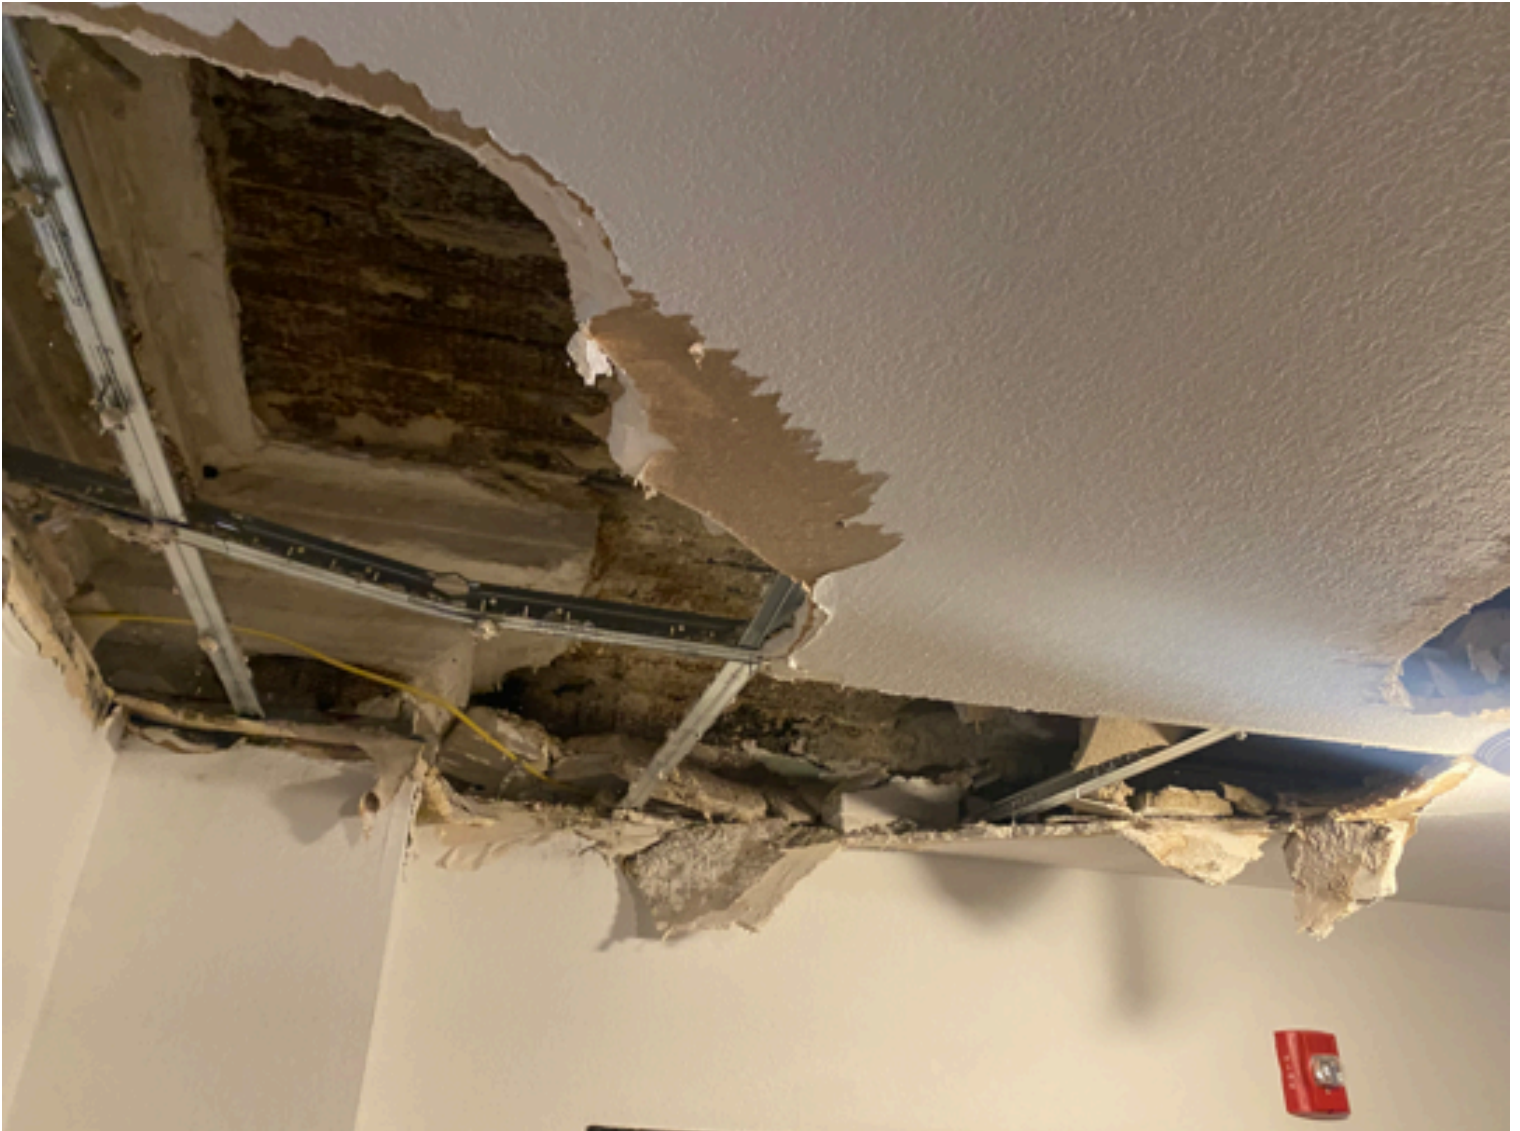
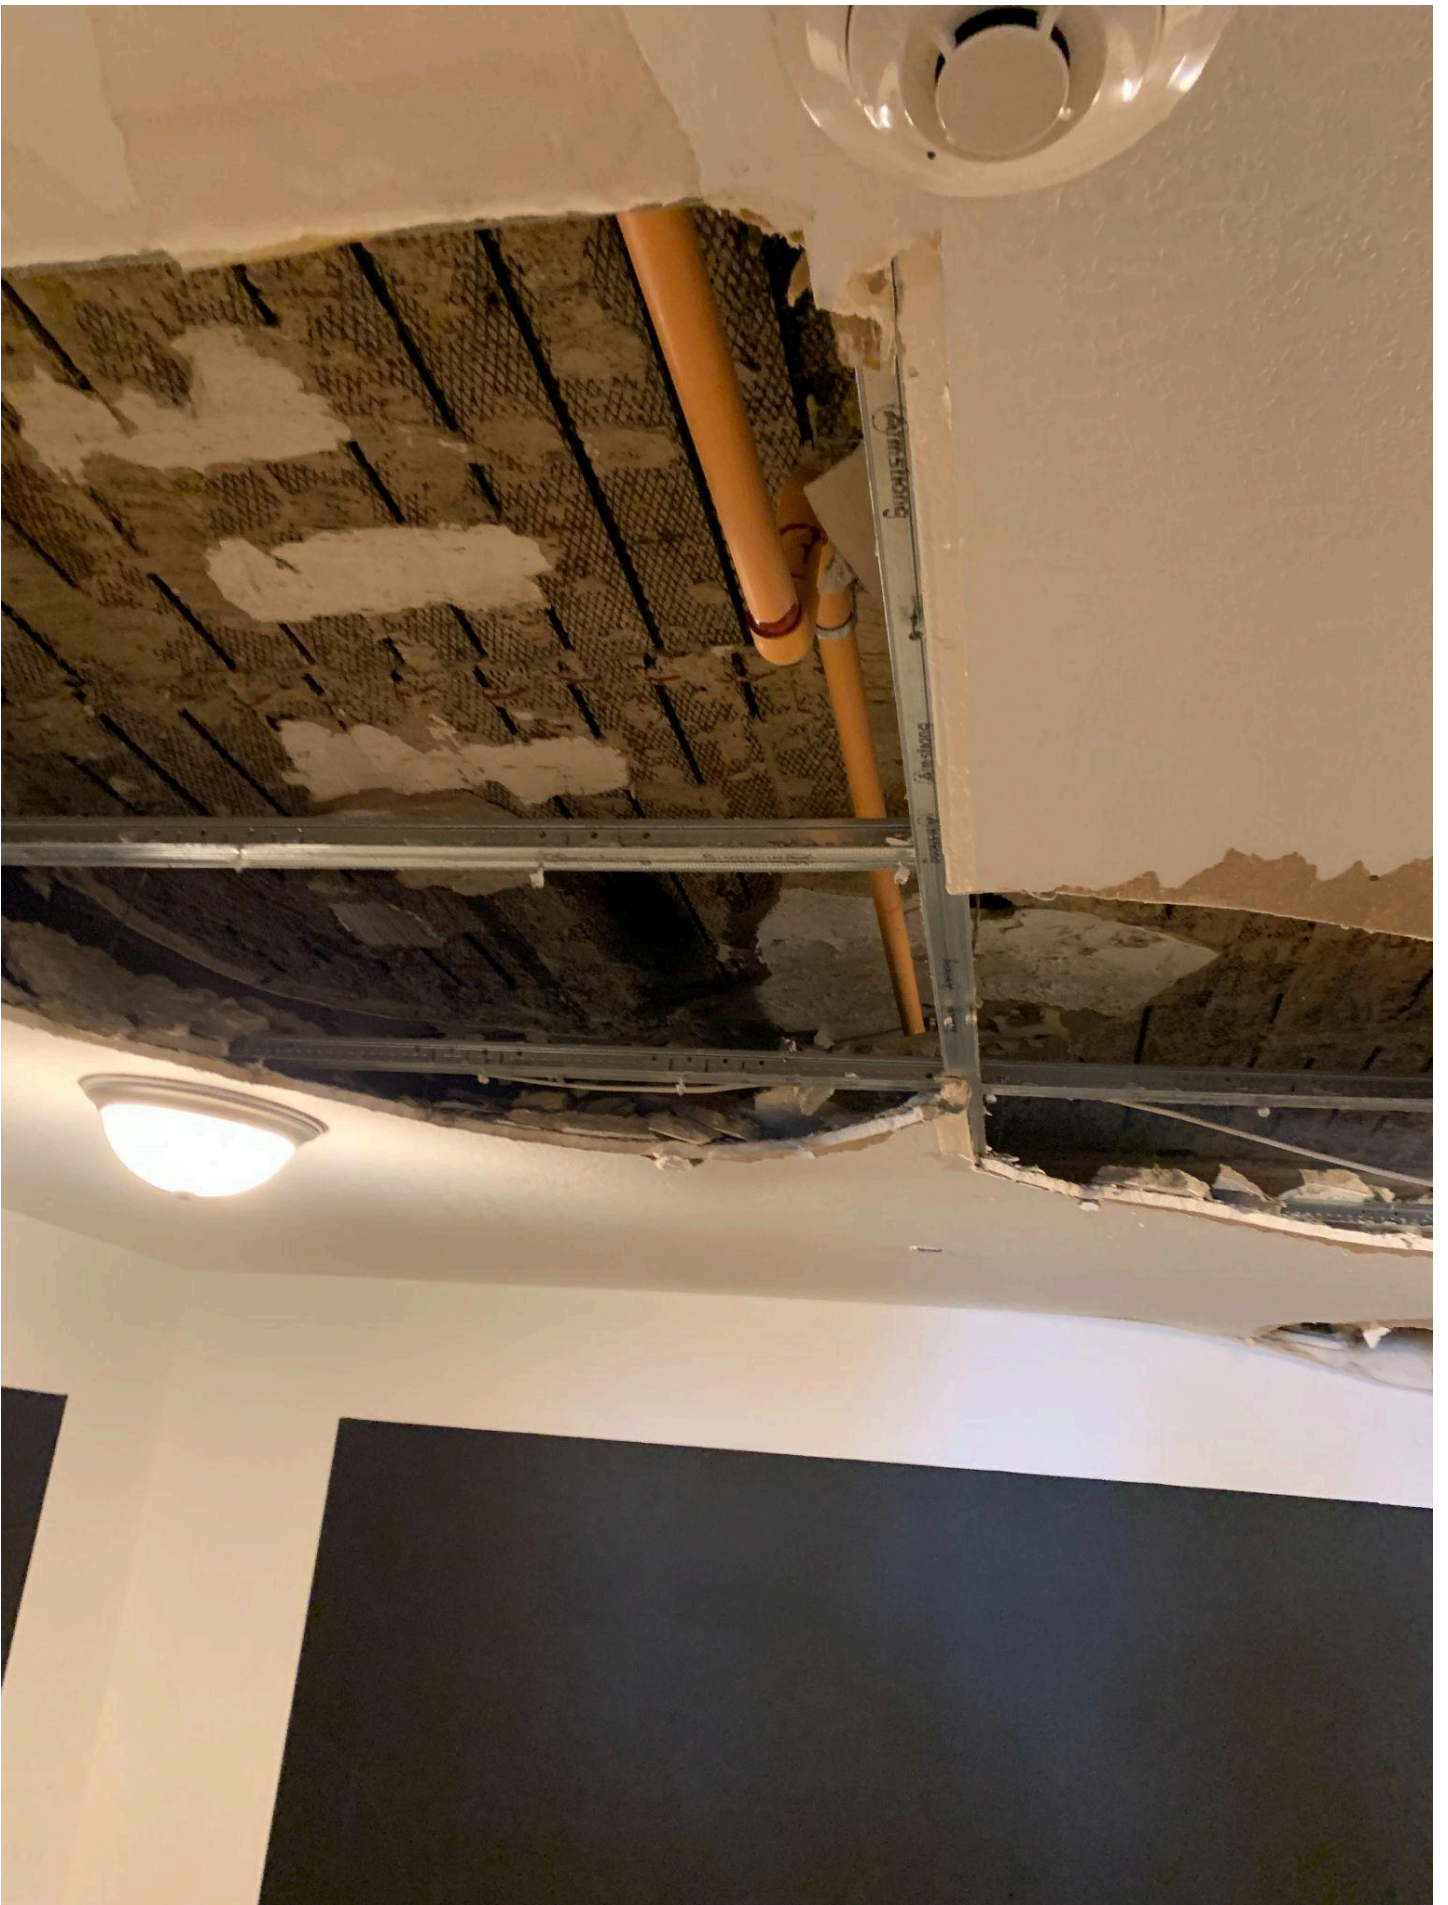
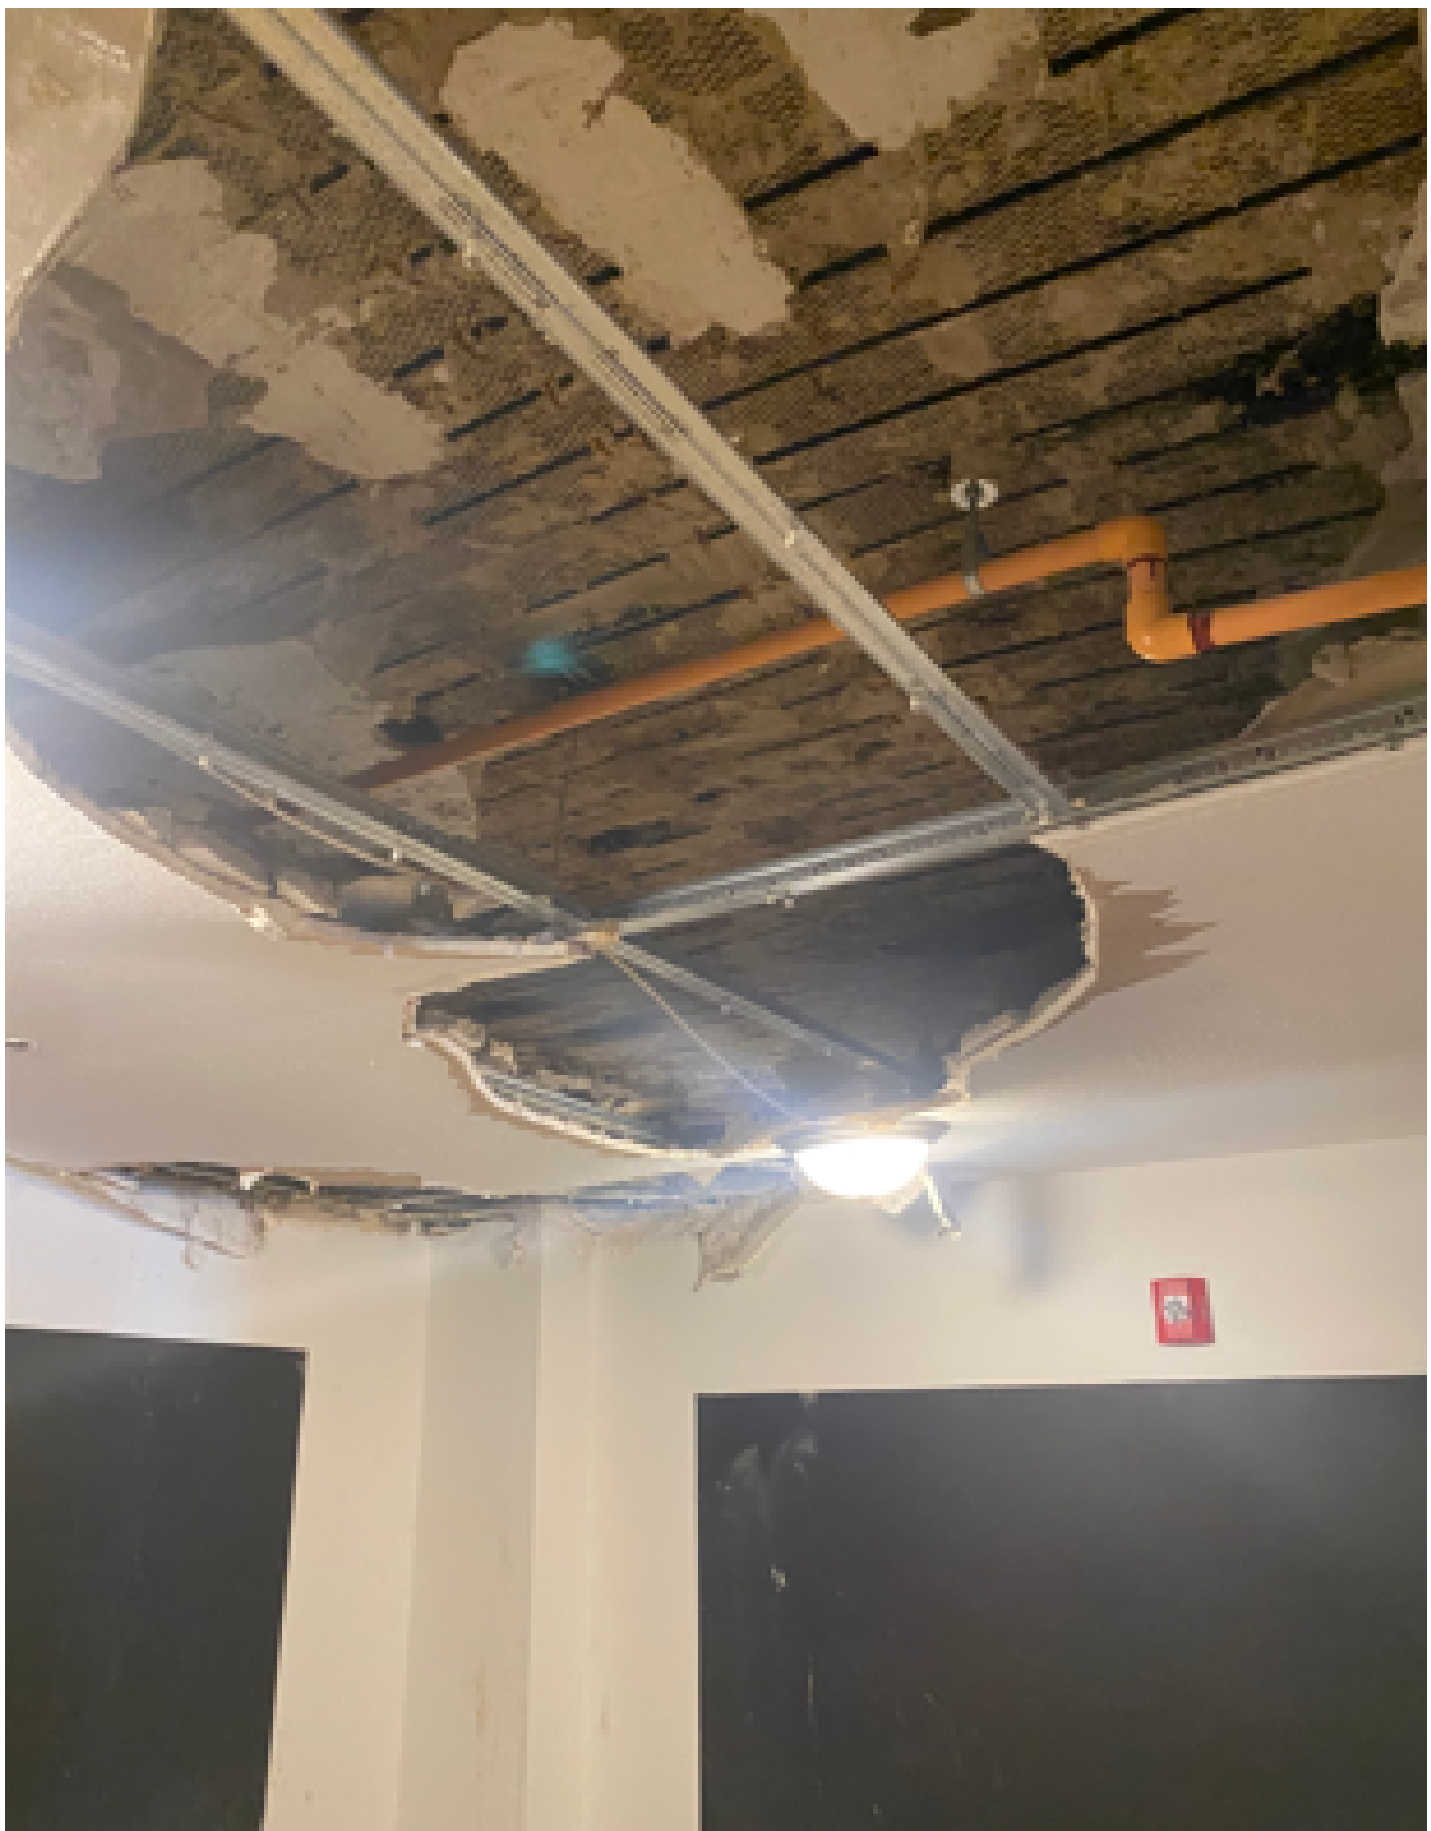
Many common areas in the Hoffman Hotel appear to suffer from construction defects or warrant massive, urgent repairs. One of the clearest examples of this is the previously mentioned music room, where photographs of drug paraphernalia were taken. In the picture directly below, the metal bar supporting the ceiling is bending towards the ground, suggesting that it has been permanently damaged. Tenants surmised that non-residents use the exposed ceilings to store their goods. The music room has since been locked.

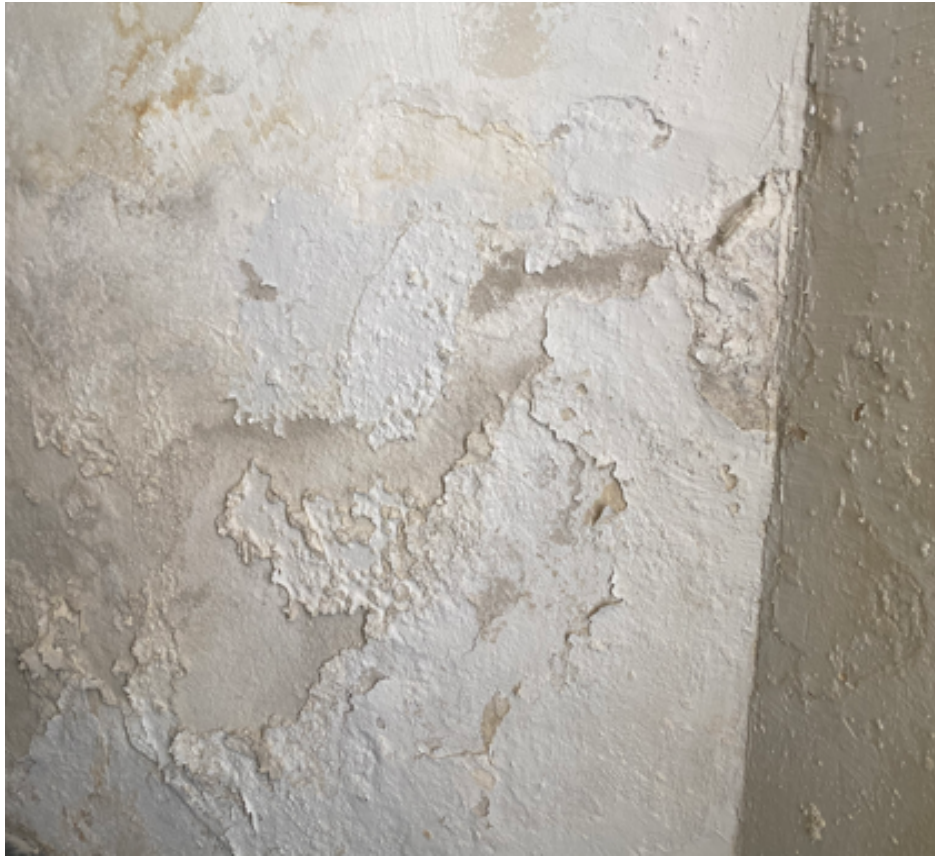
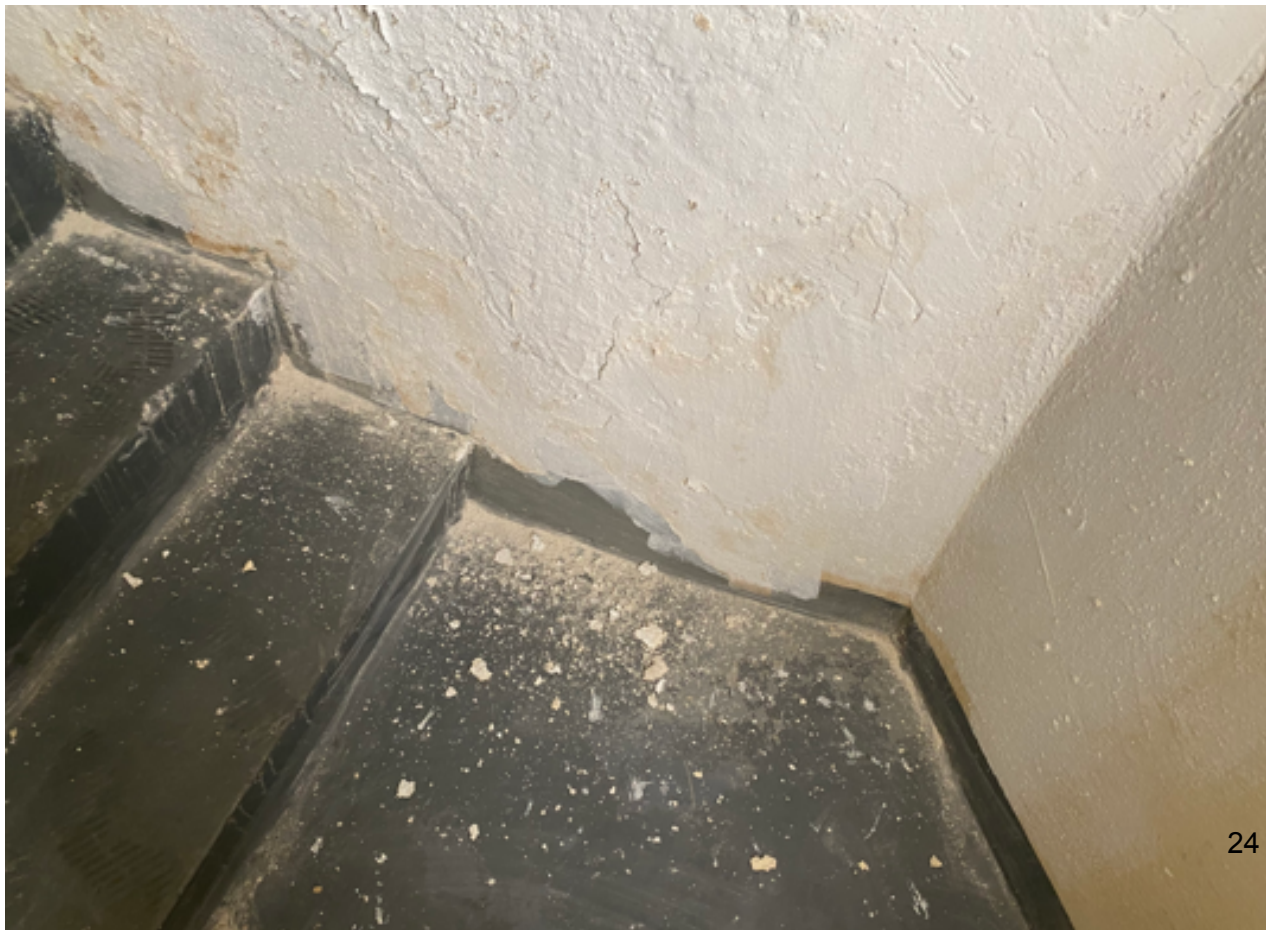
In the stairwells, there are clear signs of water damage to the walls. Residents claimed that this damage was a result of improper maintenance, beginning sometime during 2020.
