THE LAW SCHOOL
CLINICAL LAW CENTER

Press release concerning the living conditions at the Hoffman Hotel

March 19, 2026

NOTRE DAME LAW CLINIC PRESS RELEASE:

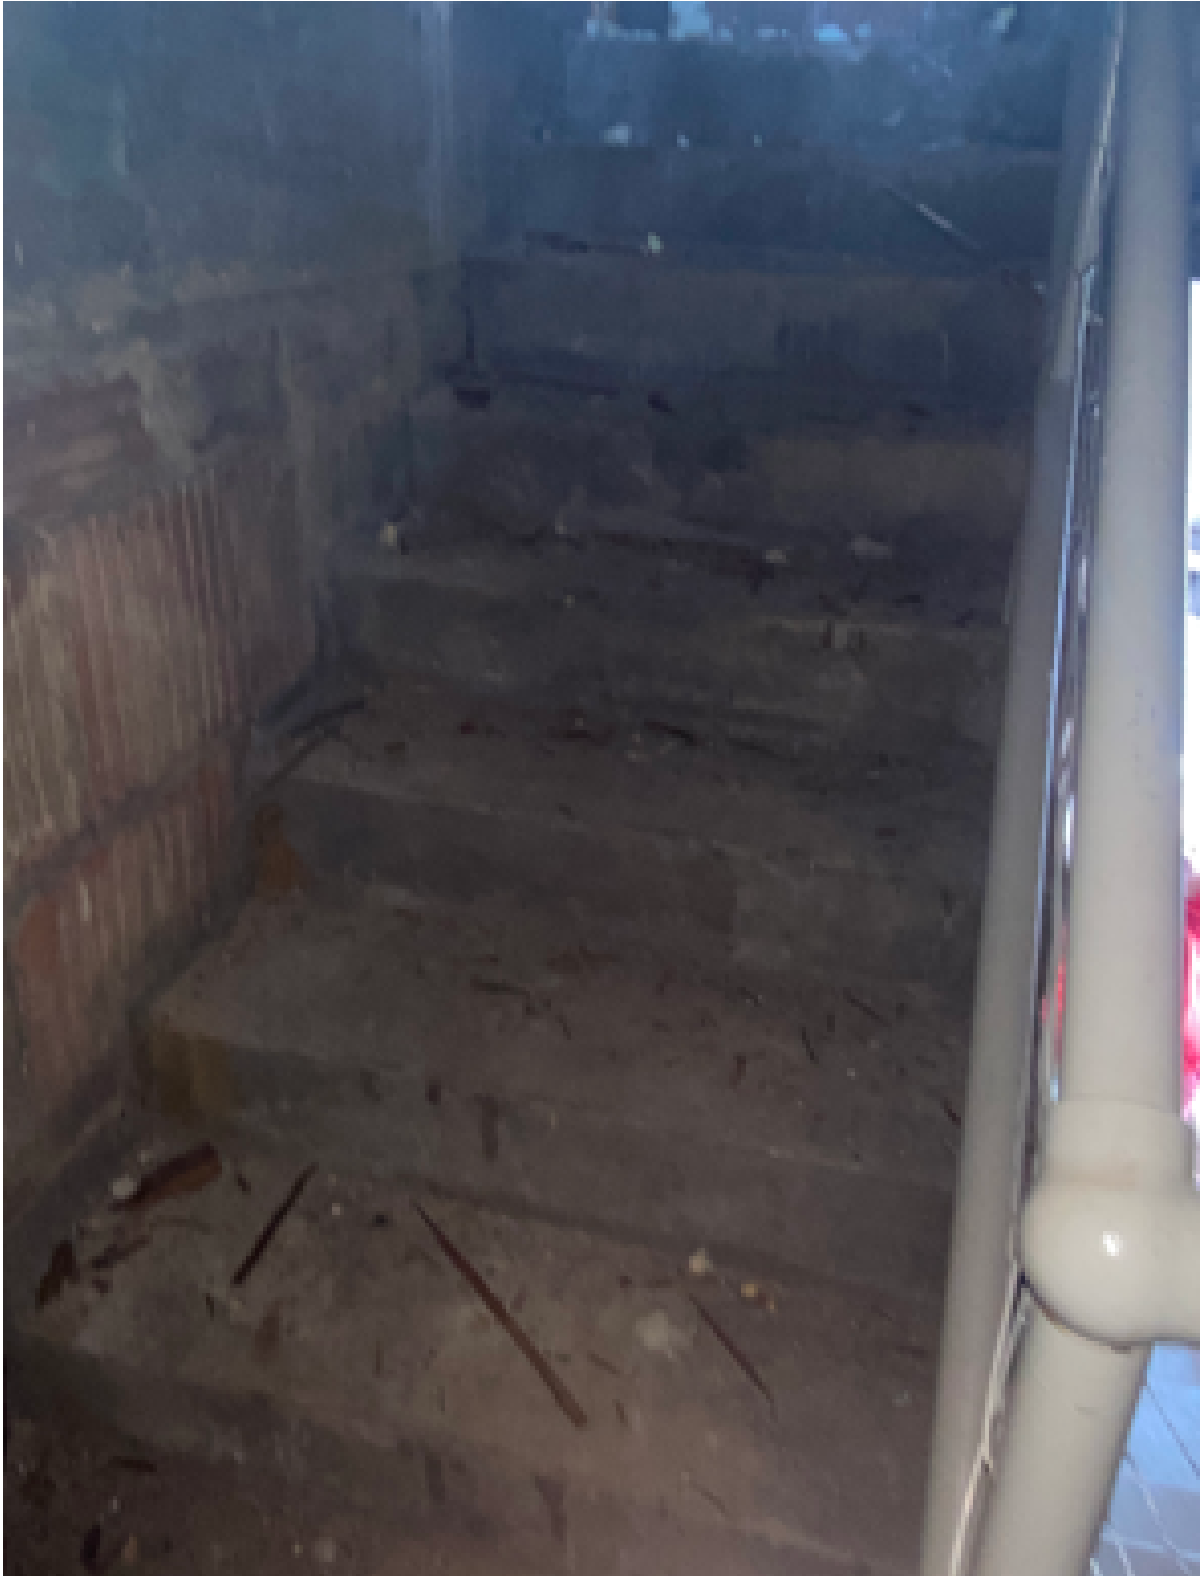
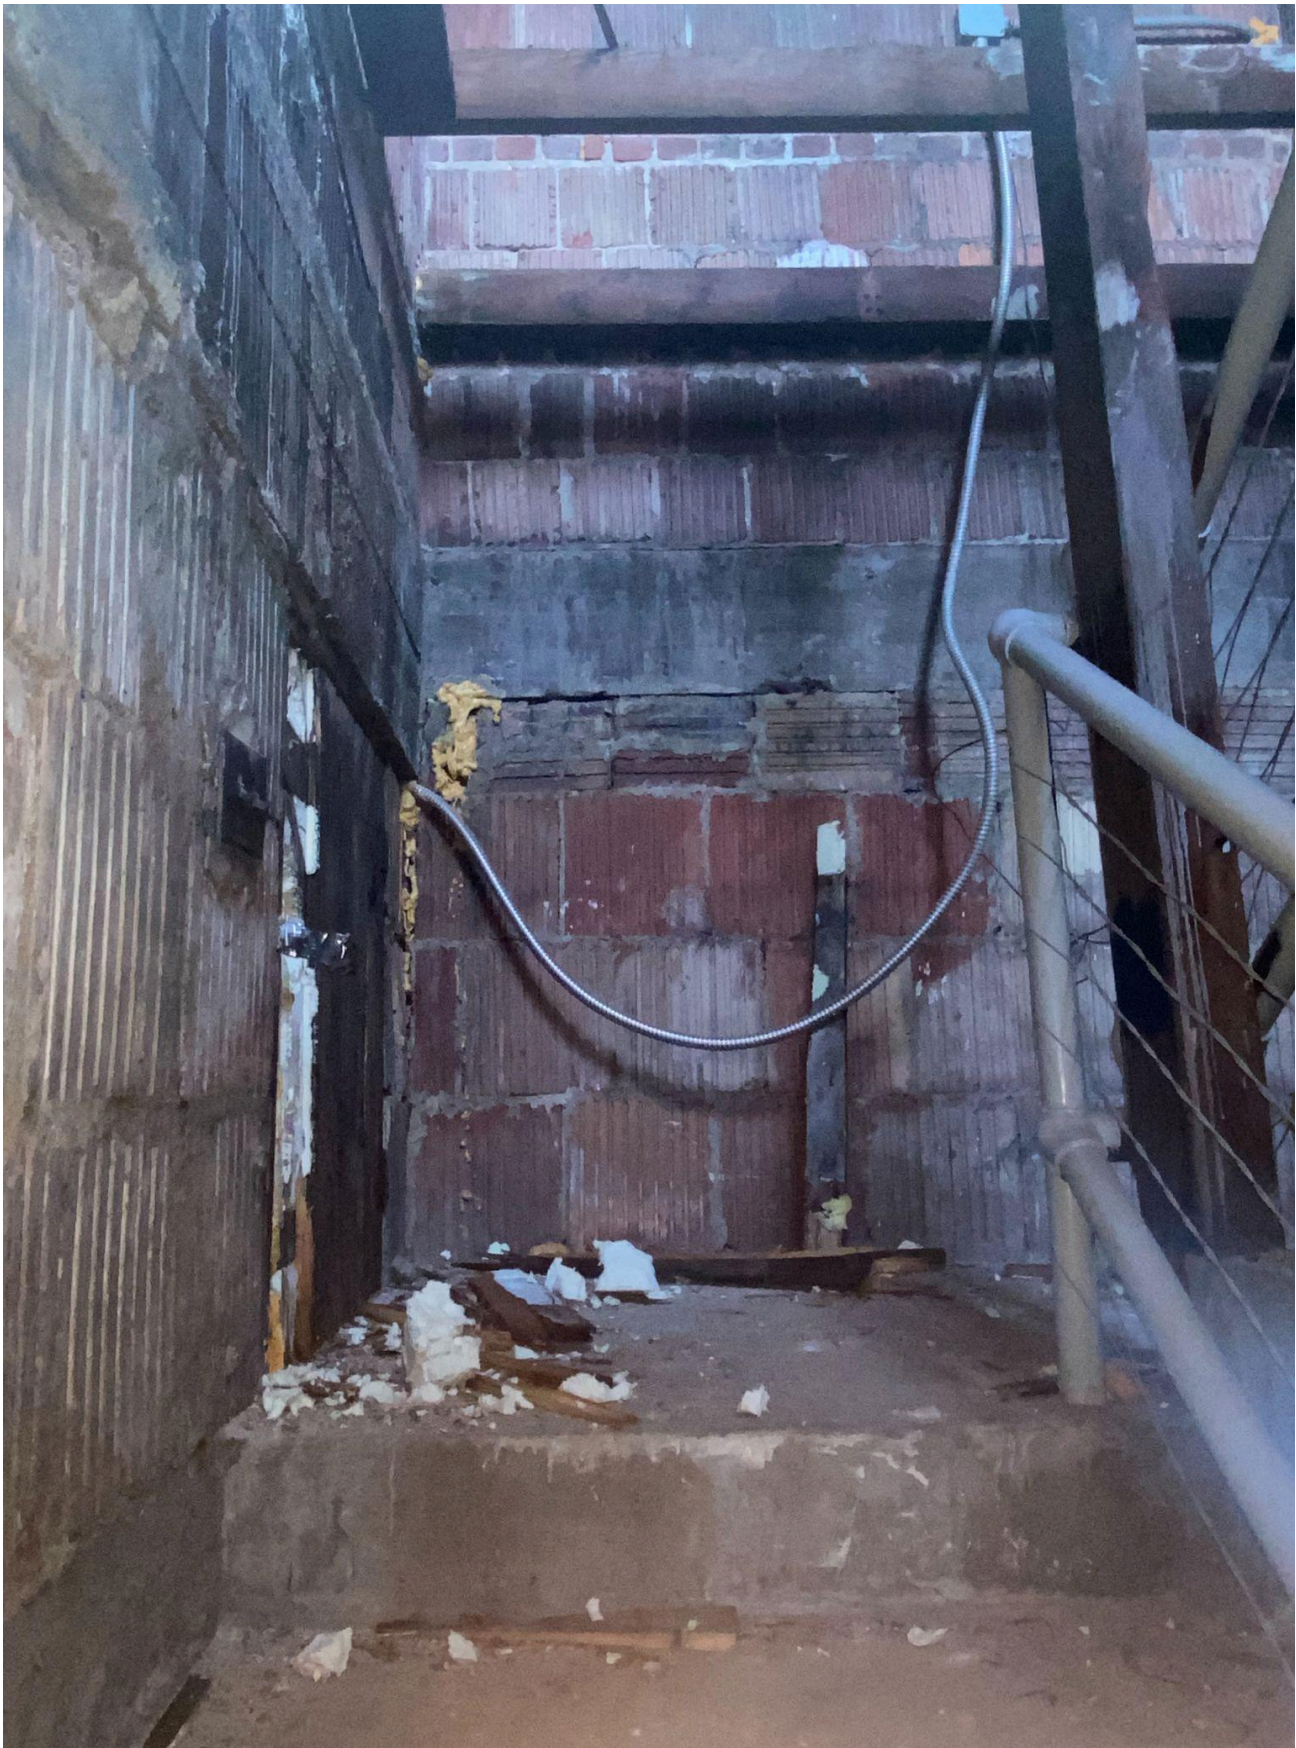
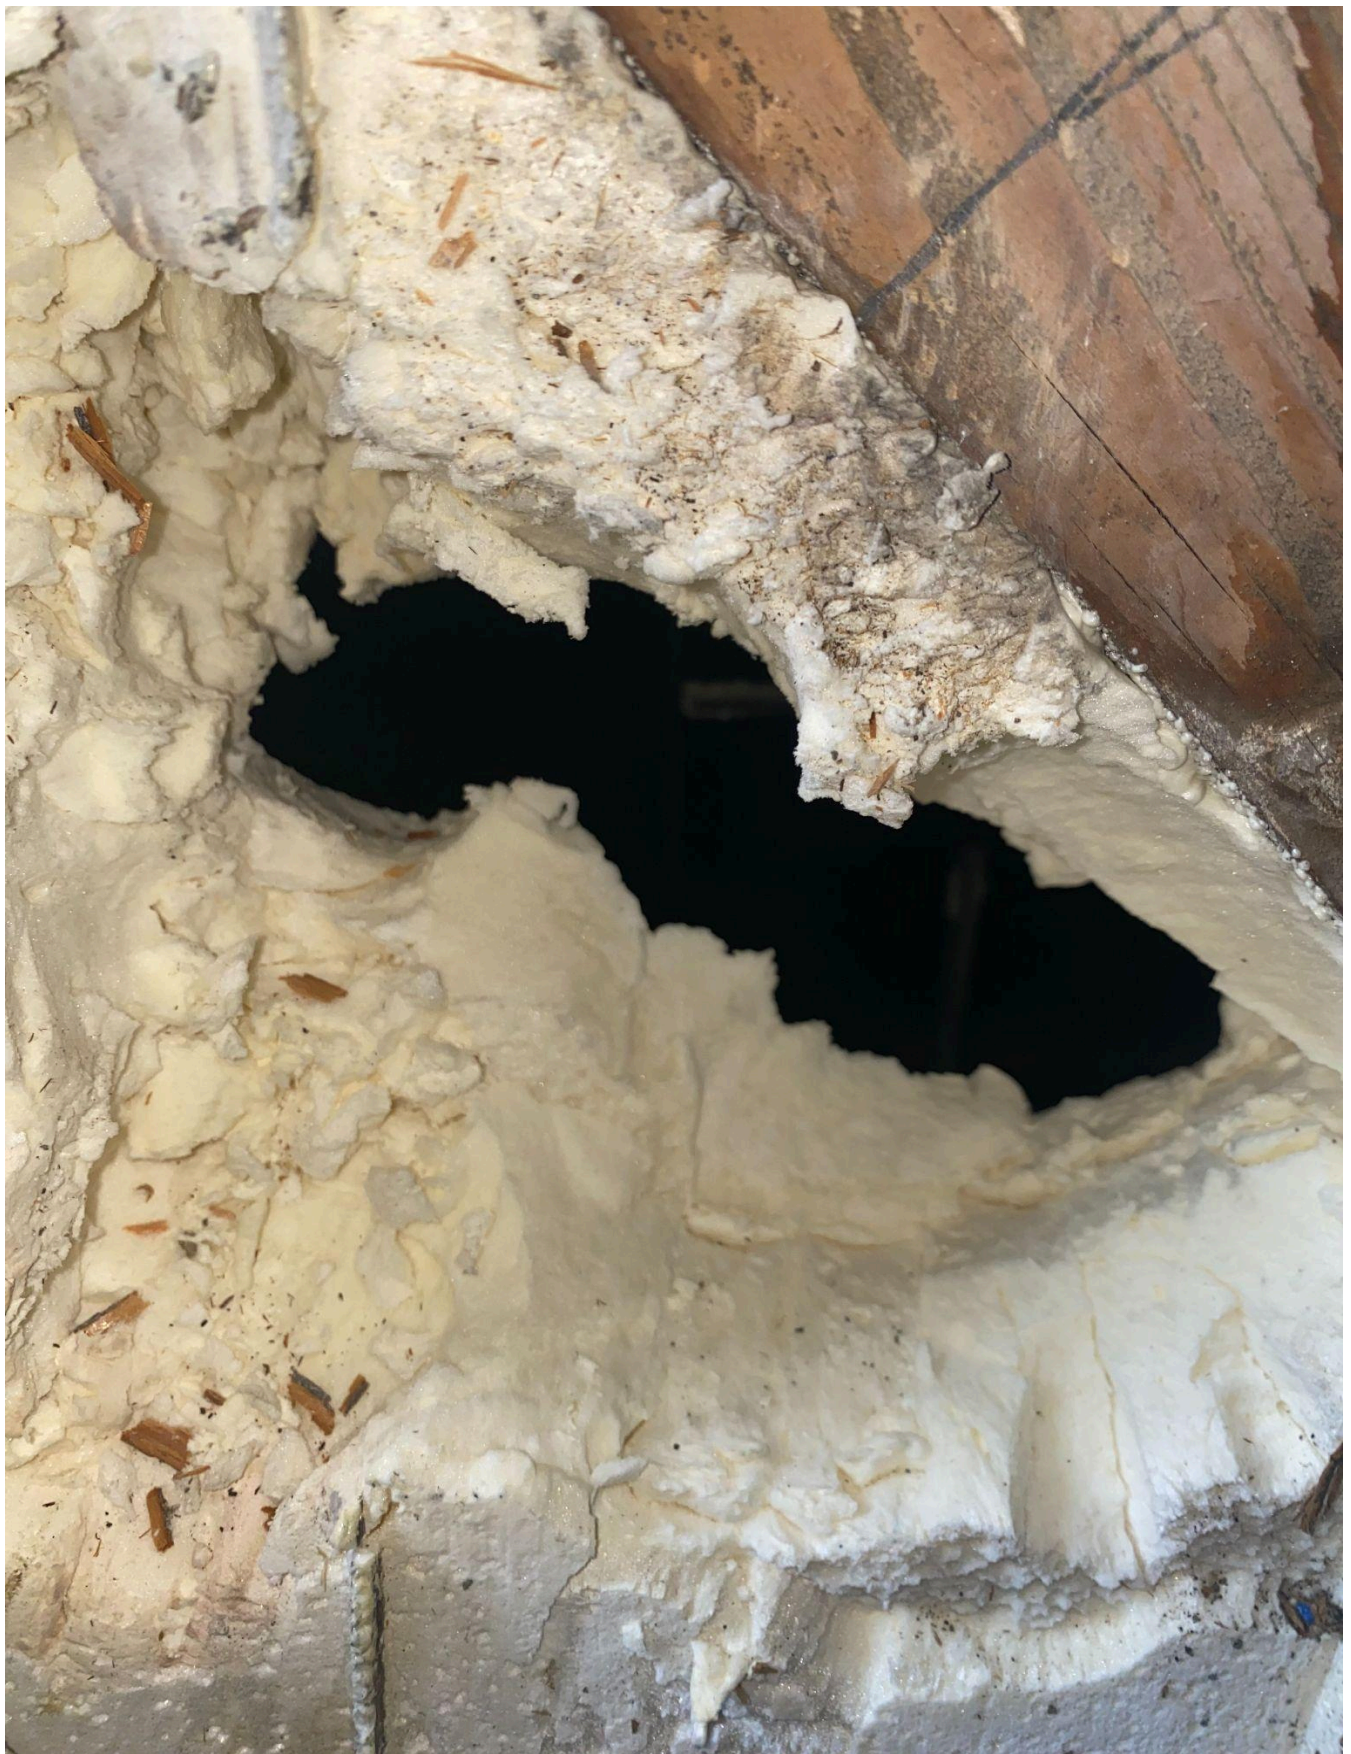
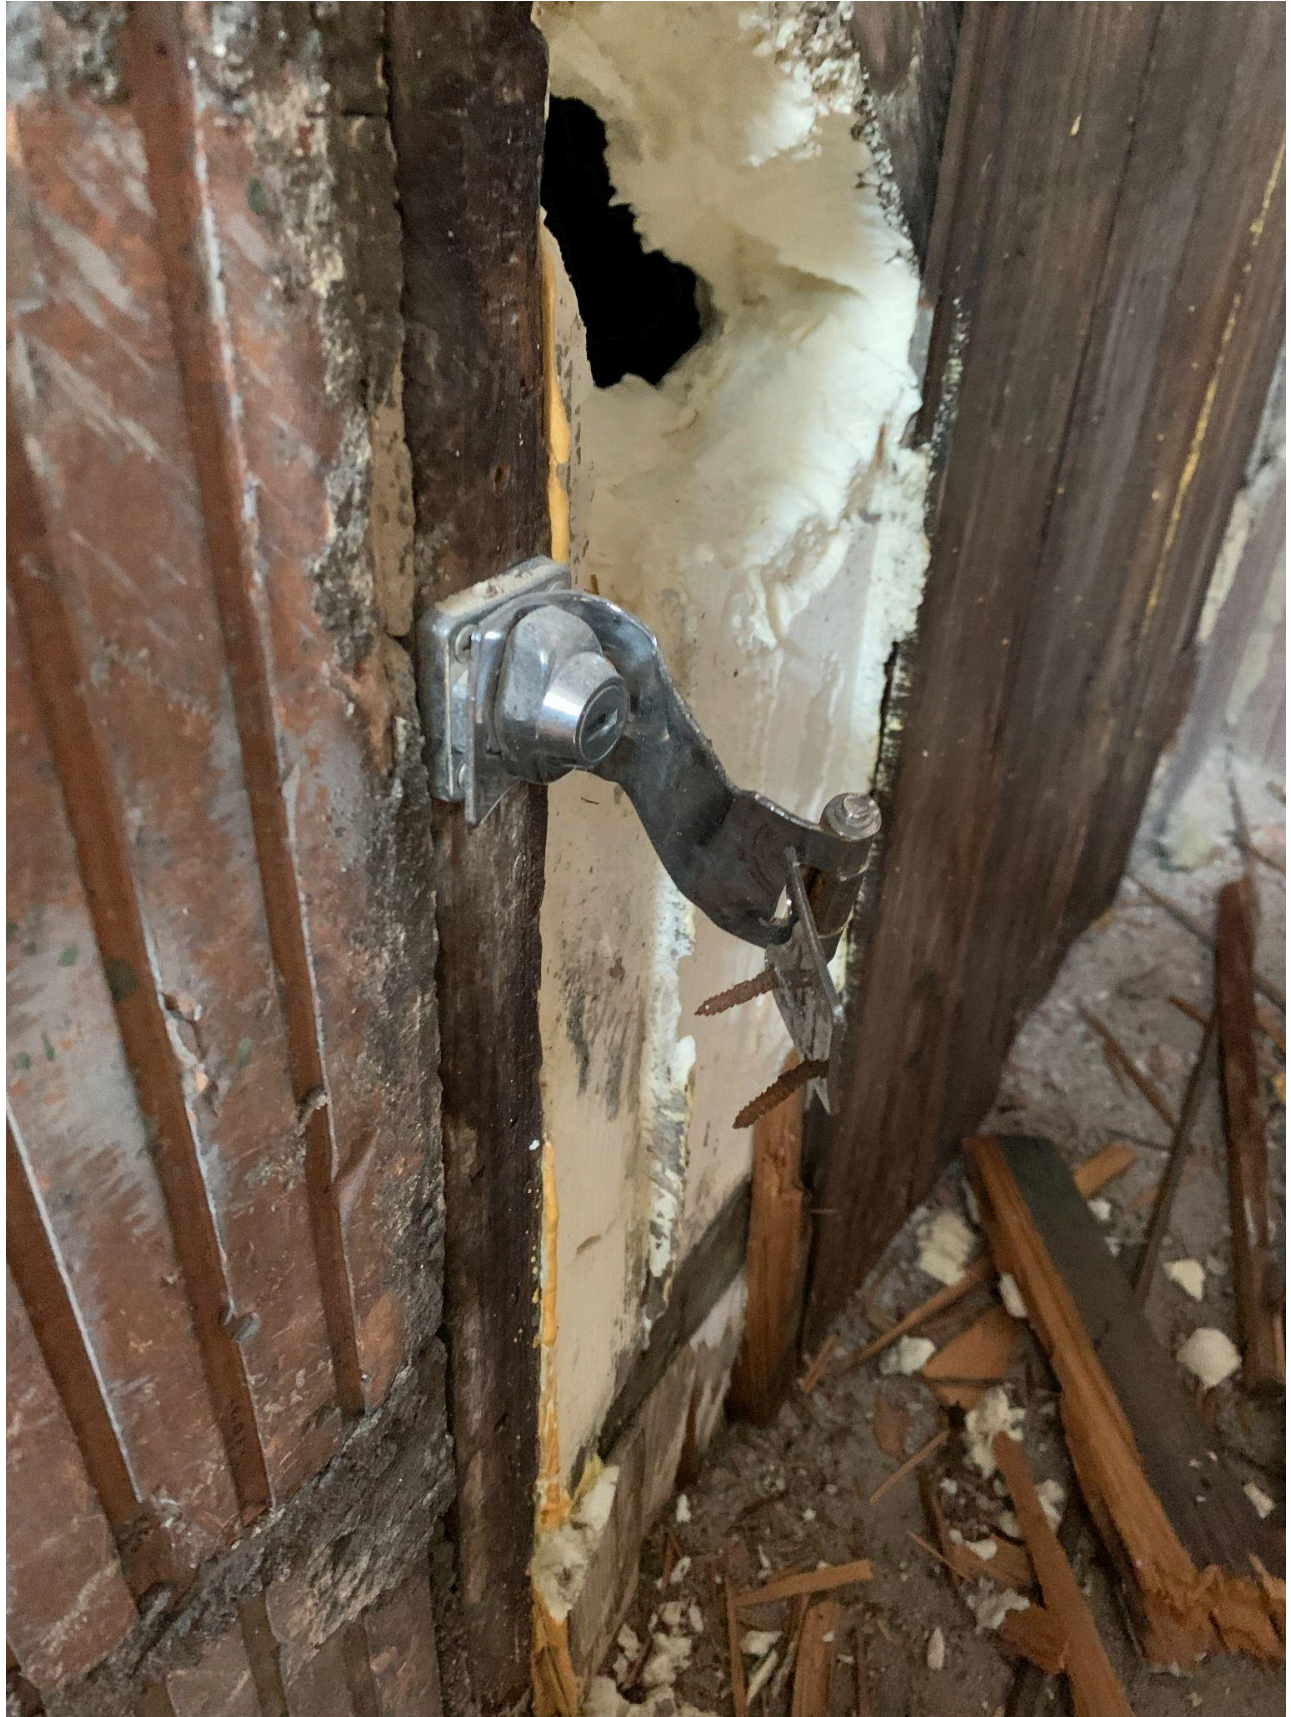
At the top of one of the two stairwells, there was debris from the walls littering the steps, exposed wiring, nails jutting out of the walls, and a hole in the walls leading to a cavernous space.

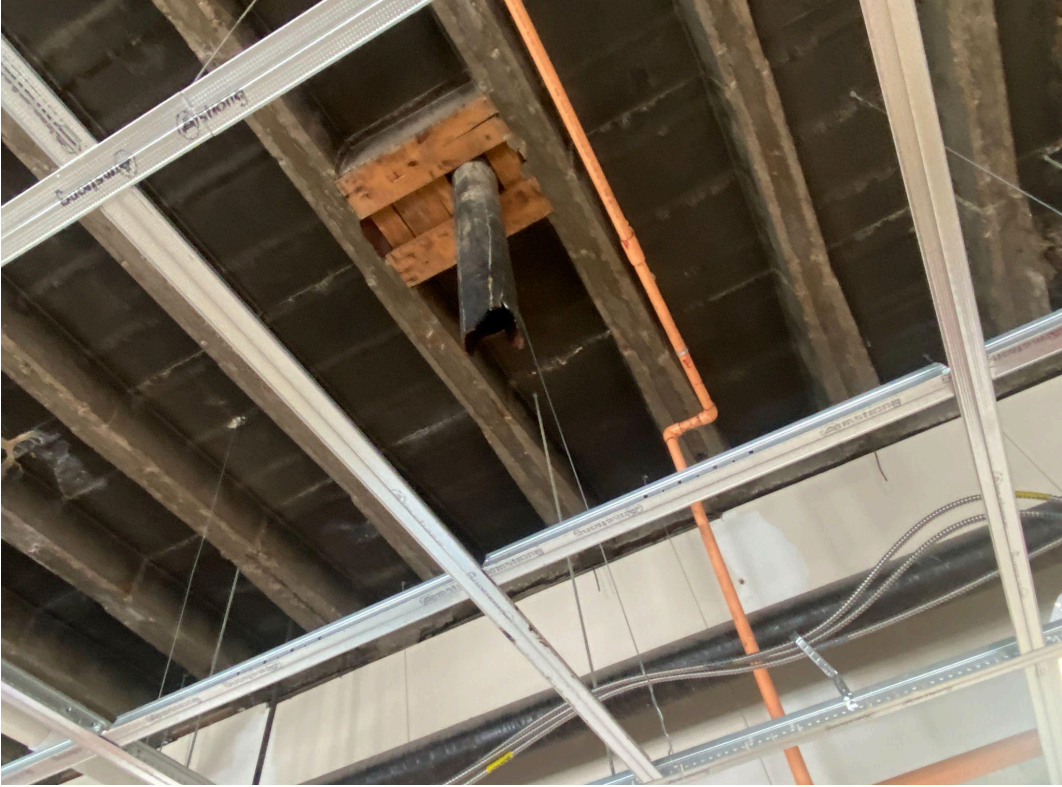
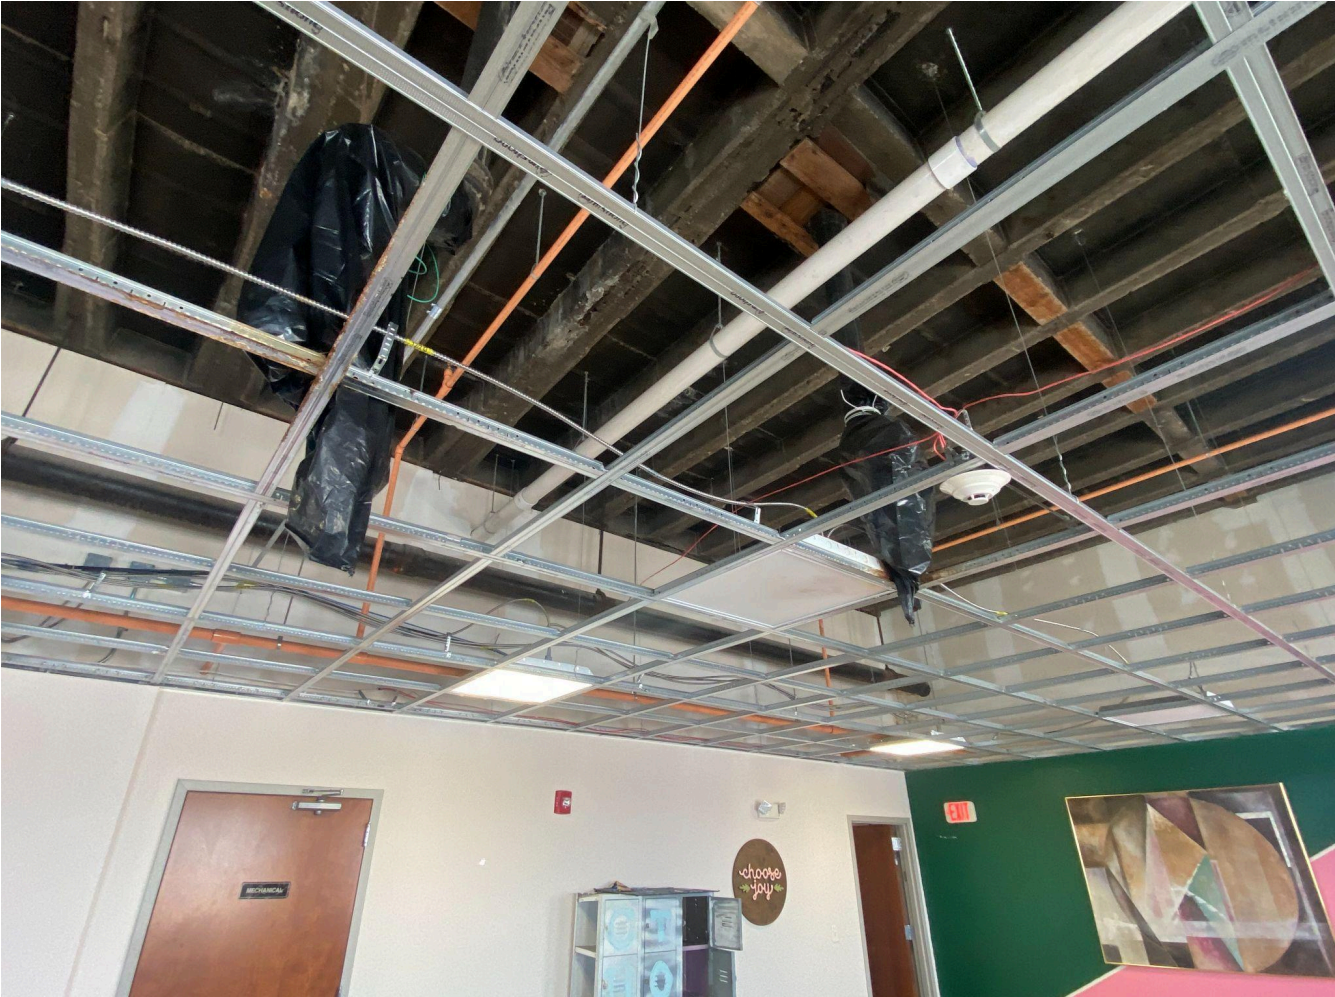
In the former Lounge Area, there is no tiling on the ceiling, leading to exposed wiring hanging from the ceiling, as well as uncovered piping.

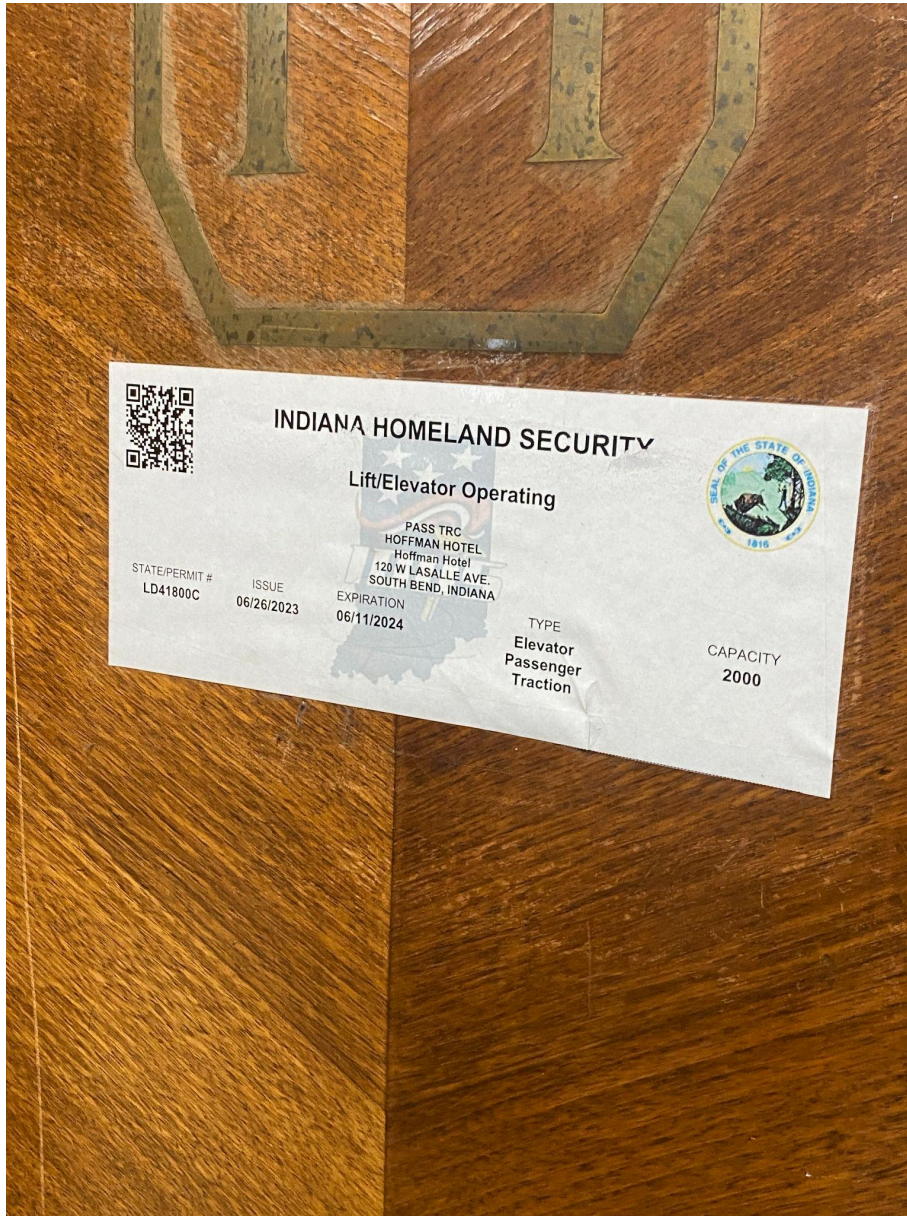
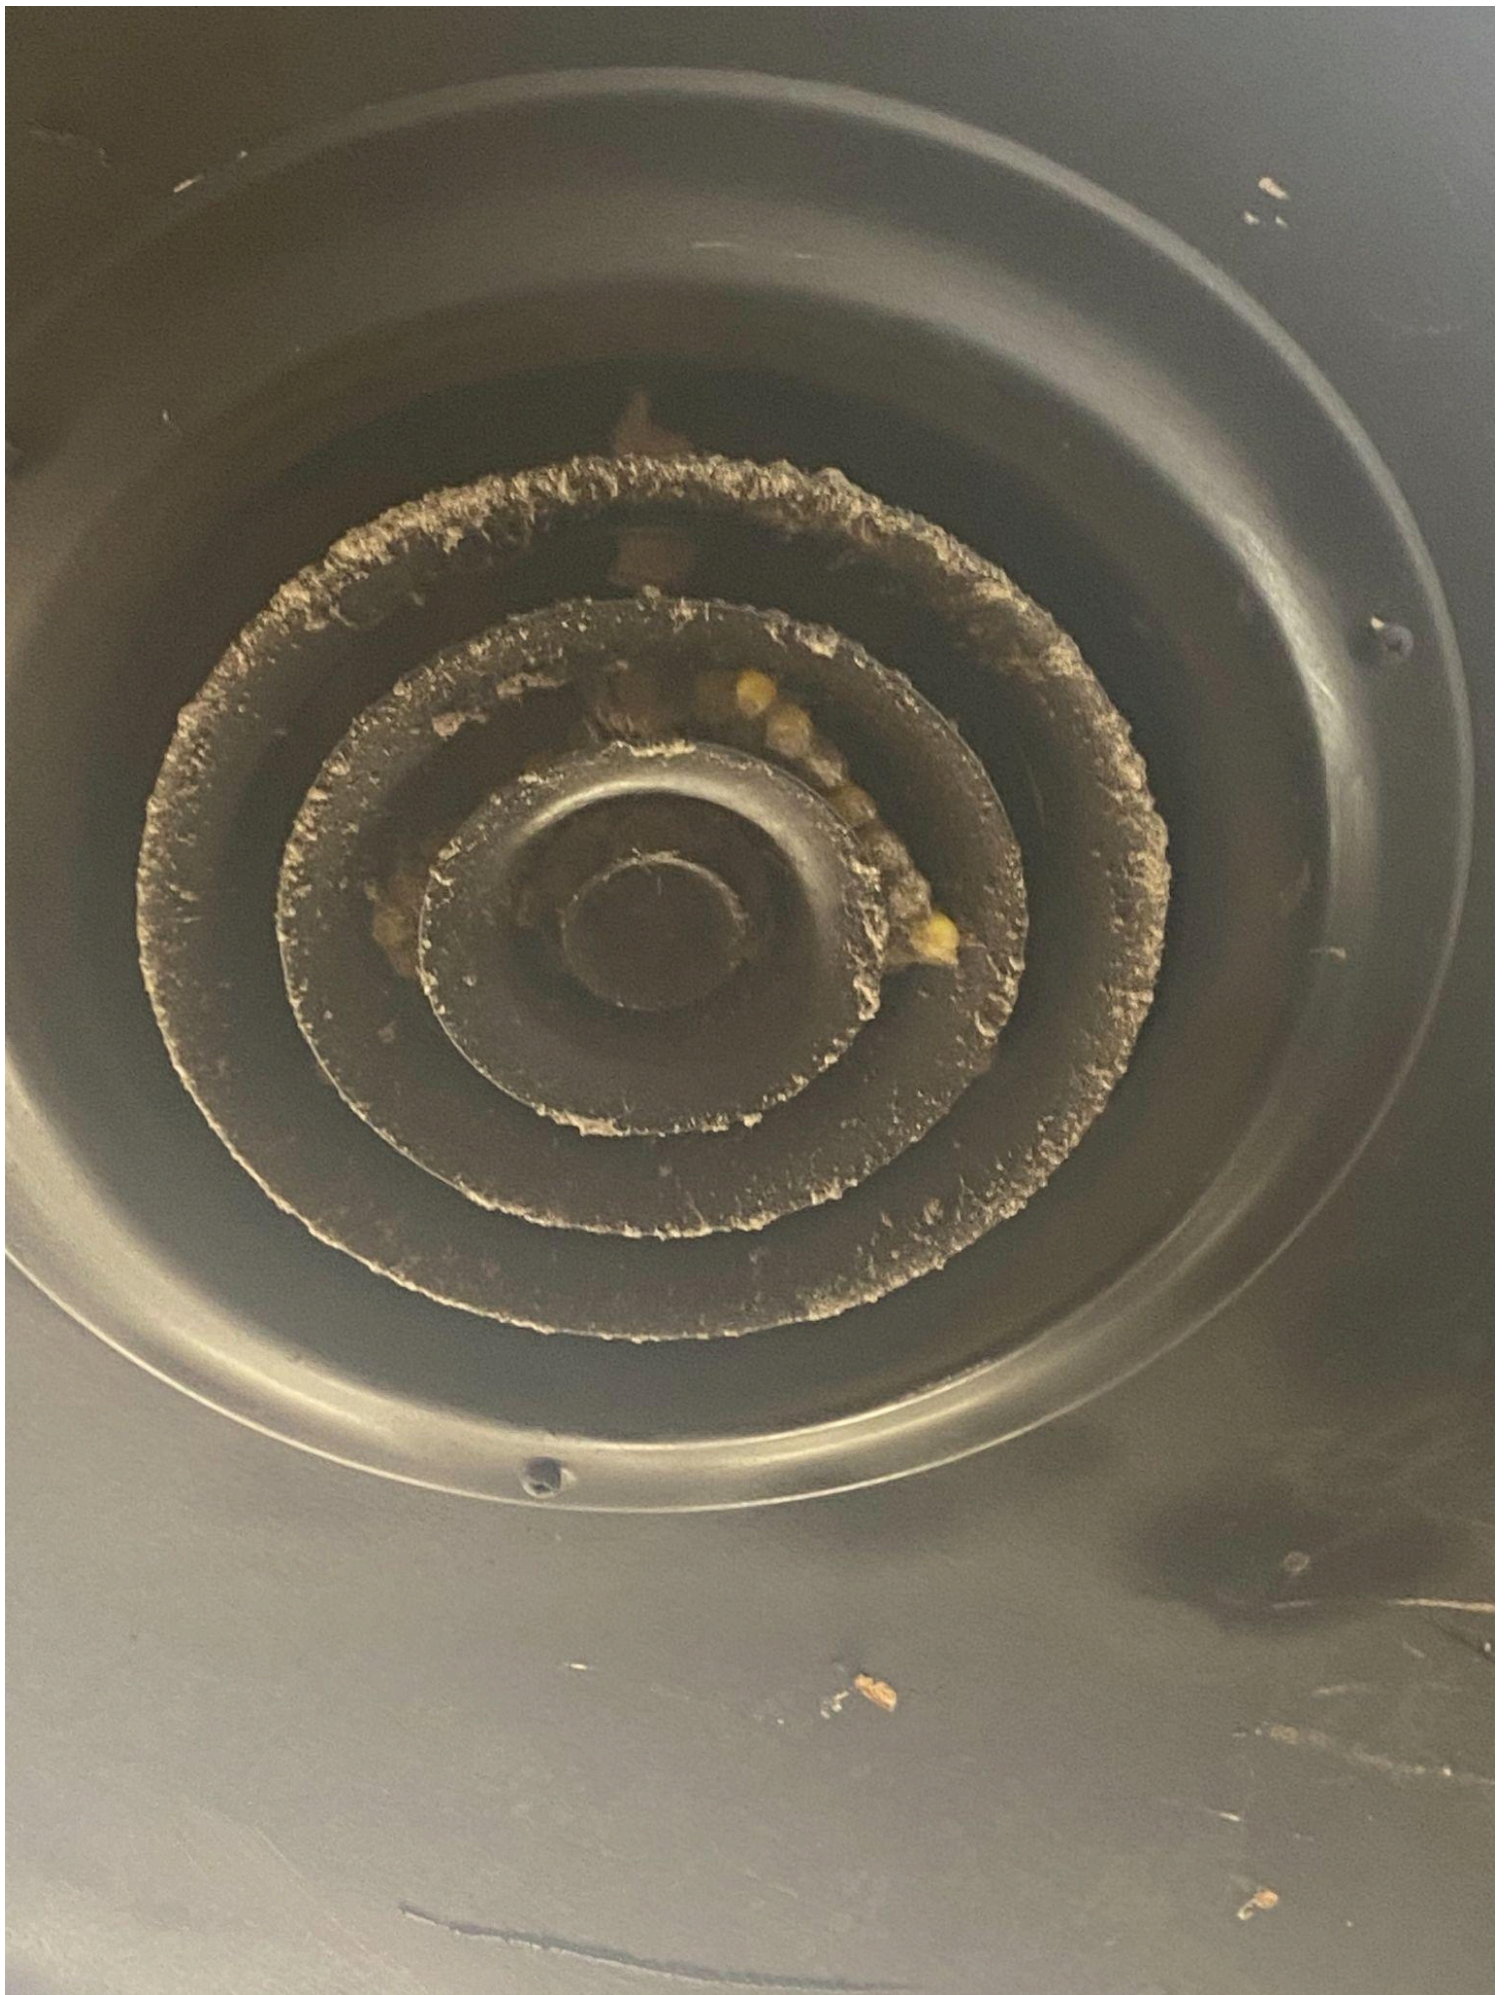
The Elevators at Hoffman Hotel, which have their own storied history,¹⁰ are only in partial use. The only current functioning elevator did not have a current permit from the Indiana Homeland Security Department at the time (February 9th, 2026). The vent within the functioning elevator was covered with what looked to be some kind of fungus. Residents recently reported that the certification had been updated and placed between both elevators, although the fungus within the functioning elevator remained, and the other elevator was still not operational.

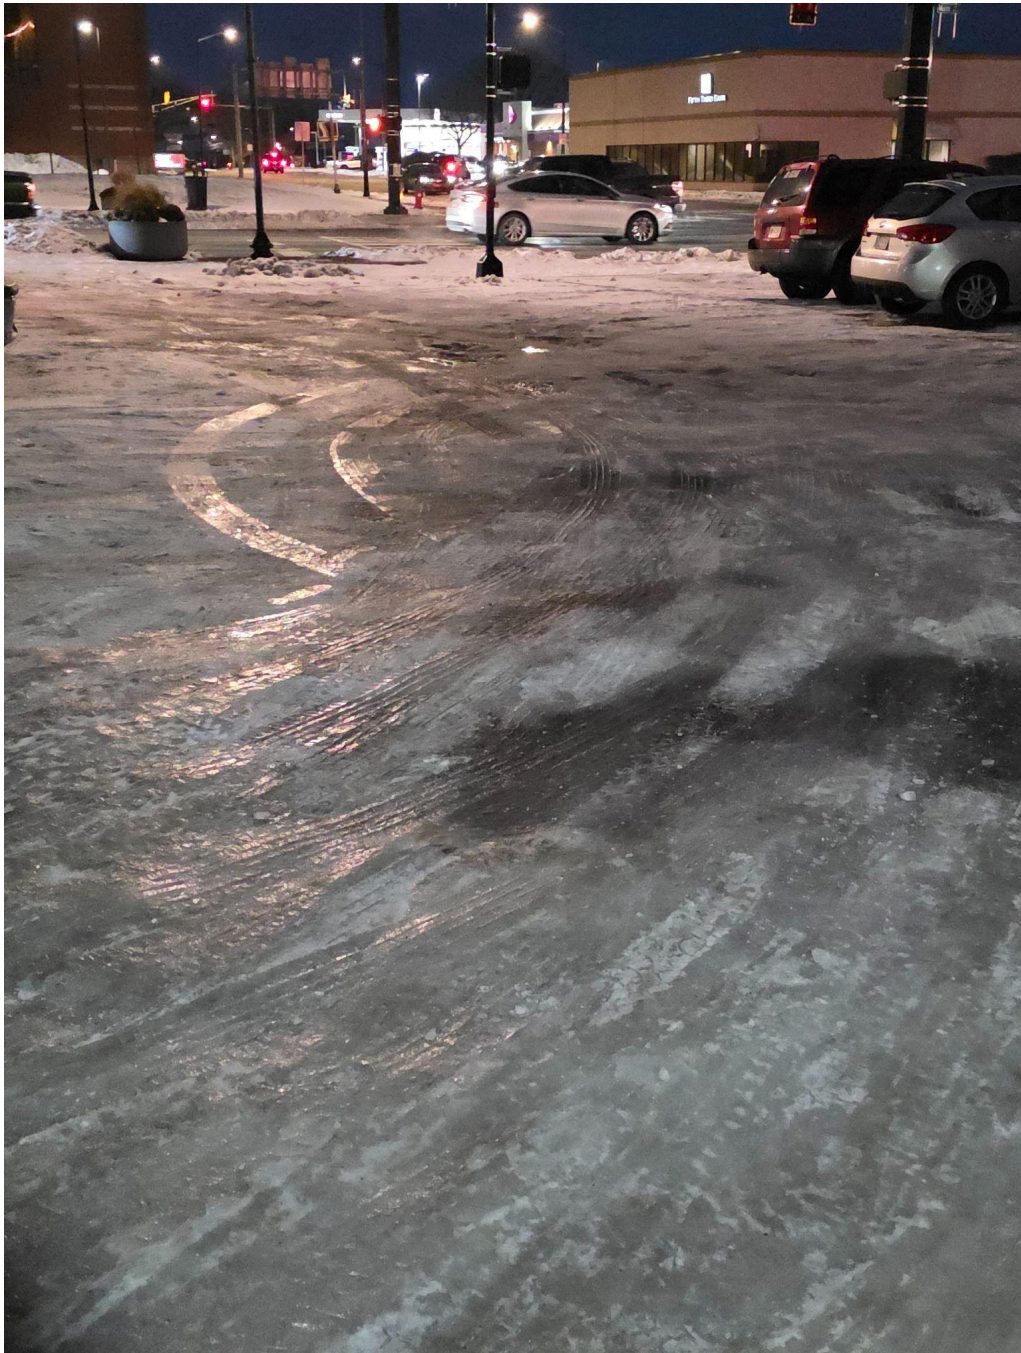
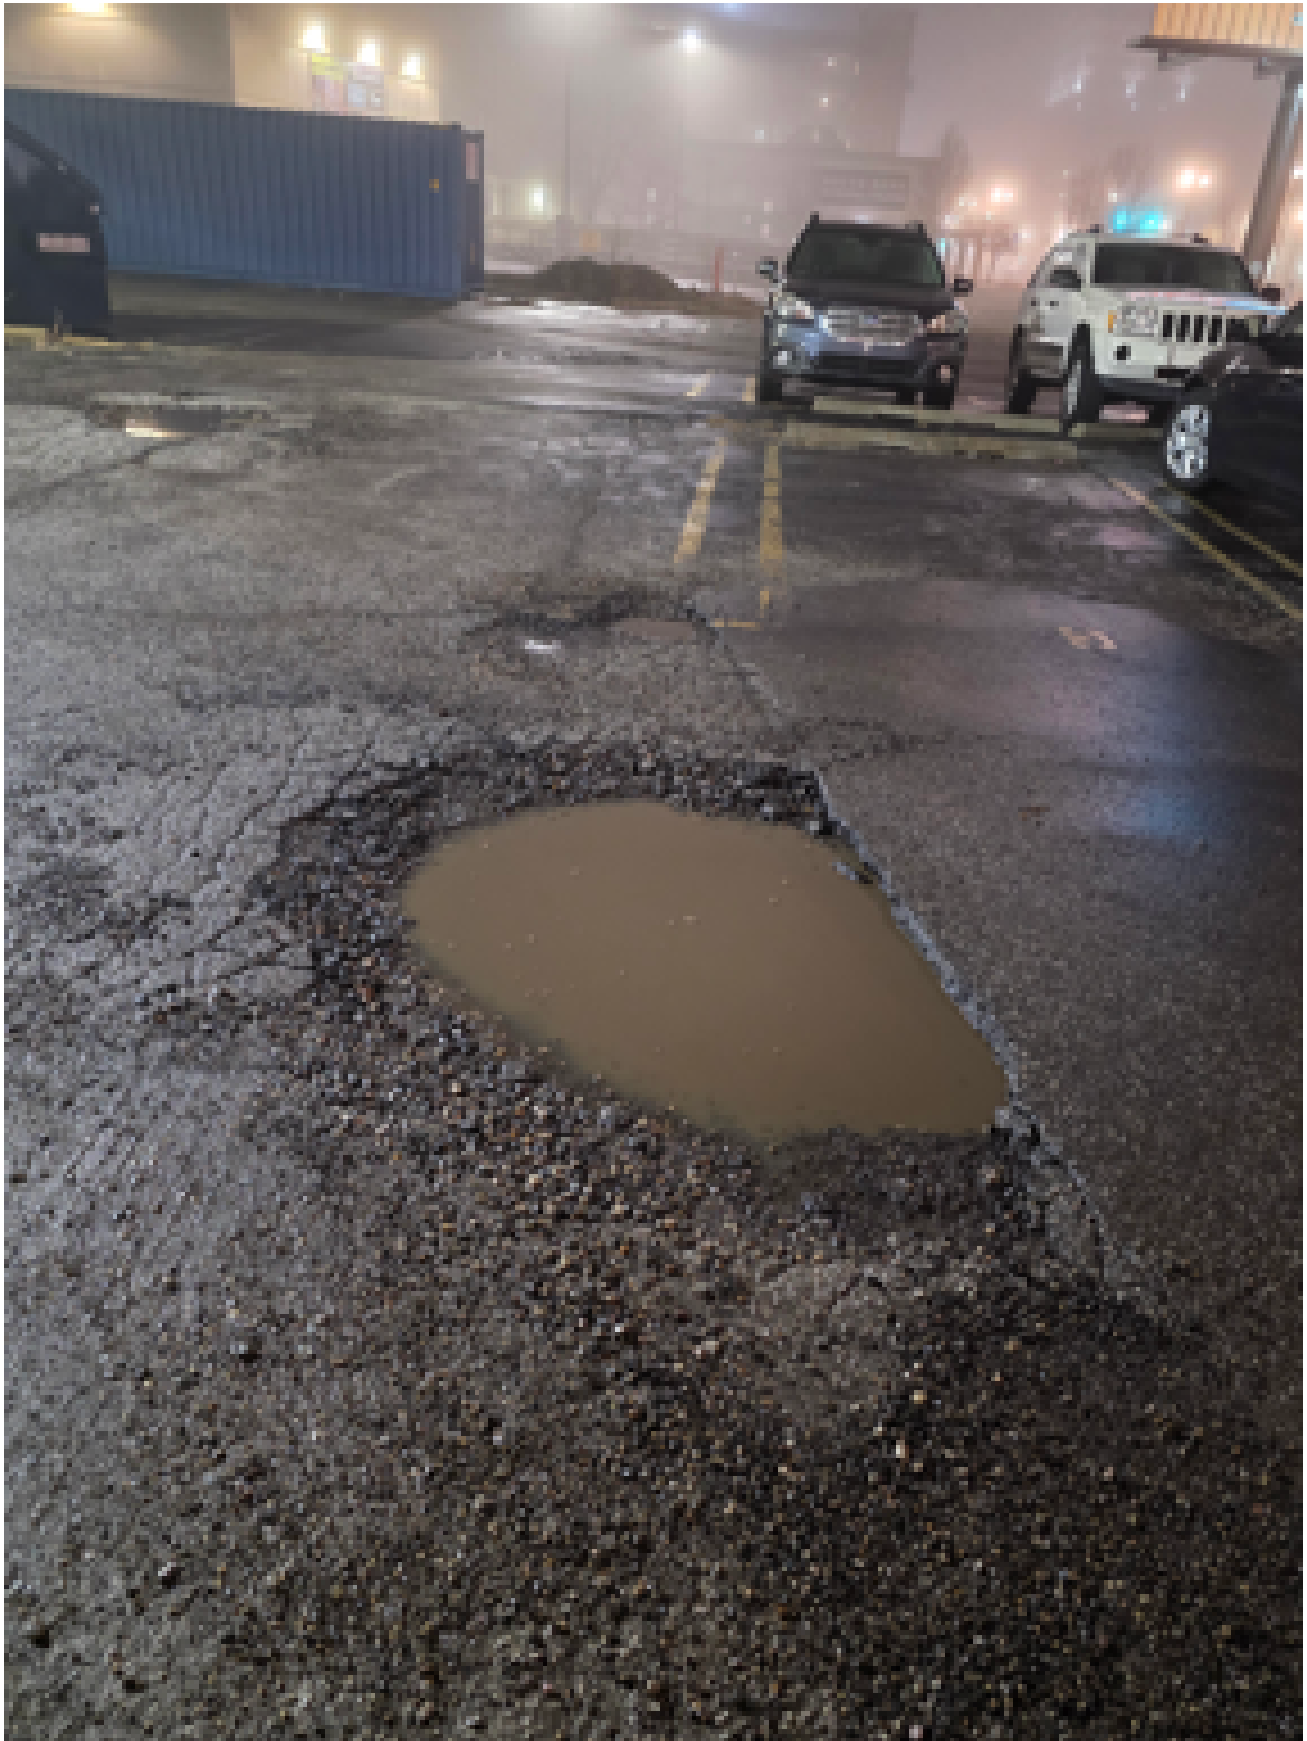
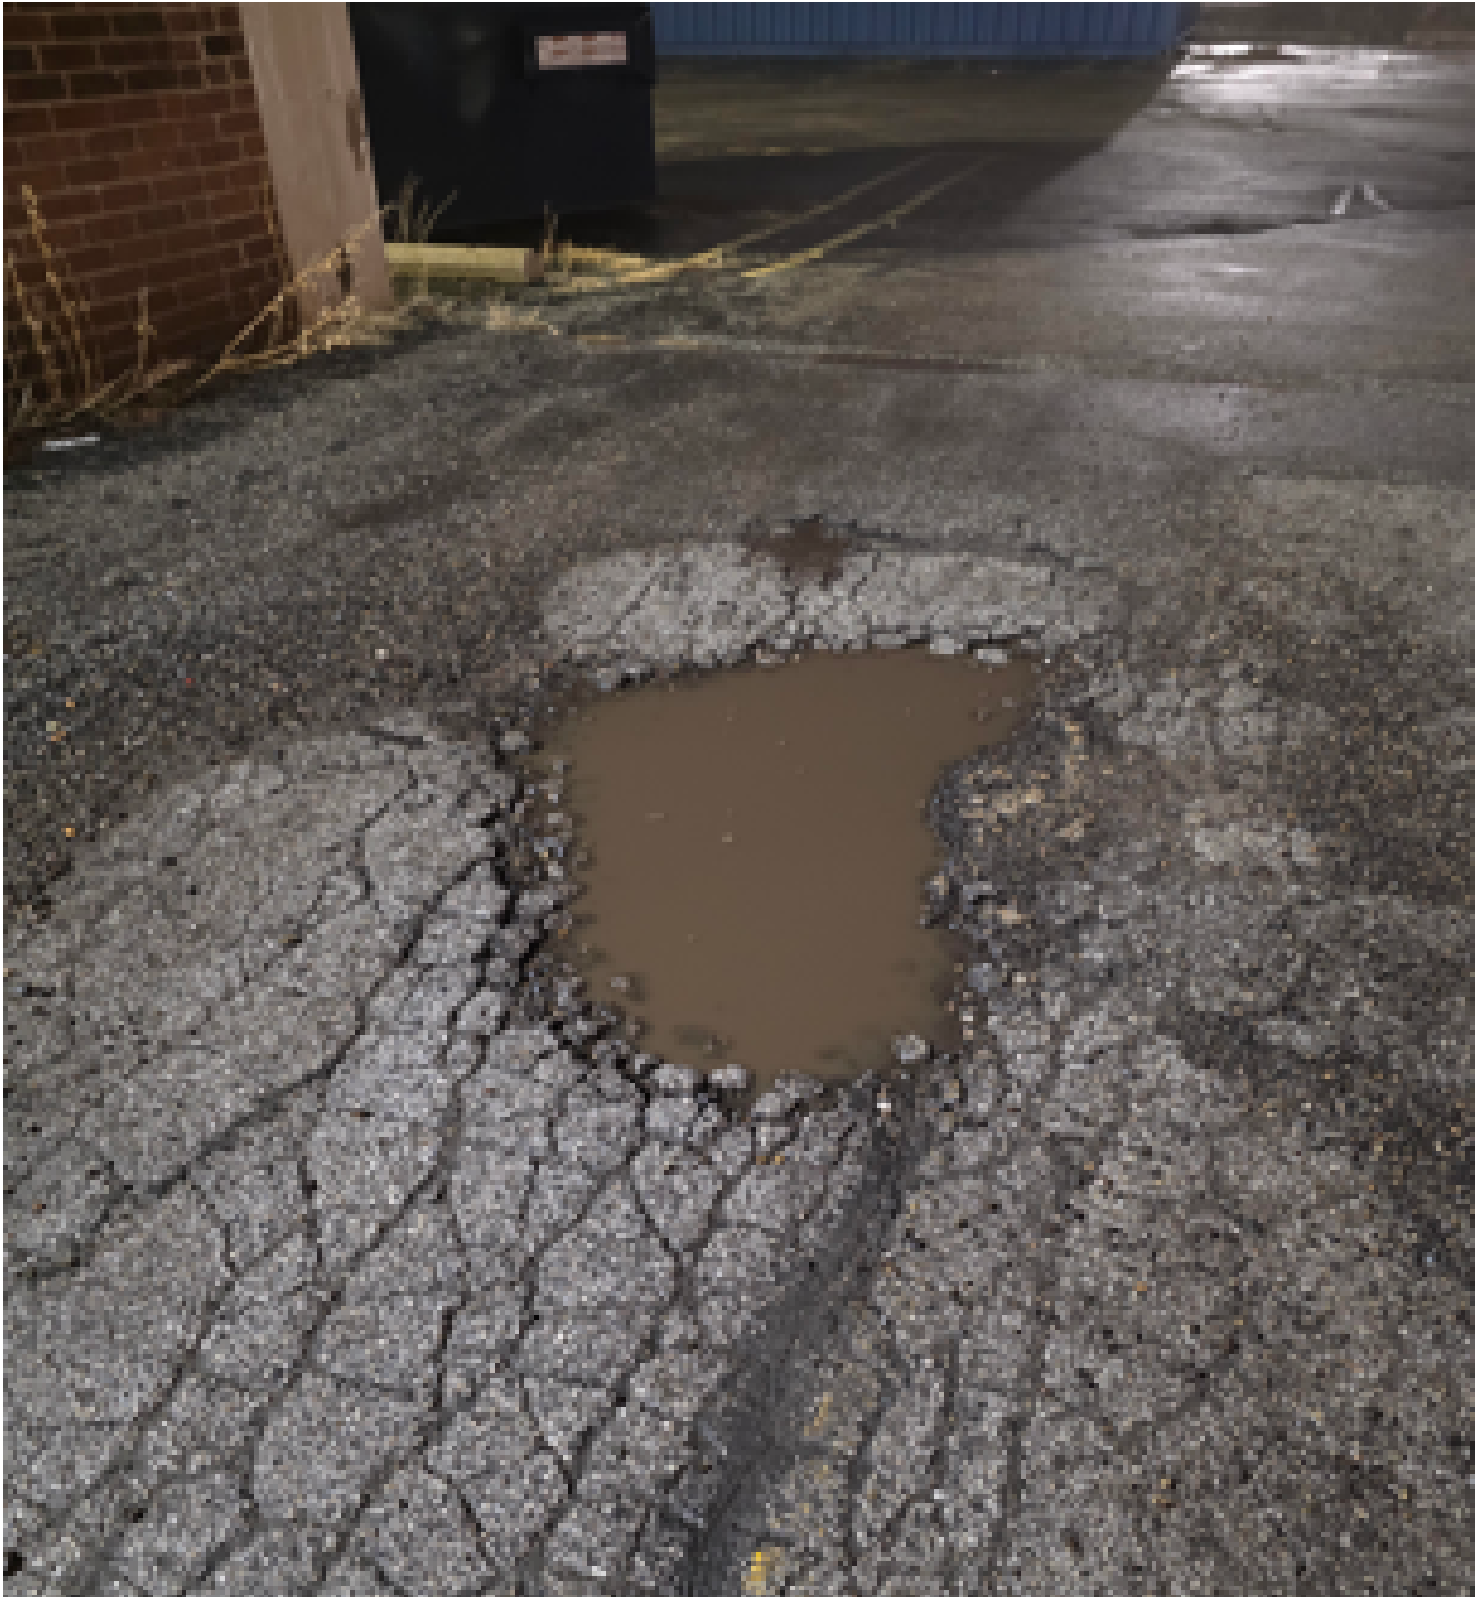
The Parking Lot used by residents is privately owned by Equal Development LLC. One tenant reported that the parking lot has not been plowed or maintained at any point in the past 4 years. Some Hoffman residents are disabled people and seniors, so not plowing the parking lot could lead to serious injury for a tenant while they try to get to their vehicle. Additionally, there are large potholes in the lot that have not been repaired for years. Equal Development LLC owns the parking lot used by Hoffman residents.
