THE LAW SCHOOL
CLINICAL LAW CENTER

Press release concerning the living conditions at the Hoffman Hotel

March 19, 2026

NOTRE DAME LAW CLINIC PRESS RELEASE:

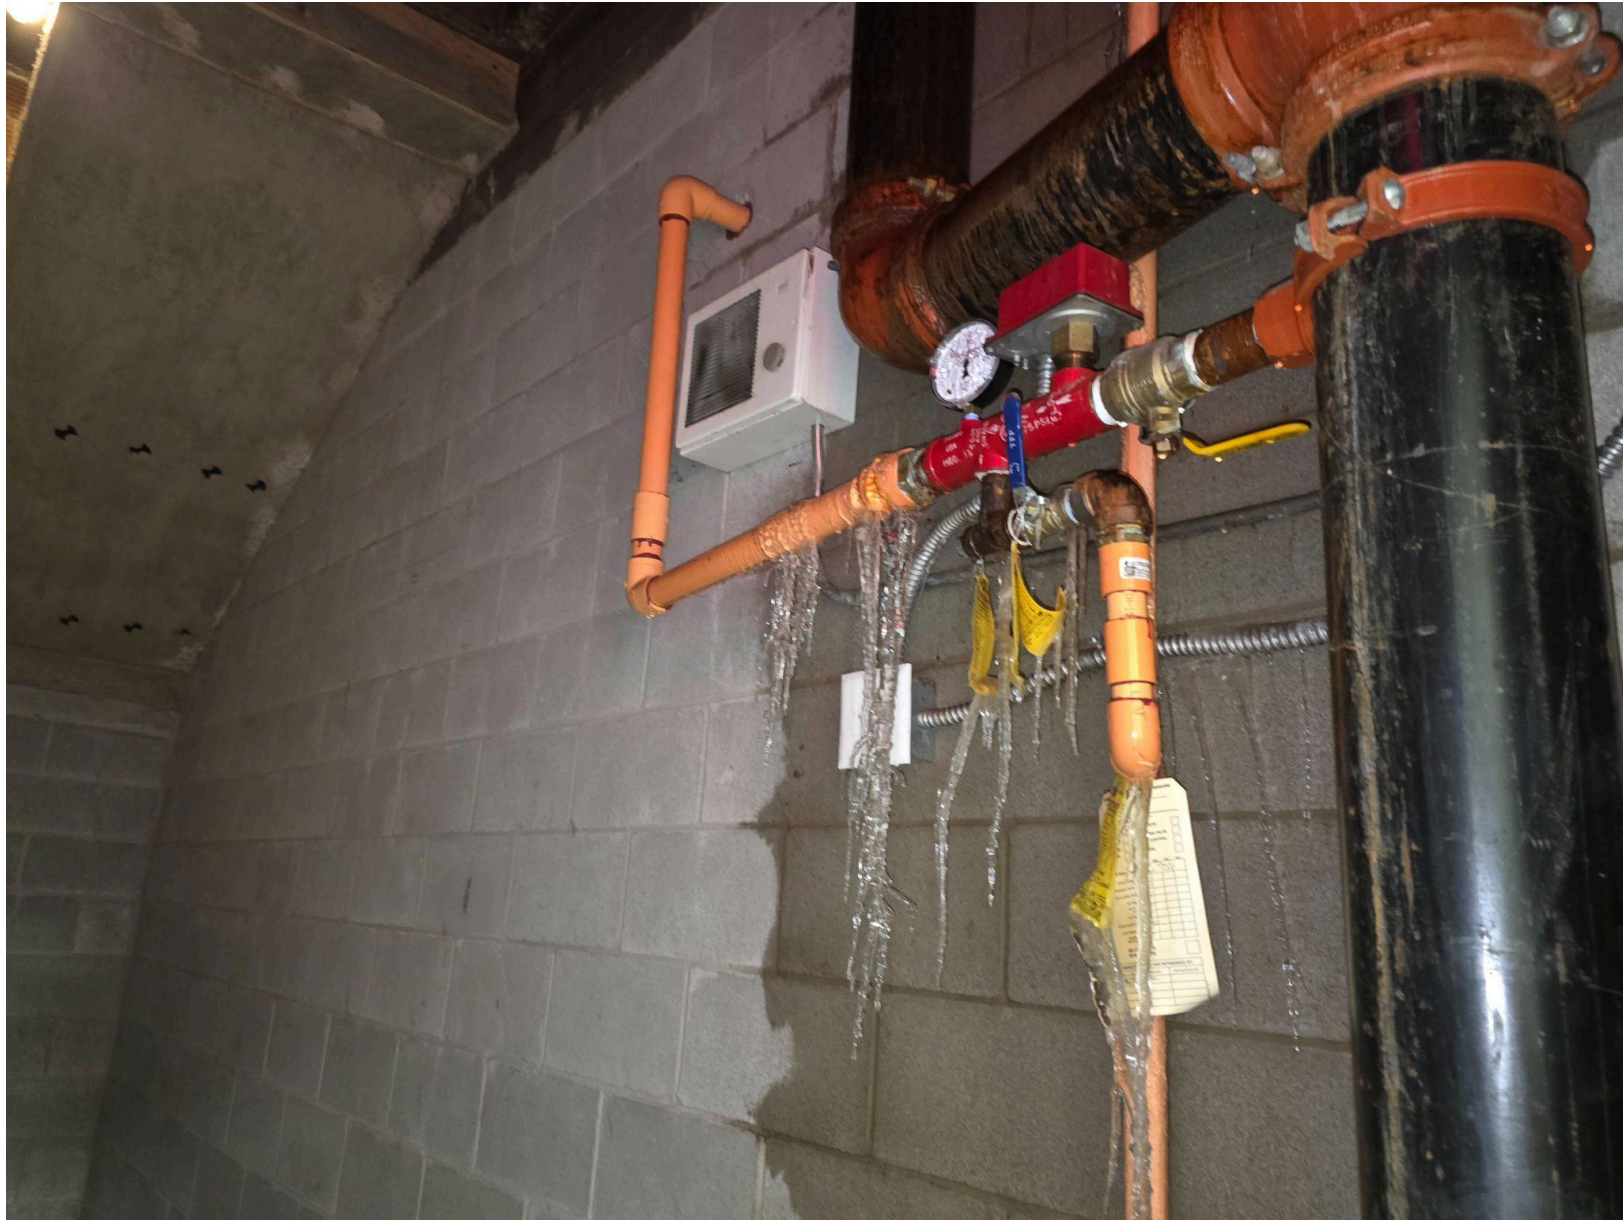
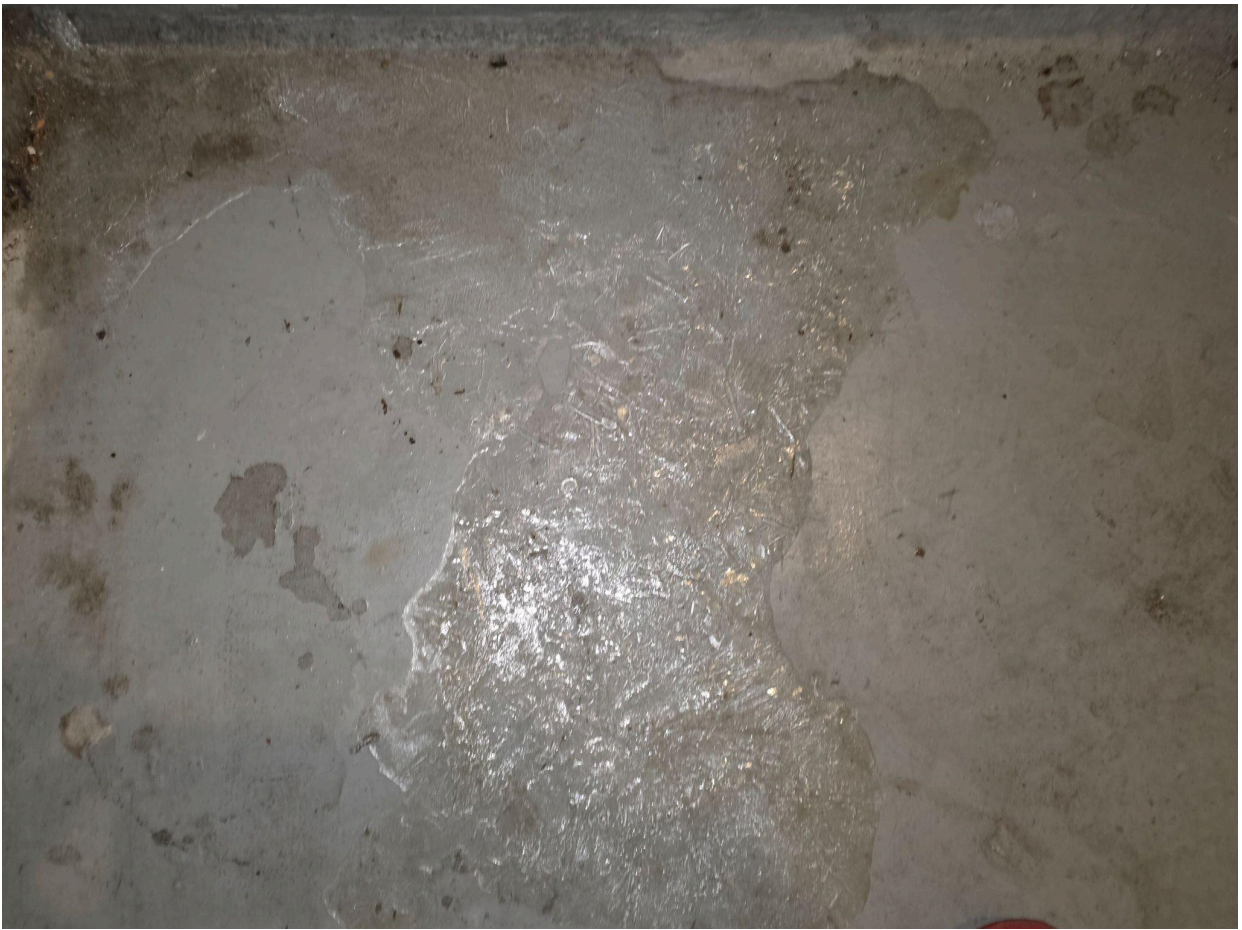
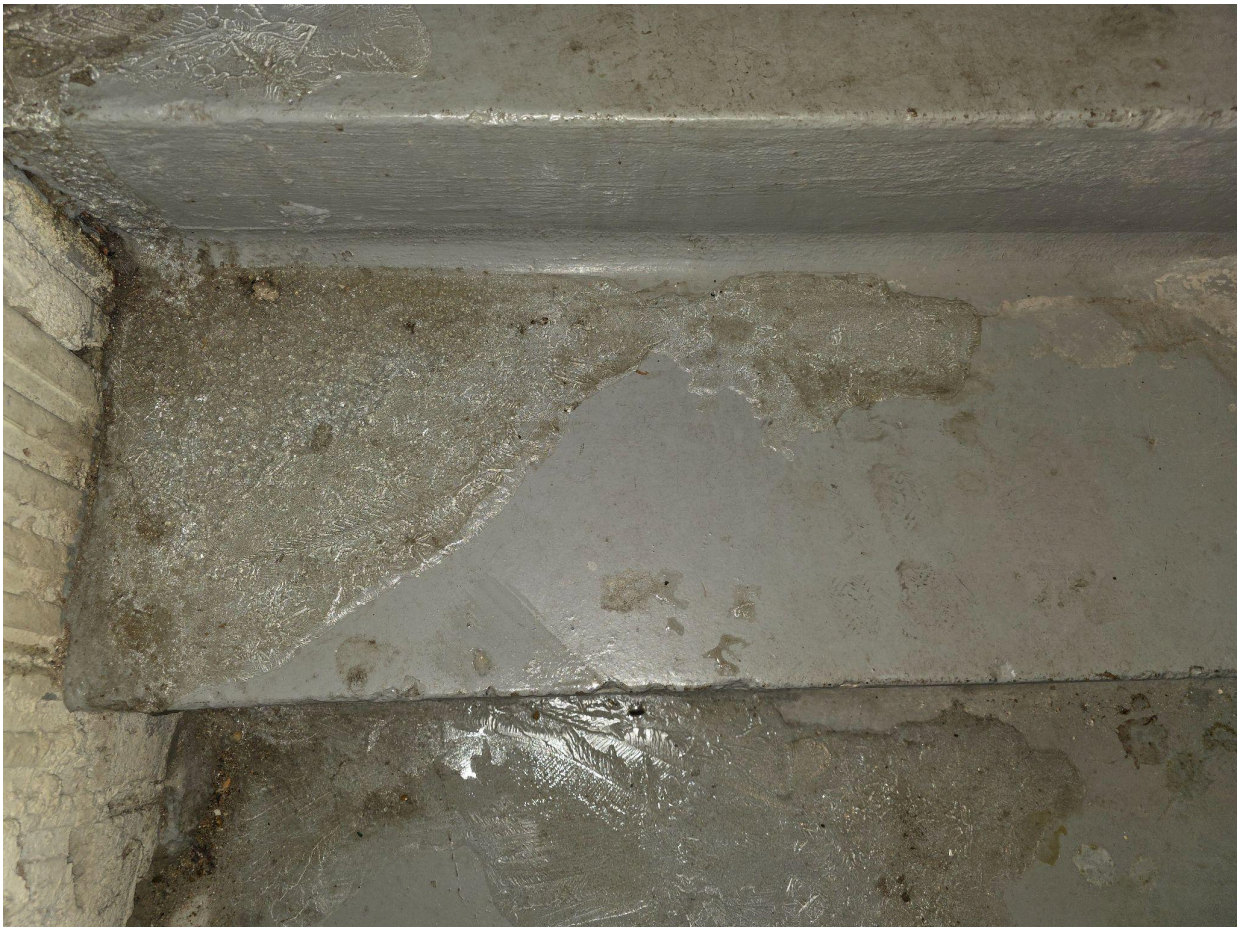
This past winter, freezing temperatures caused pipes in the stairwells to burst, leaving large icicles on the exposed pipes. Water leaking in the stairwells, combined with freezing temperatures, led to ice forming on the steps, creating an obvious safety hazard.

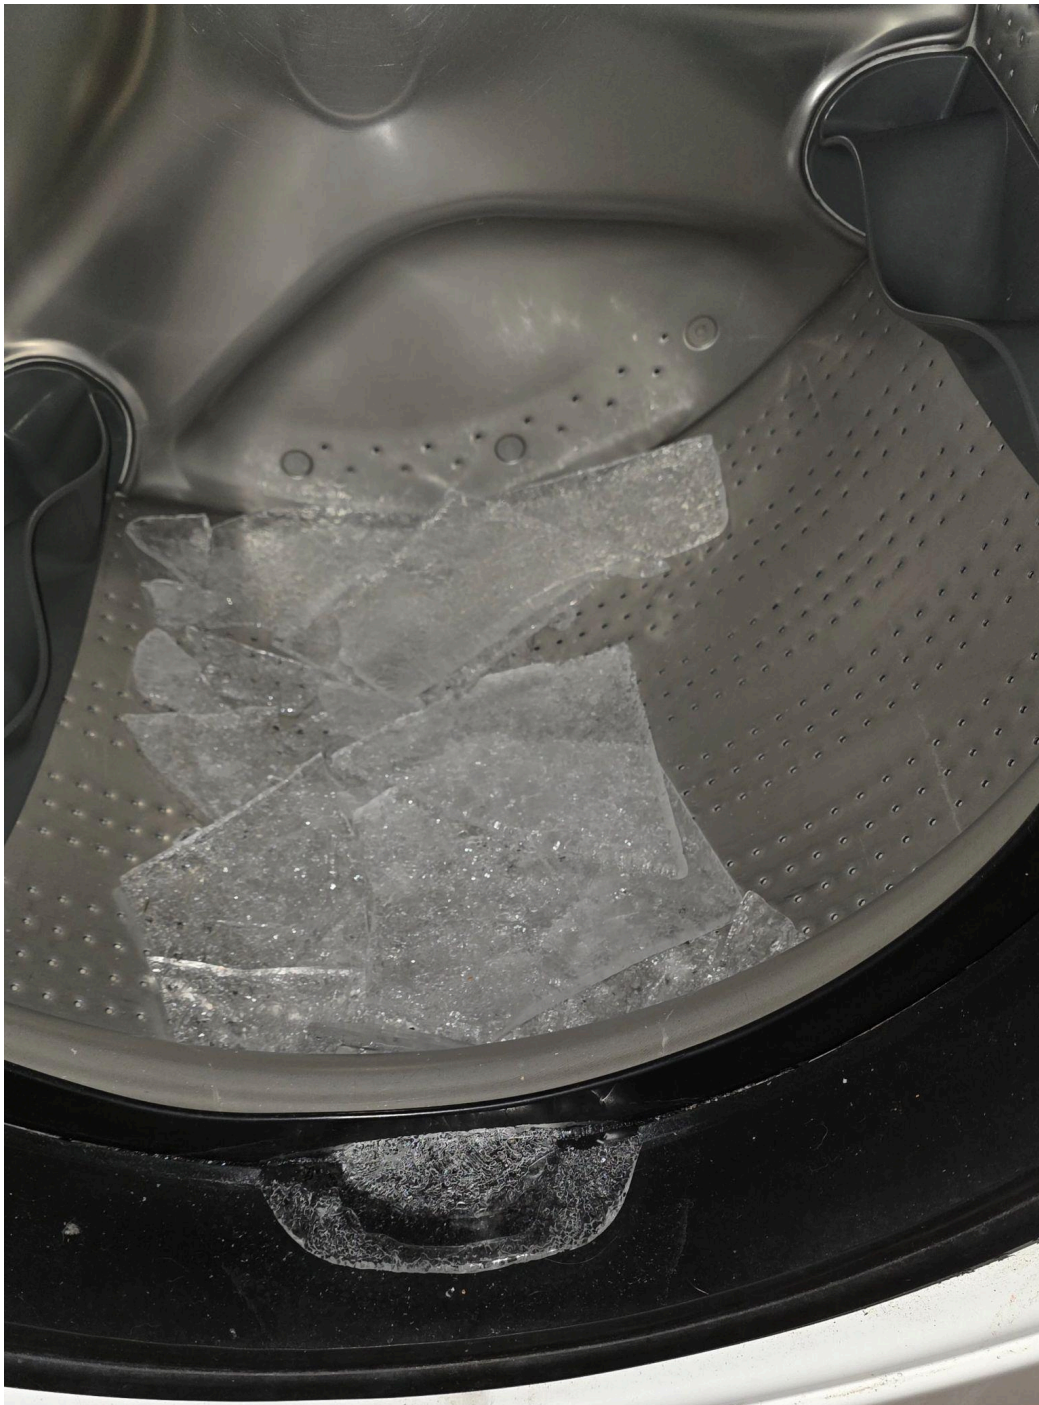
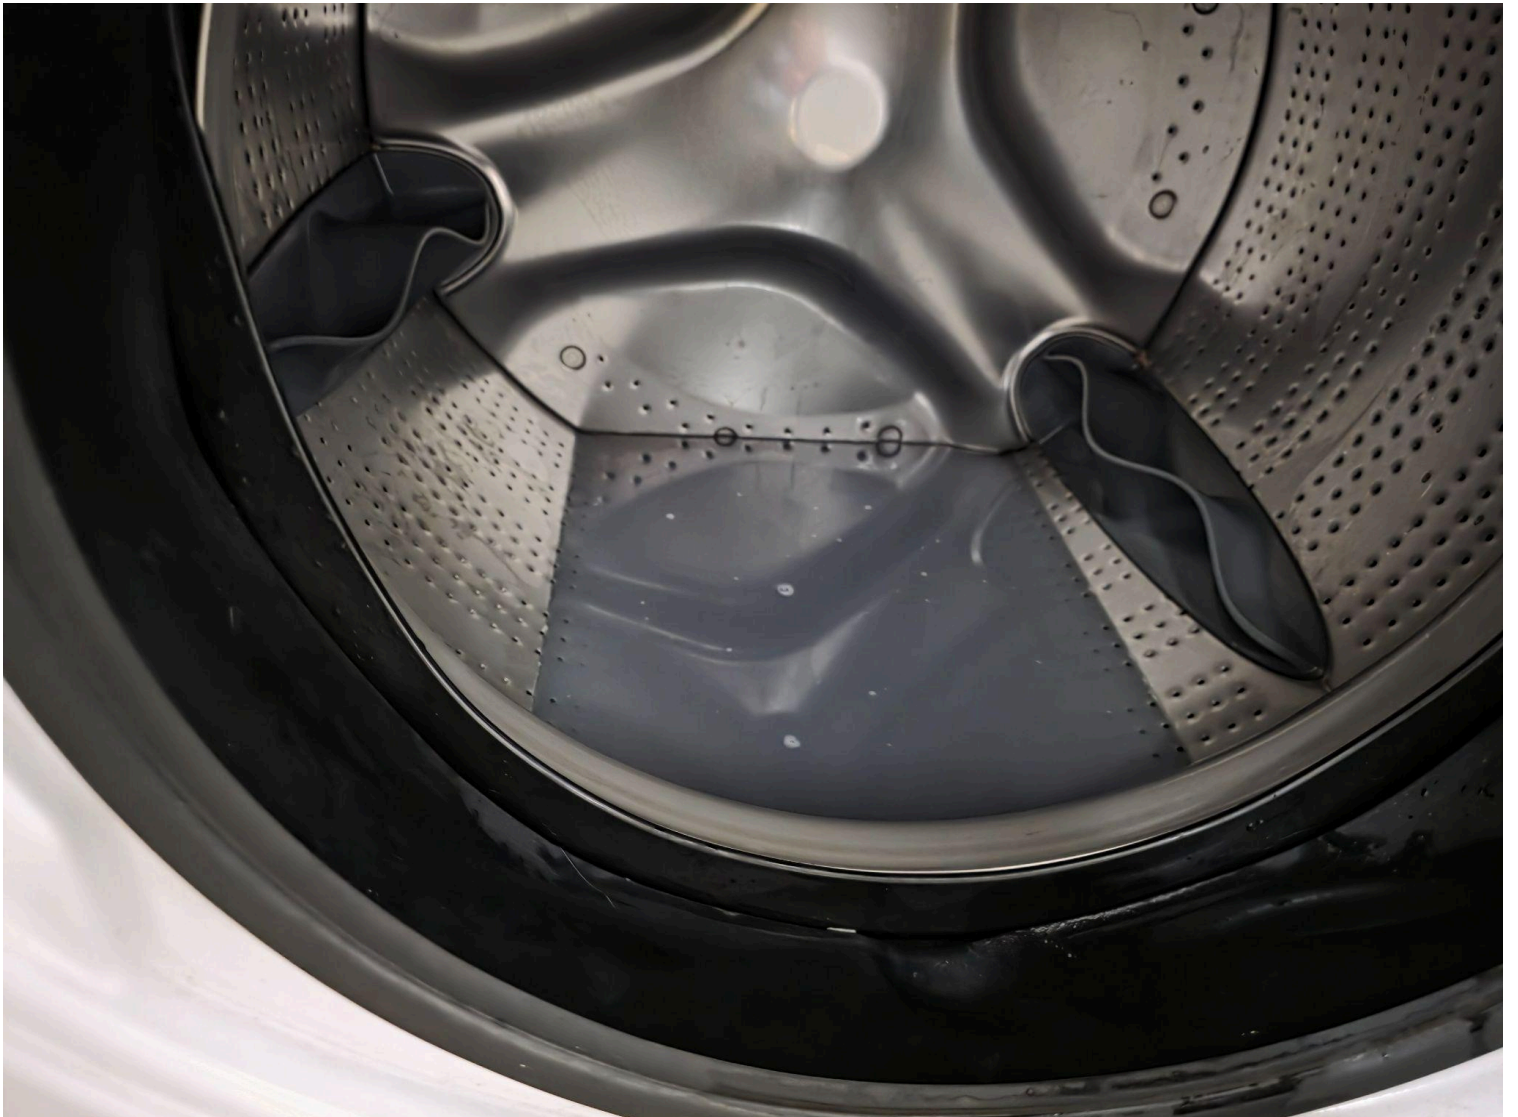
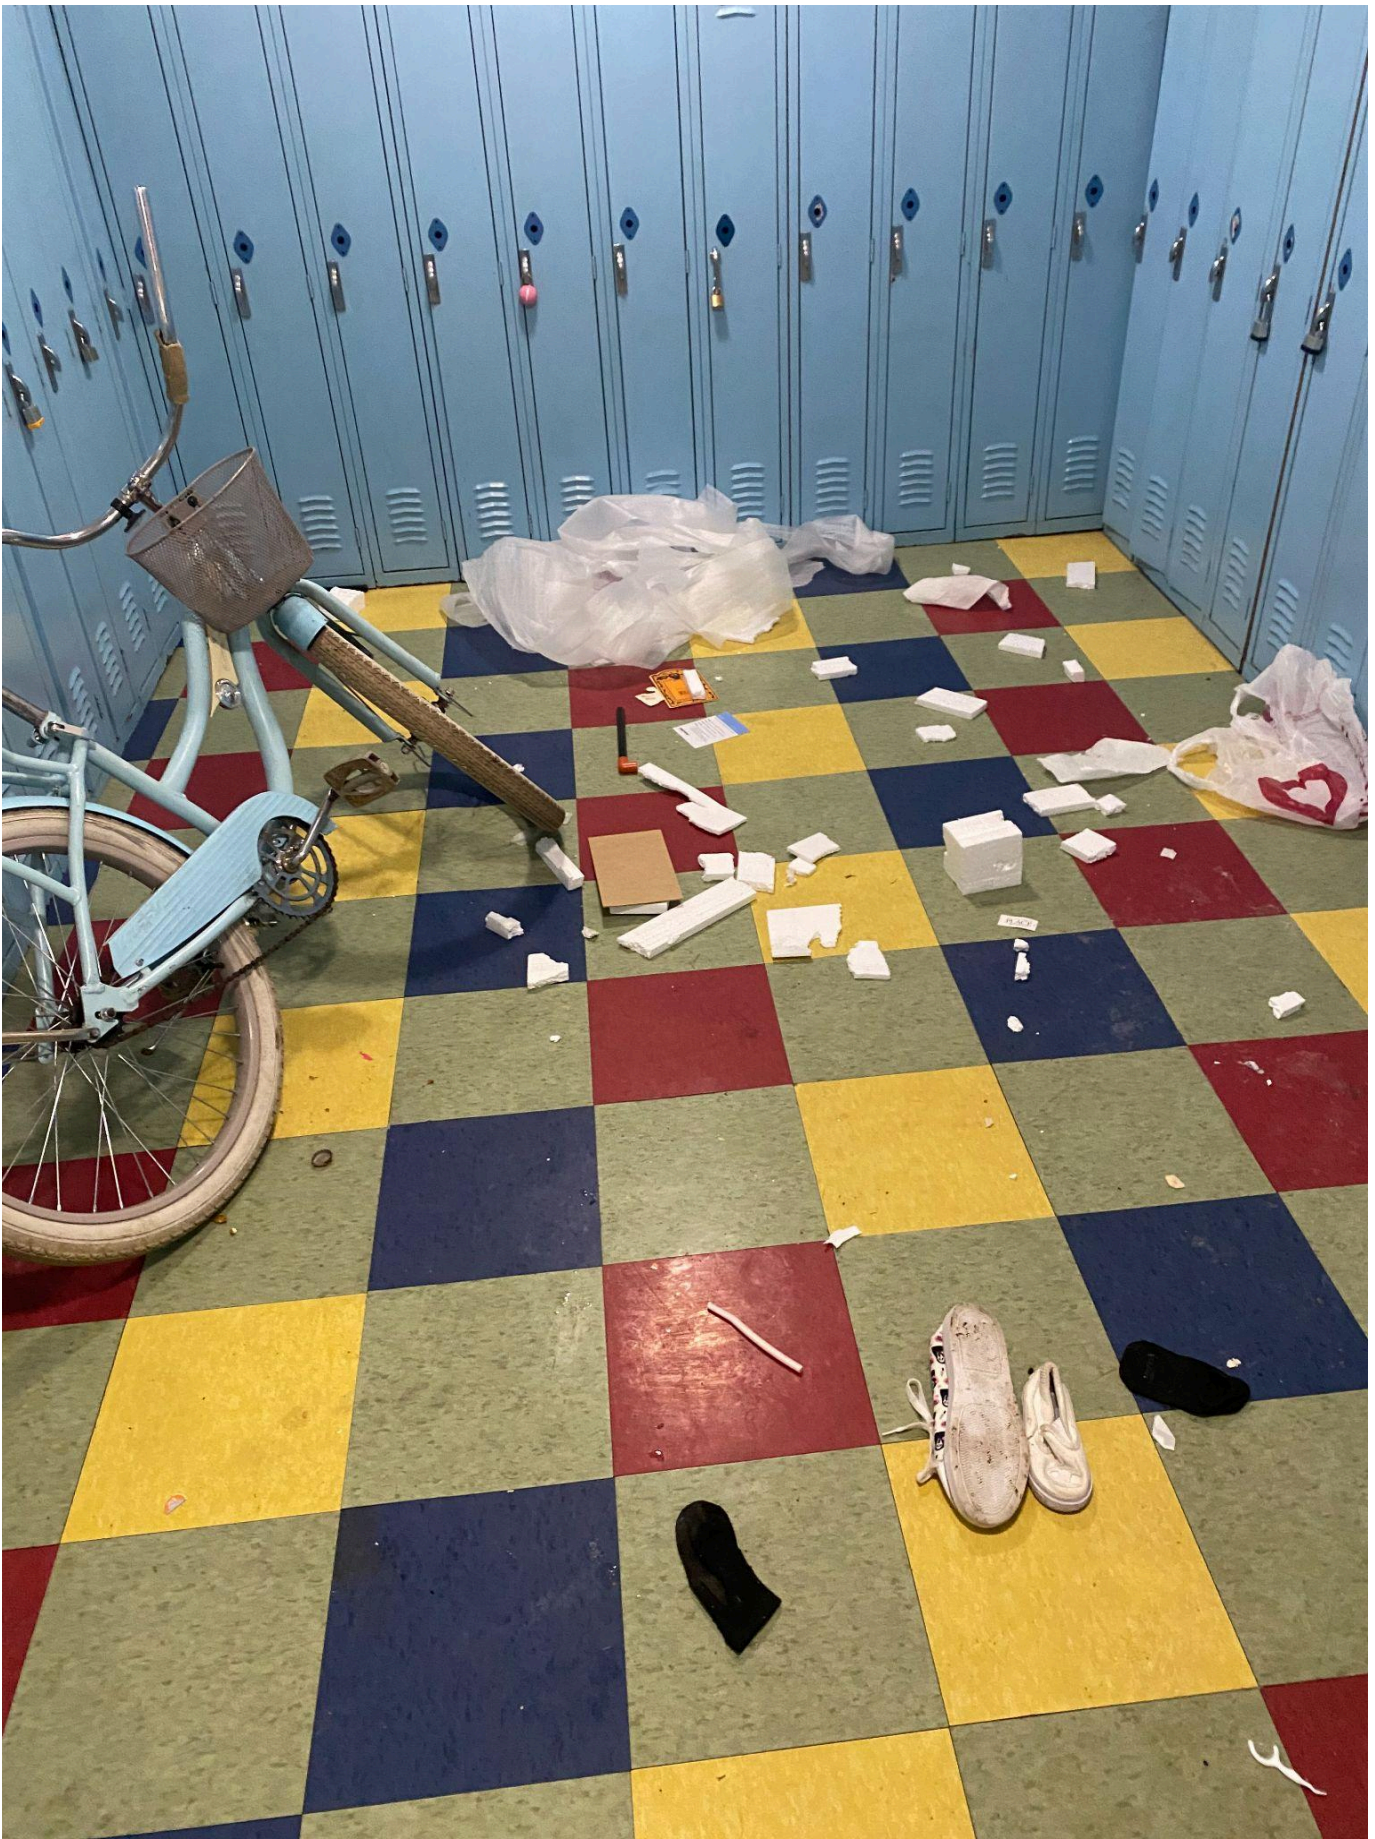
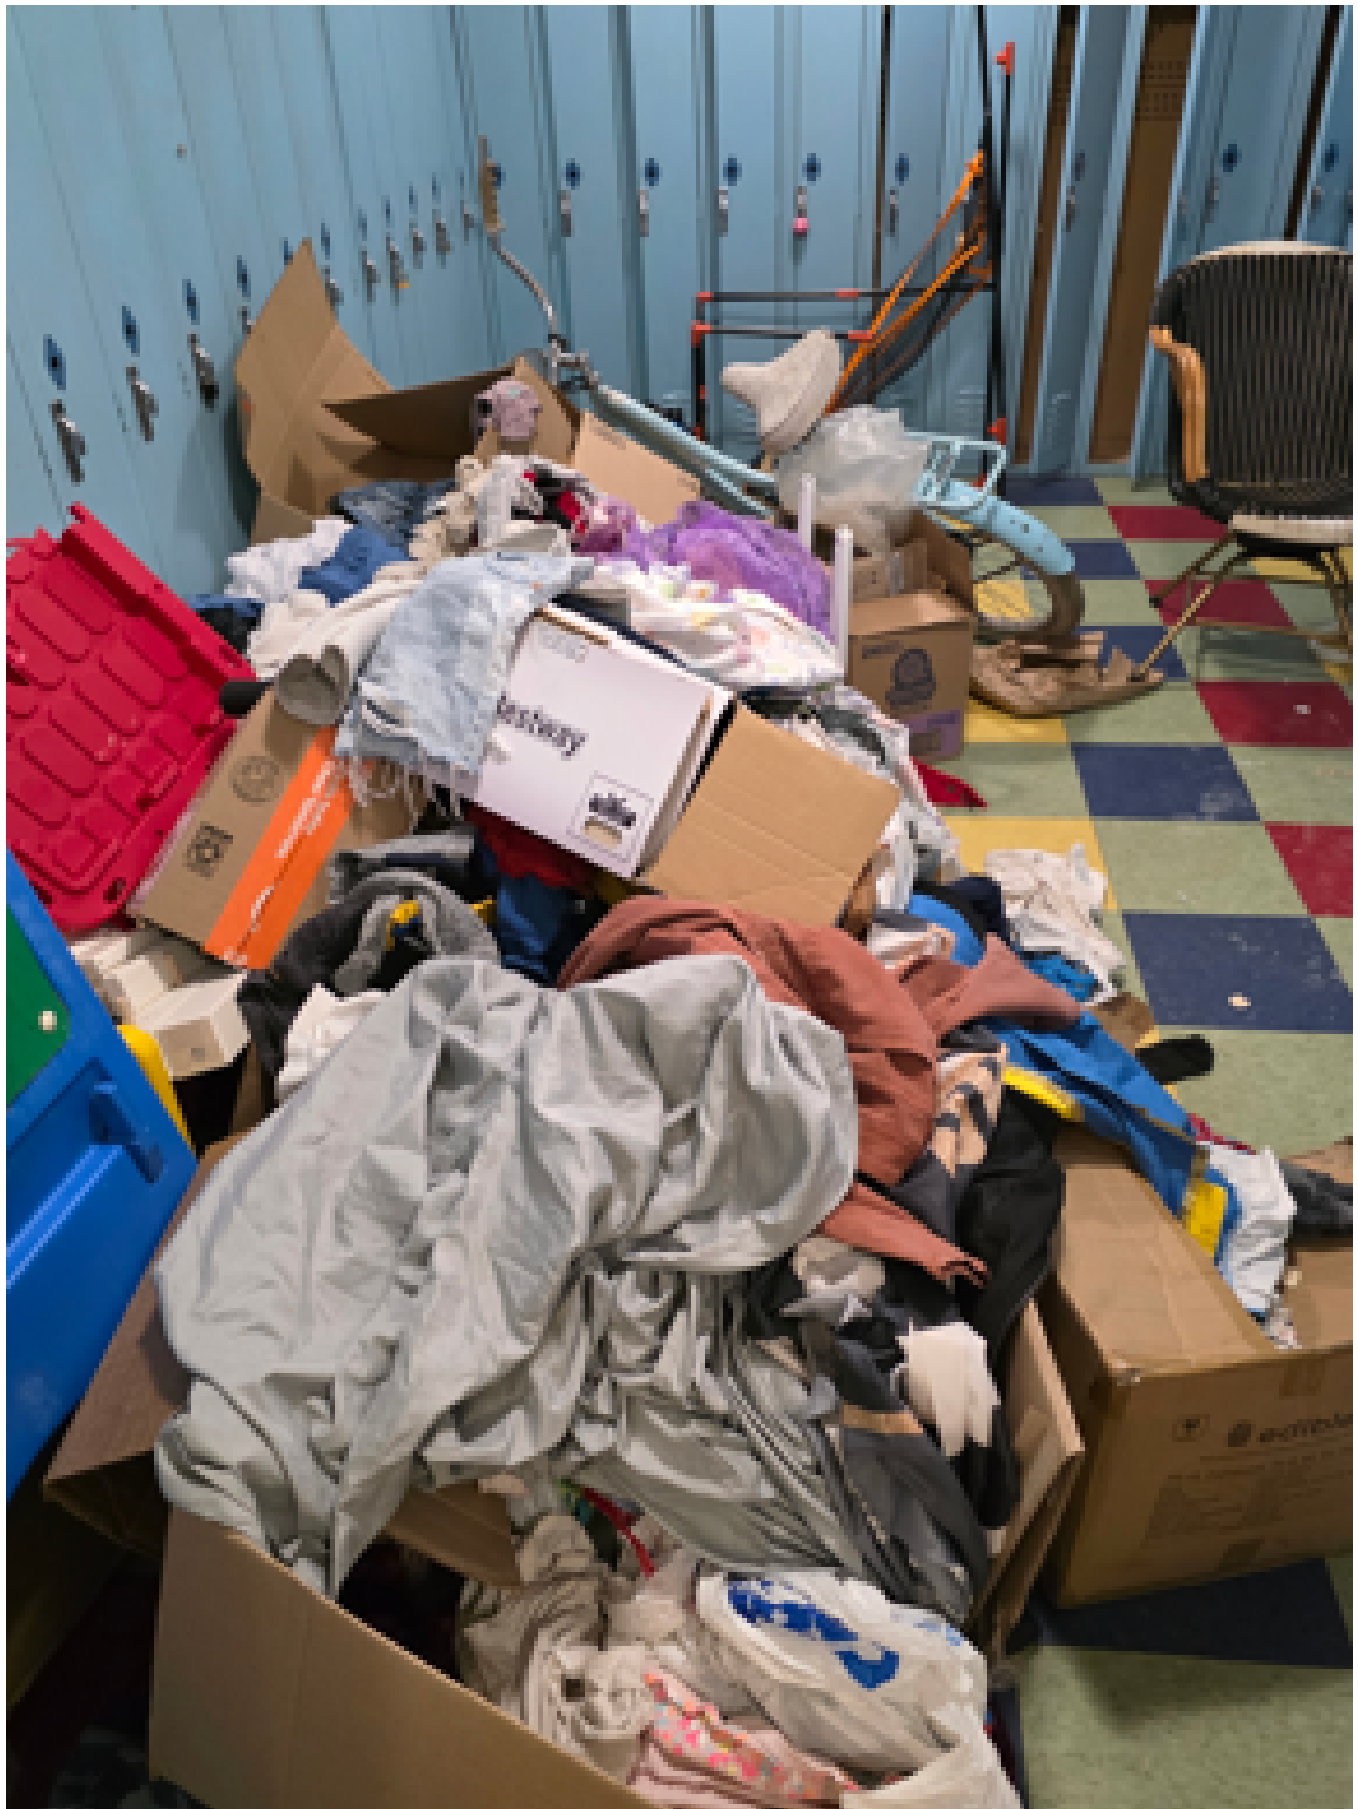
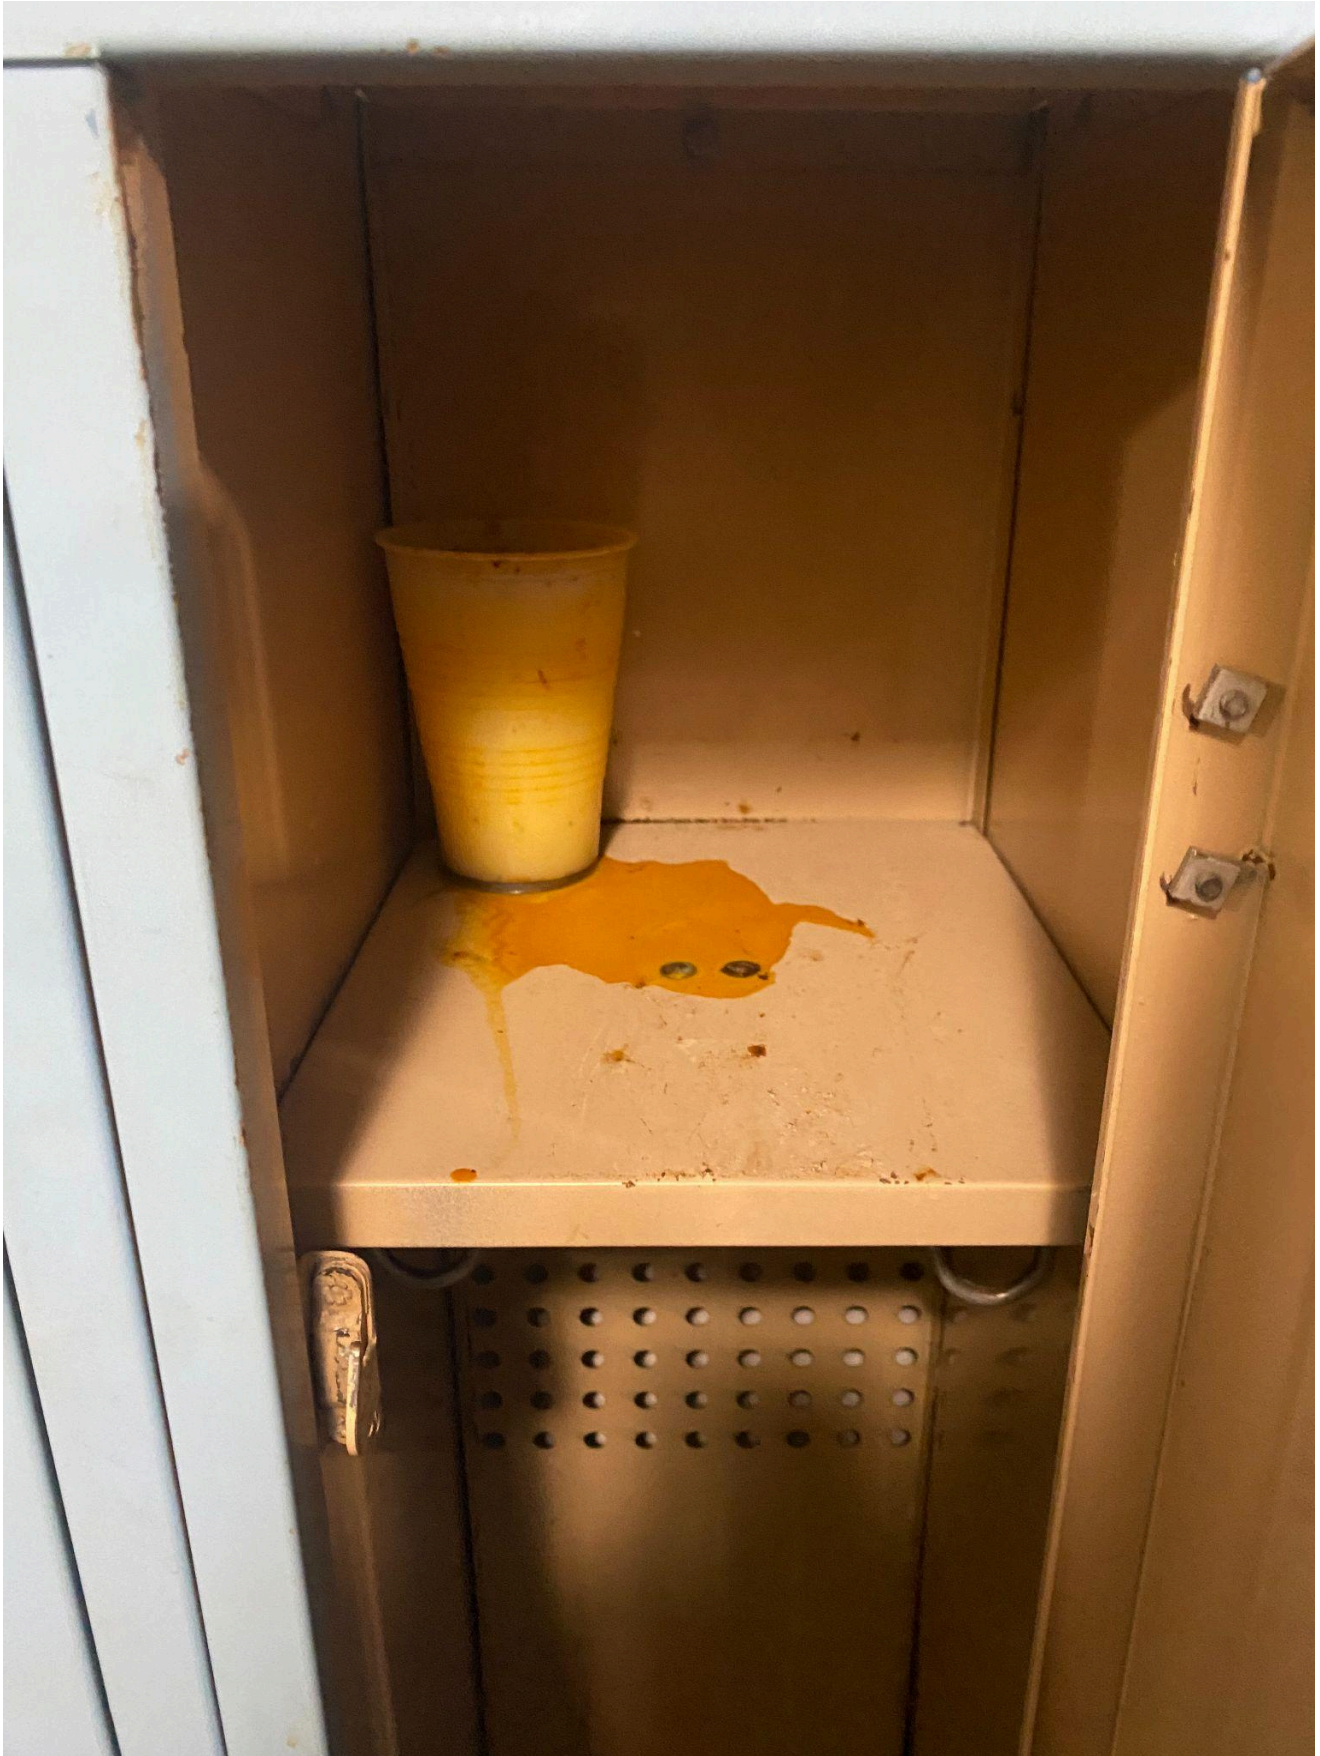
The washing machines in the resident laundry room regularly malfunction. One washer commonly has a pool of standing water in it at the bottom, which freezes, as the Laundry is not heated and reaches near zero temperatures during the winter. Additionally, there is trash covering the laundry. Thankfully, a heater has been installed in the laundry room since these photos were taken. Residents routinely have to make their own request for repairs to an outside company, as opposed to management addressing the issues themselves.
