THE LAW SCHOOL
CLINICAL LAW CENTER

Press release concerning the living conditions at the Hoffman Hotel

March 19, 2026

NOTRE DAME LAW CLINIC PRESS RELEASE:

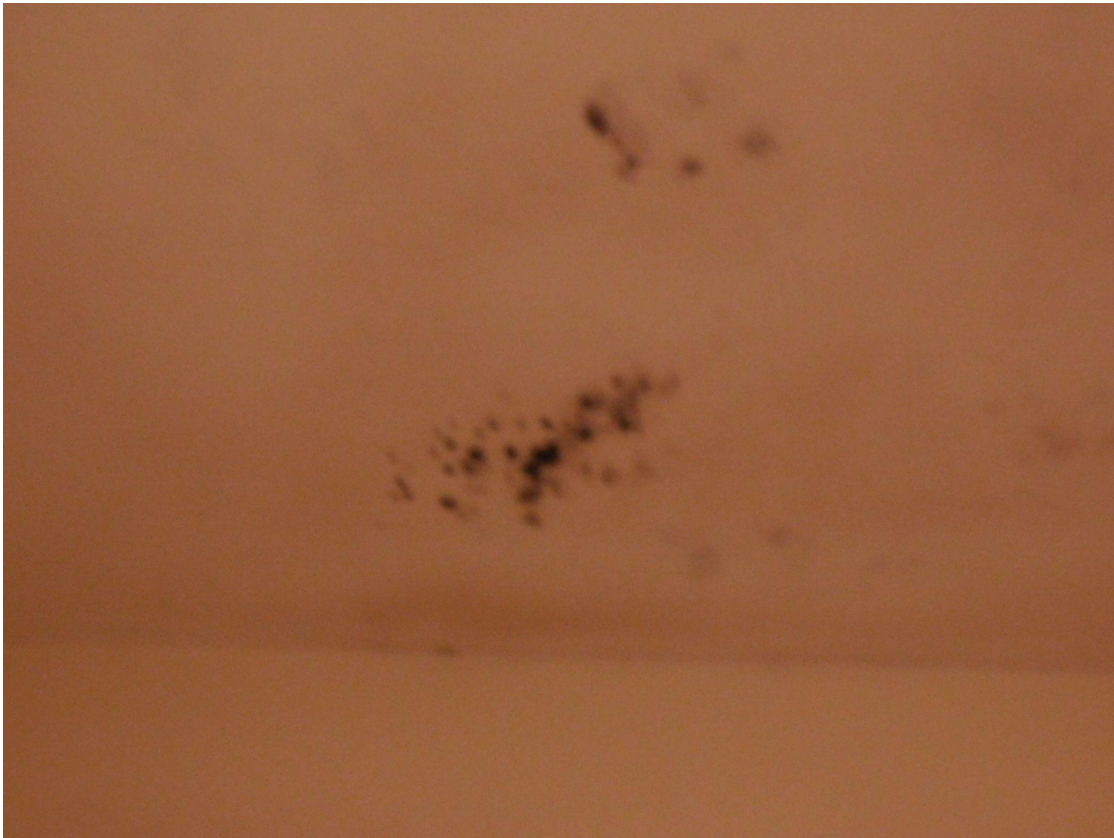
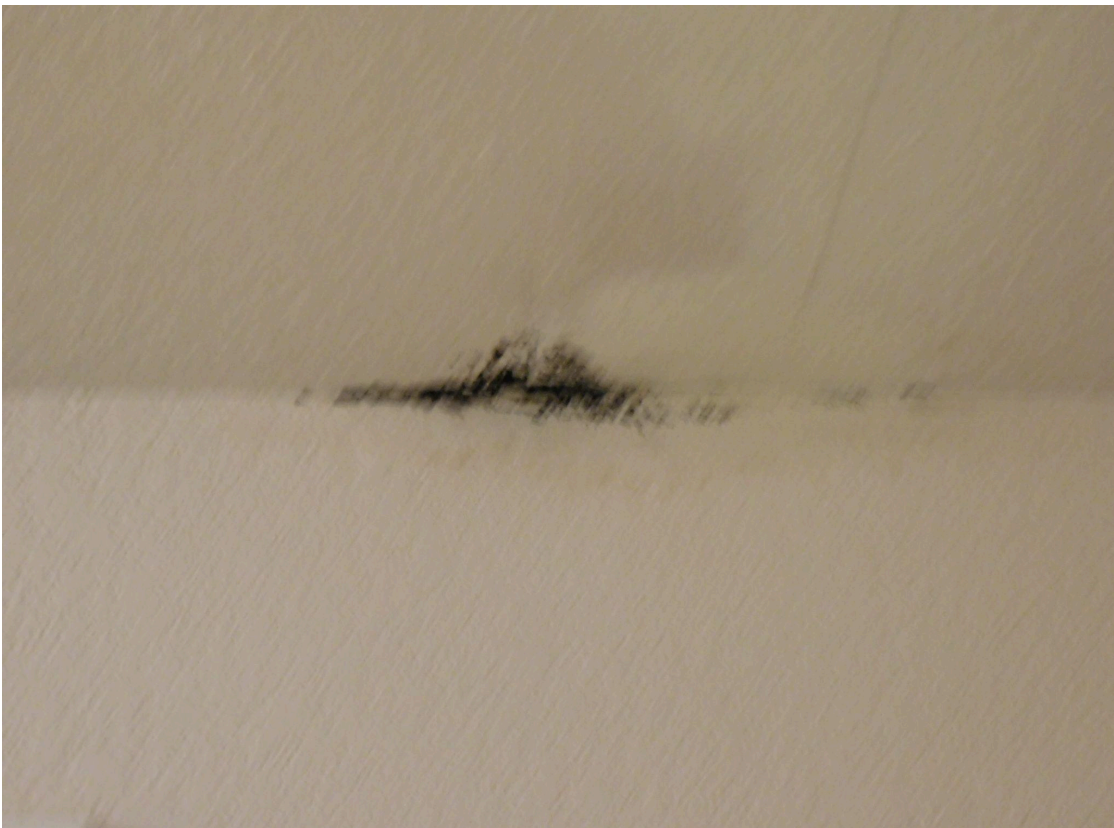
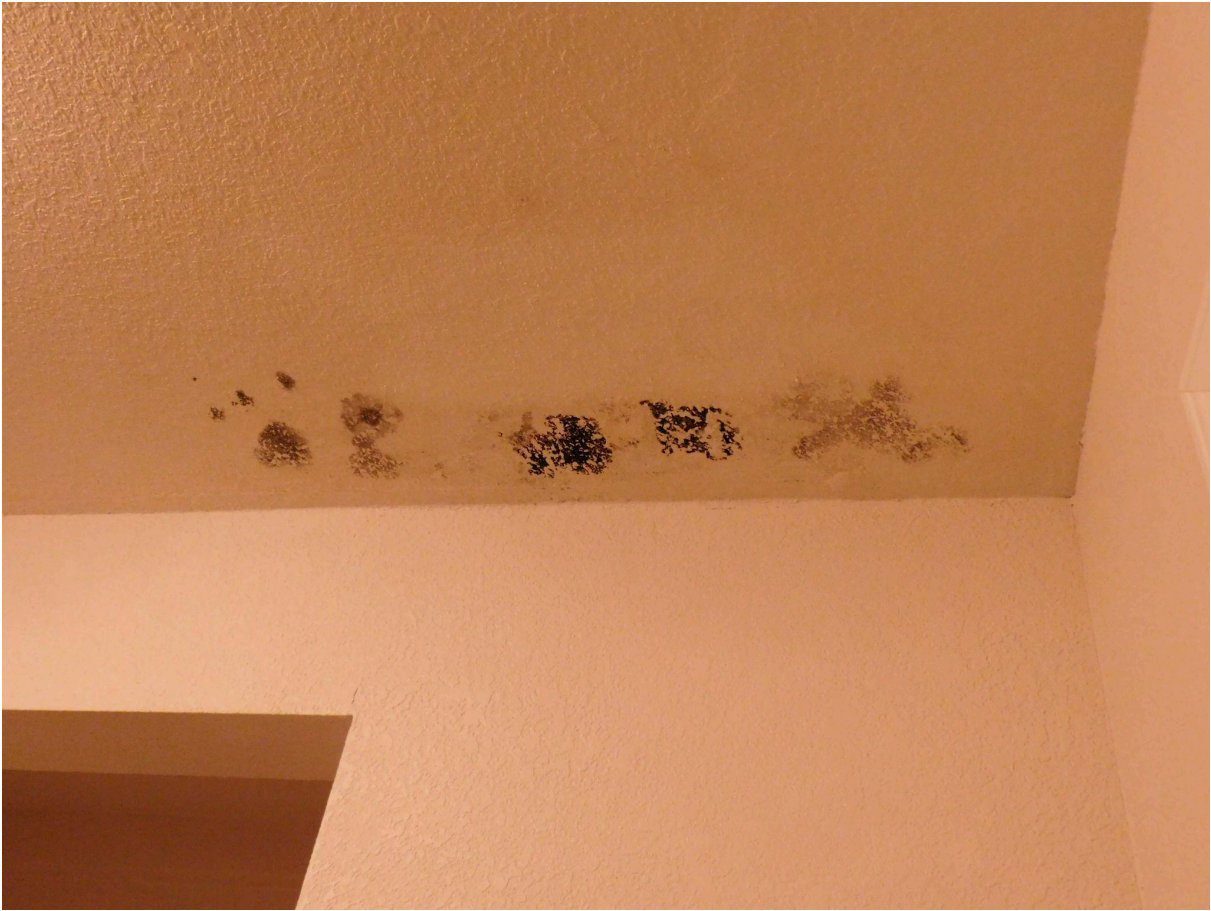
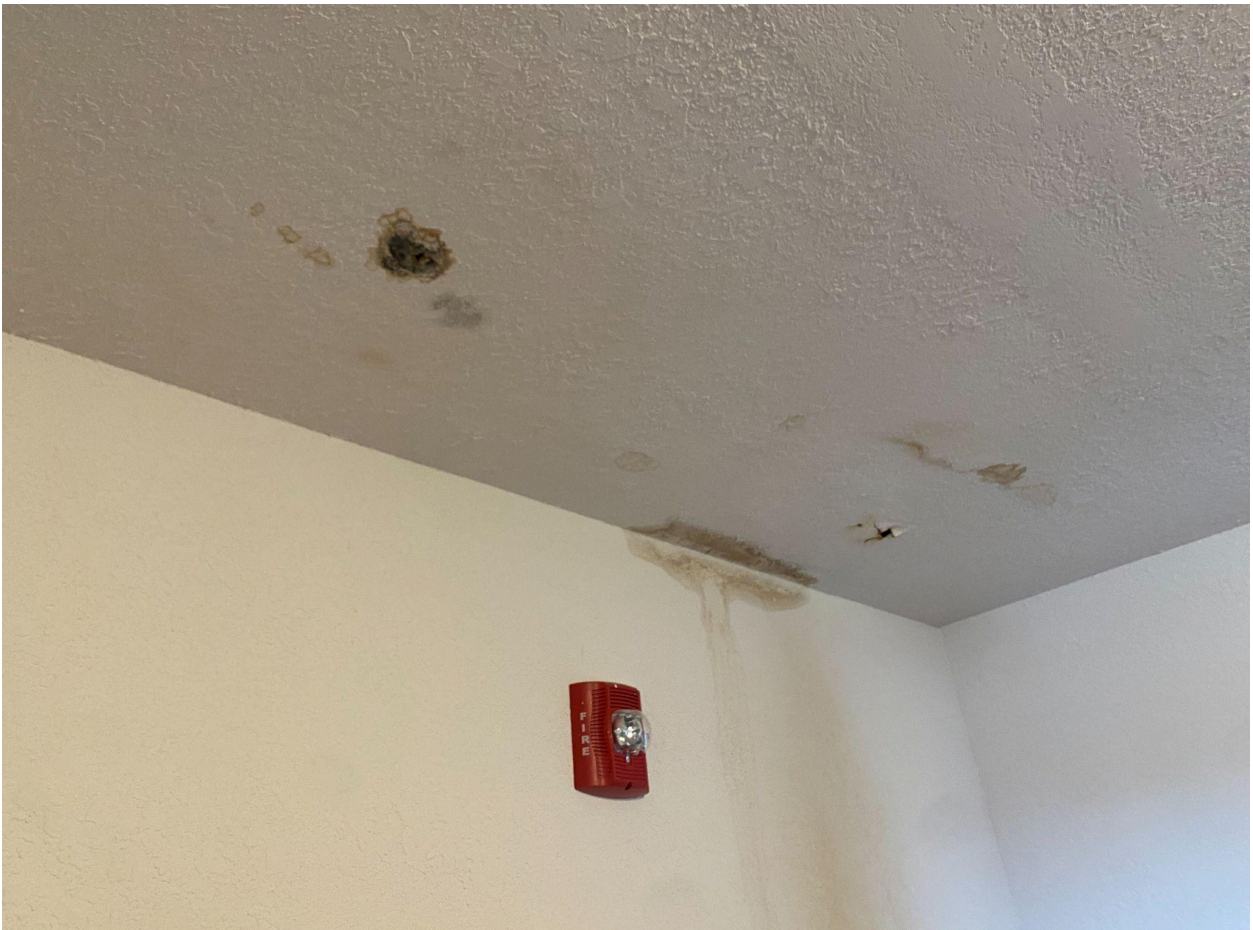
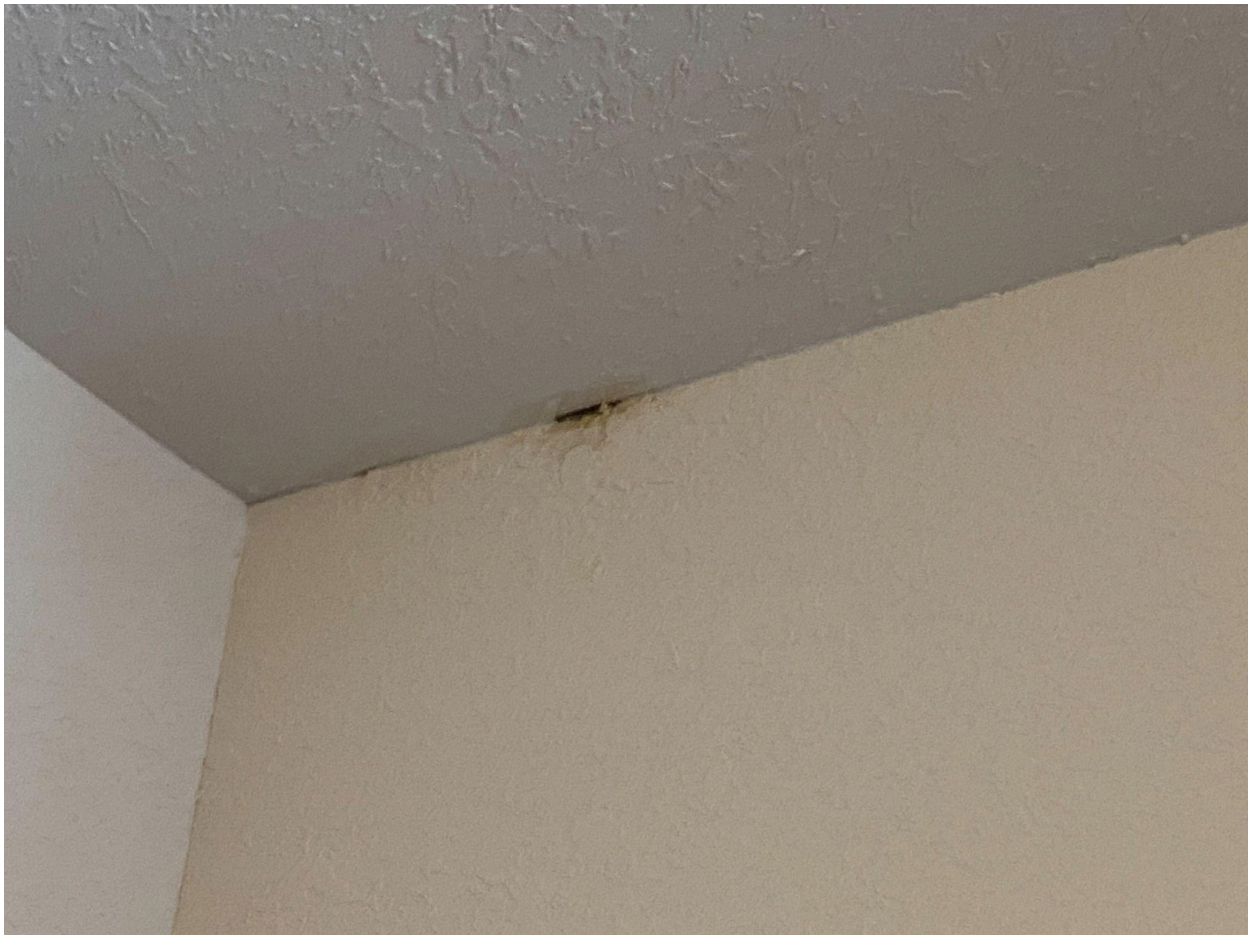
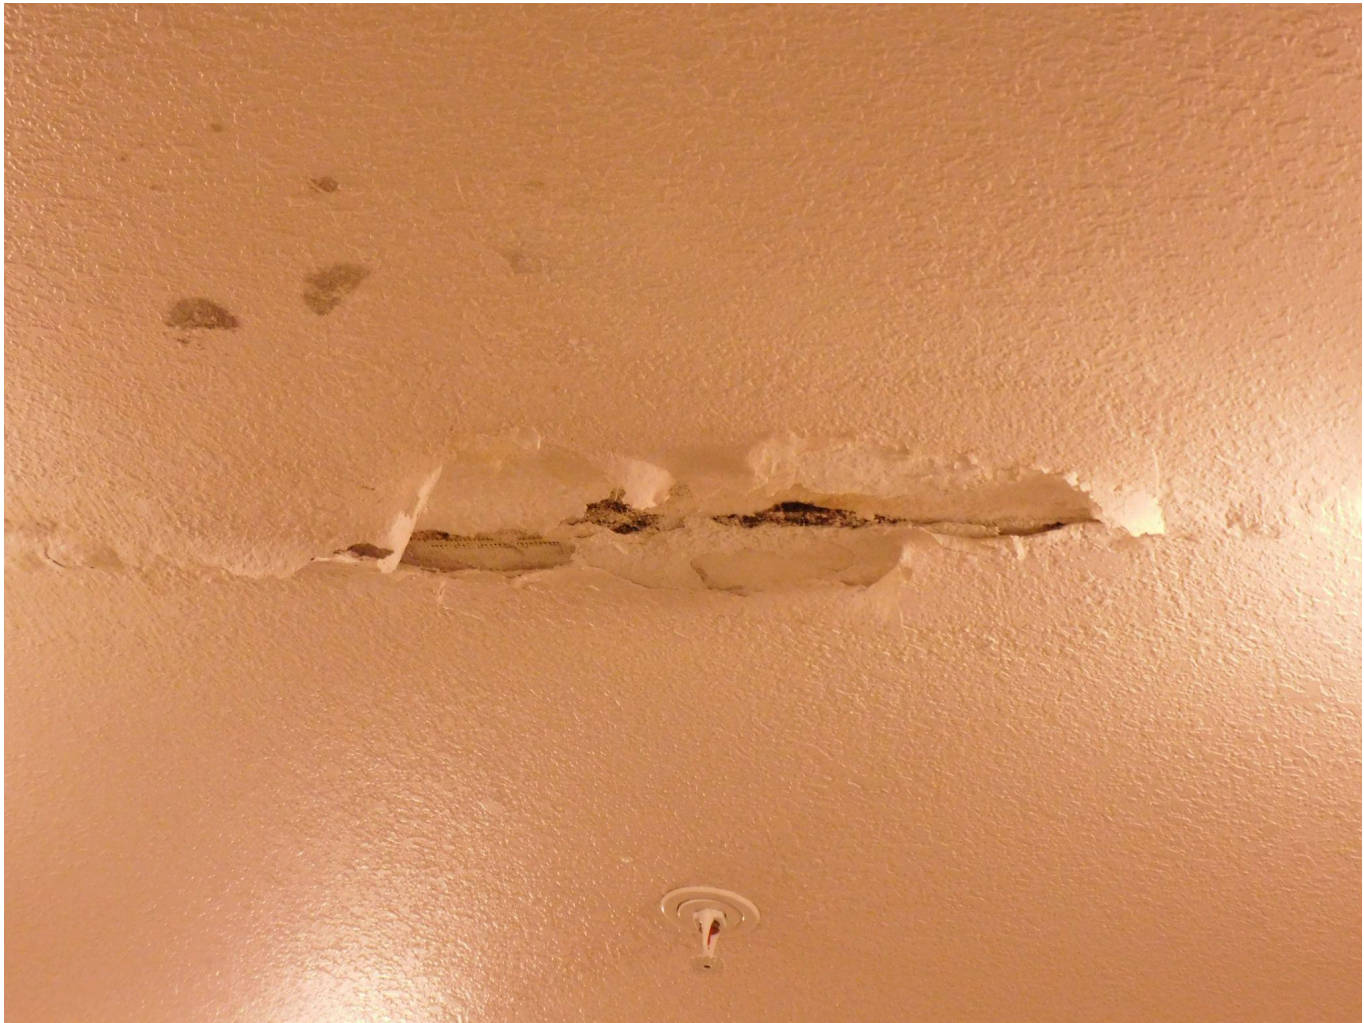
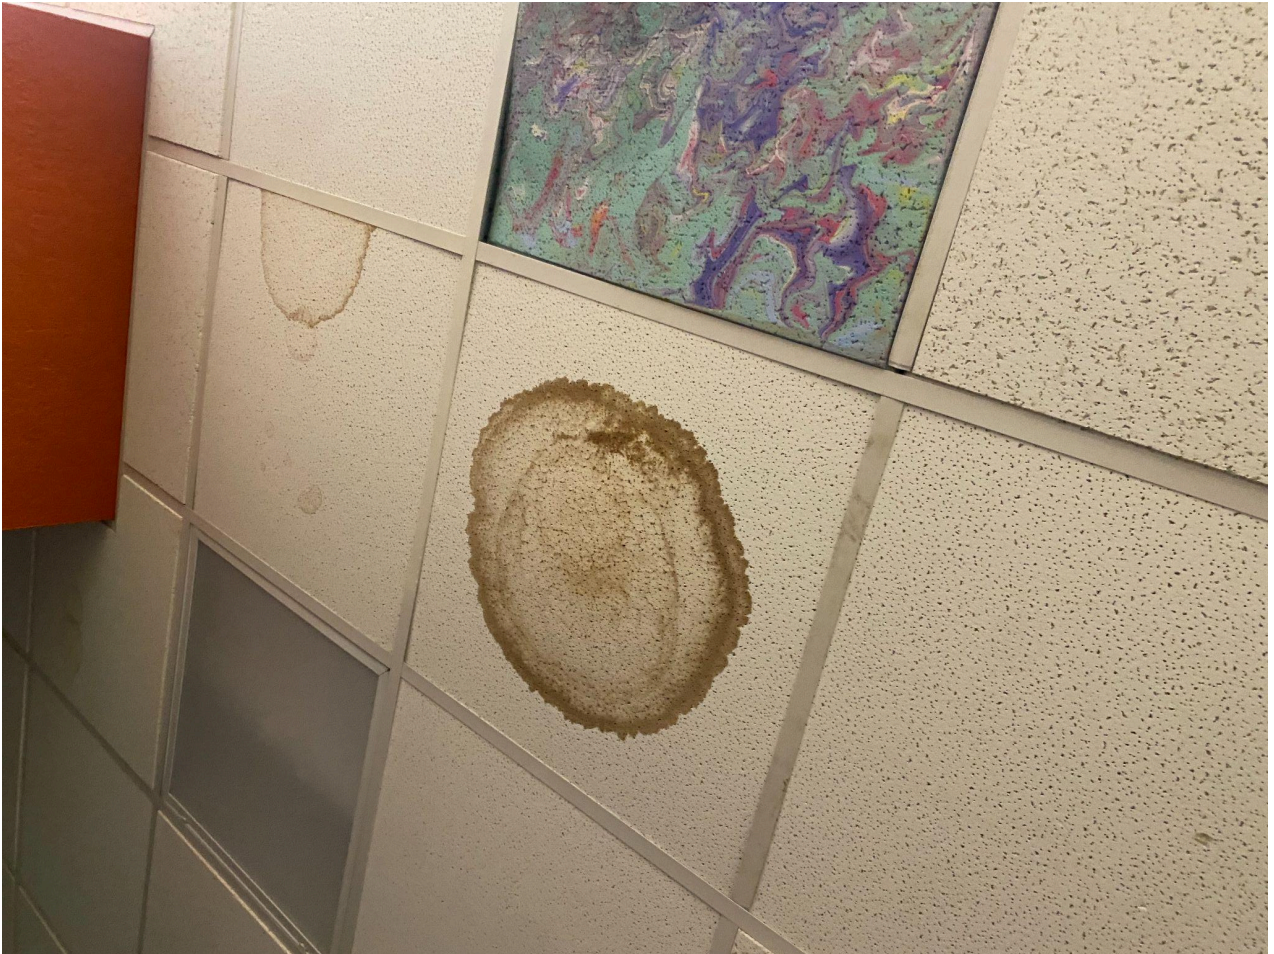
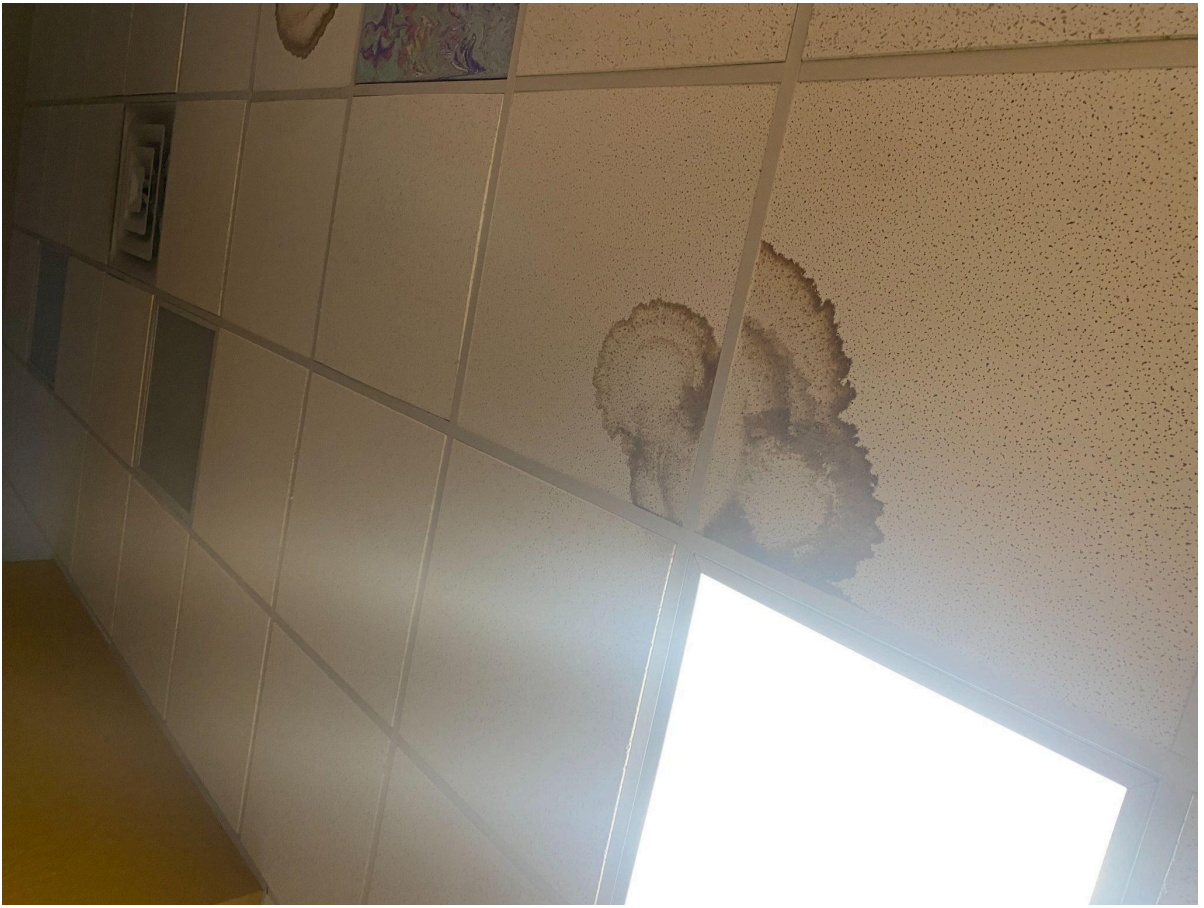
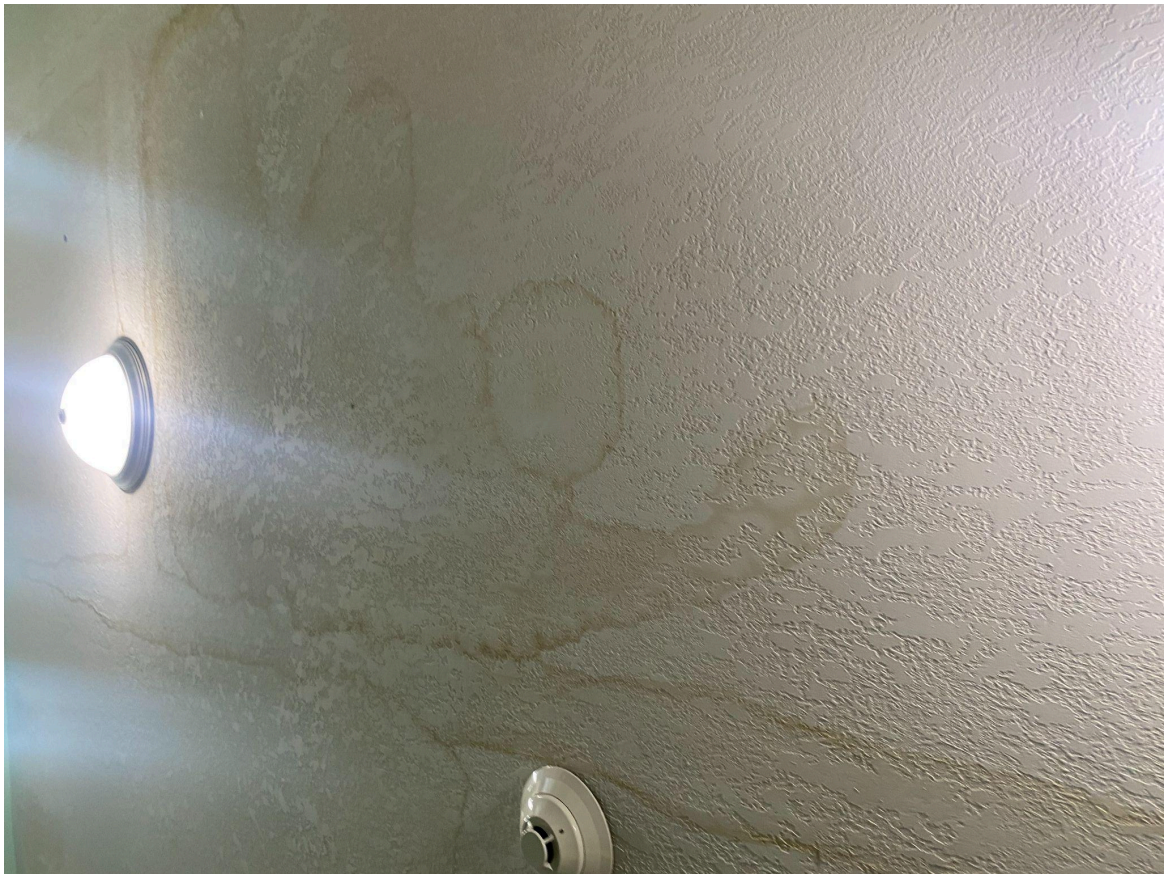
Evidence of black mold on the ceilings is common at the Hoffman Hotel, and staining (possibly from leaking pipes) on the ceilings is nearly as prevalent.
