THE LAW SCHOOL
CLINICAL LAW CENTER

Press release concerning the living conditions at the Hoffman Hotel

March 19, 2026

NOTRE DAME LAW CLINIC PRESS RELEASE:

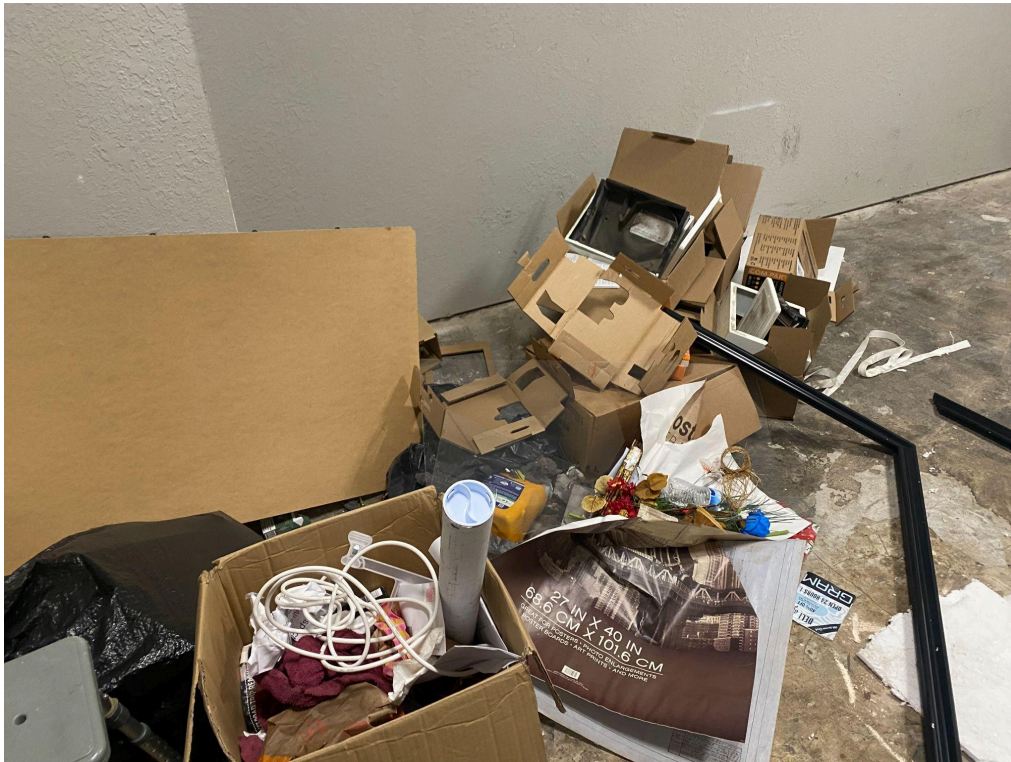
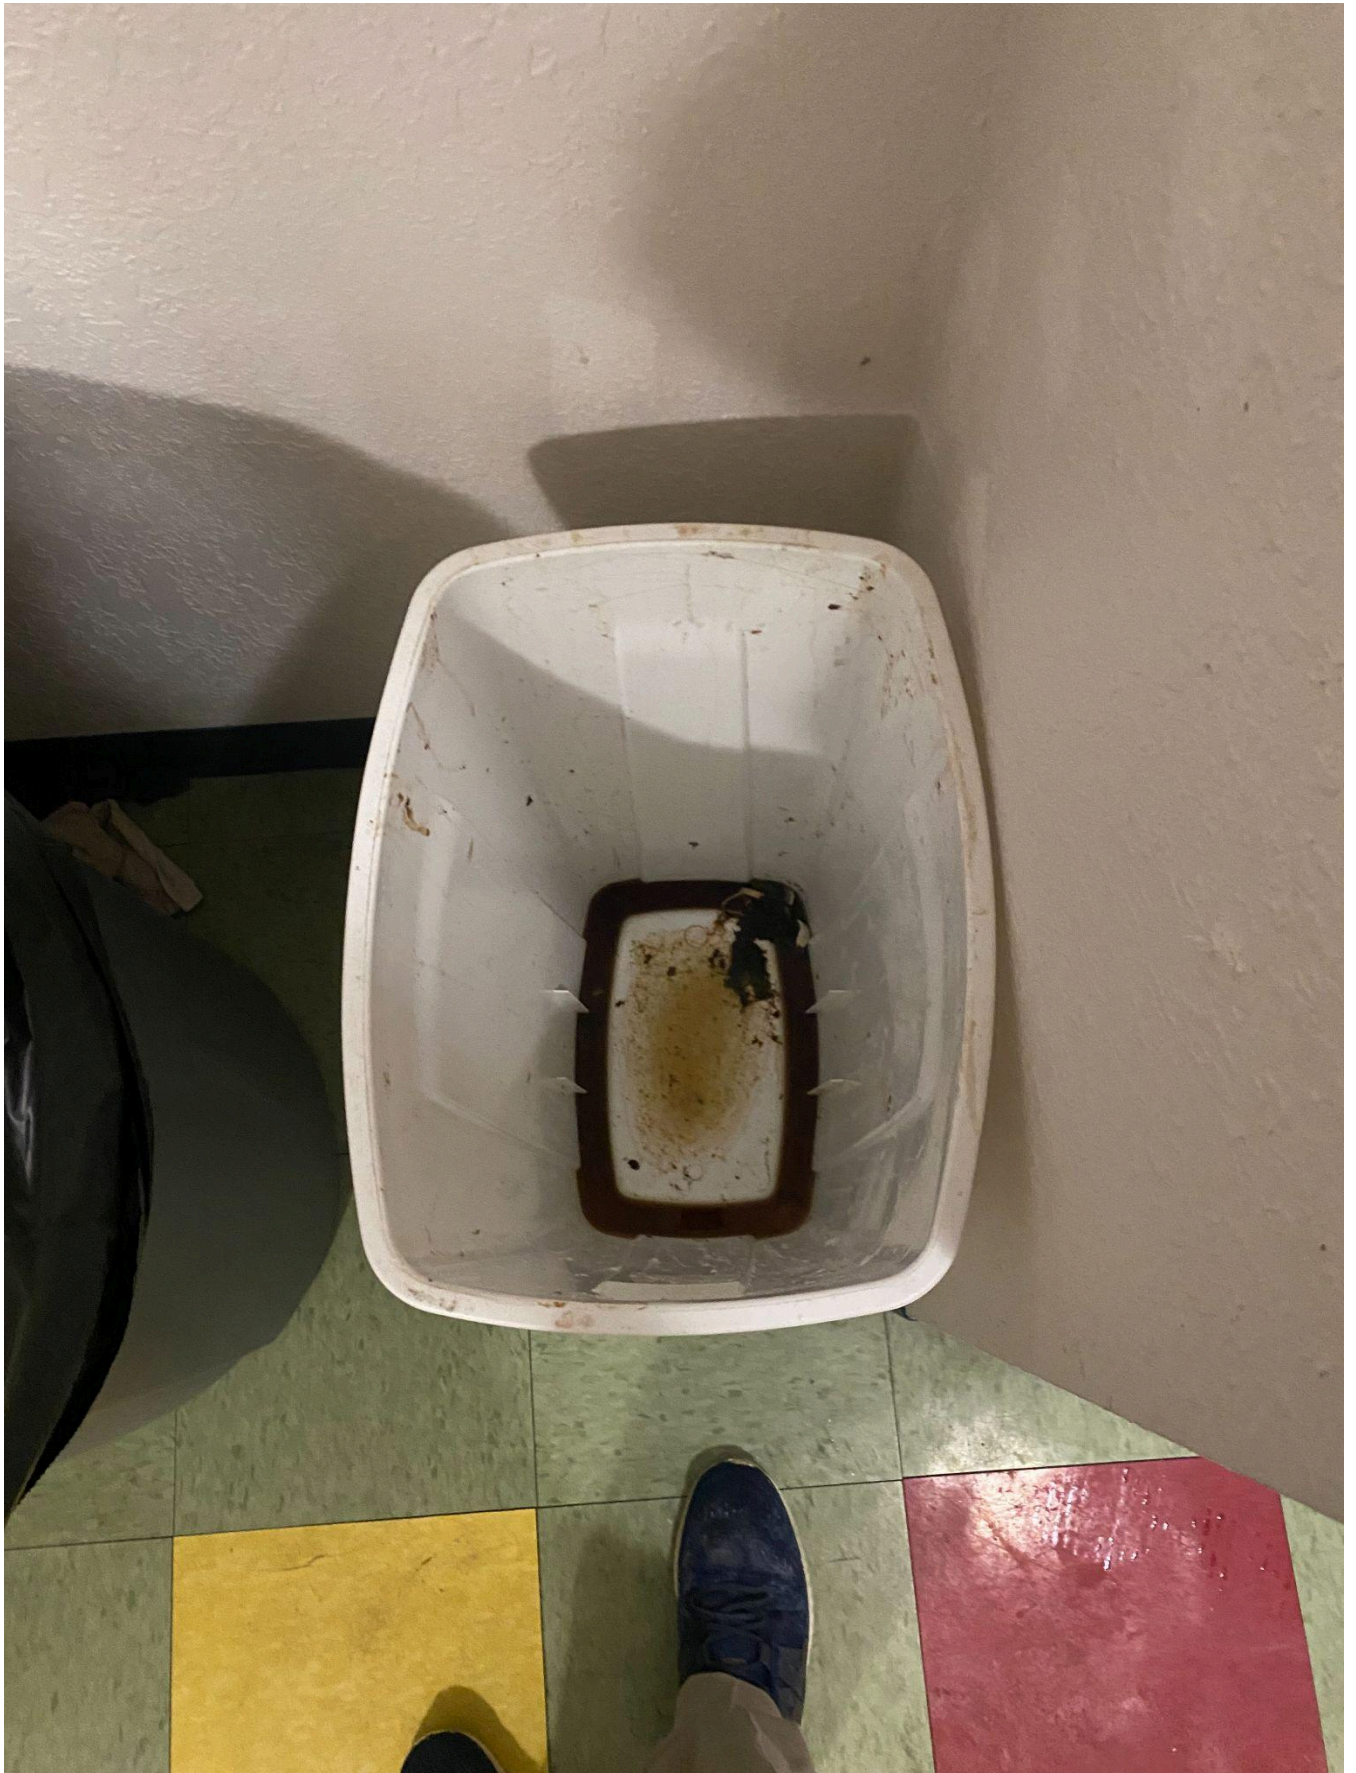
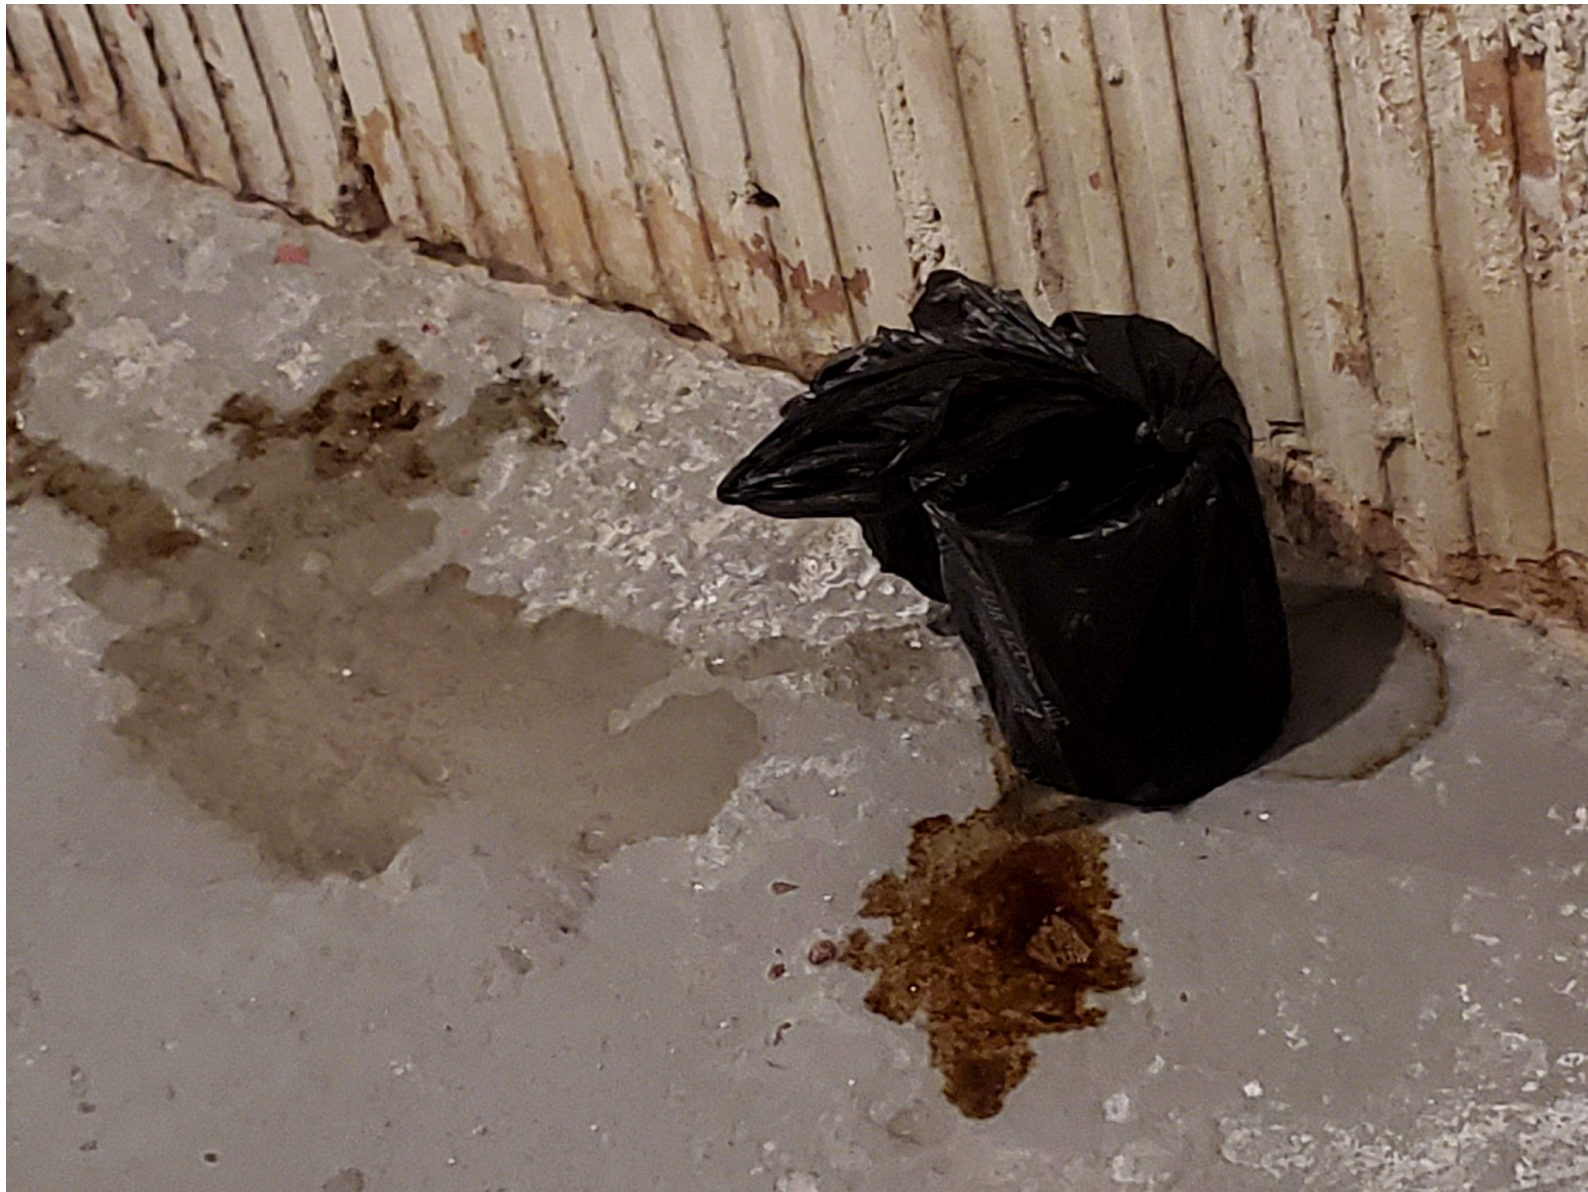
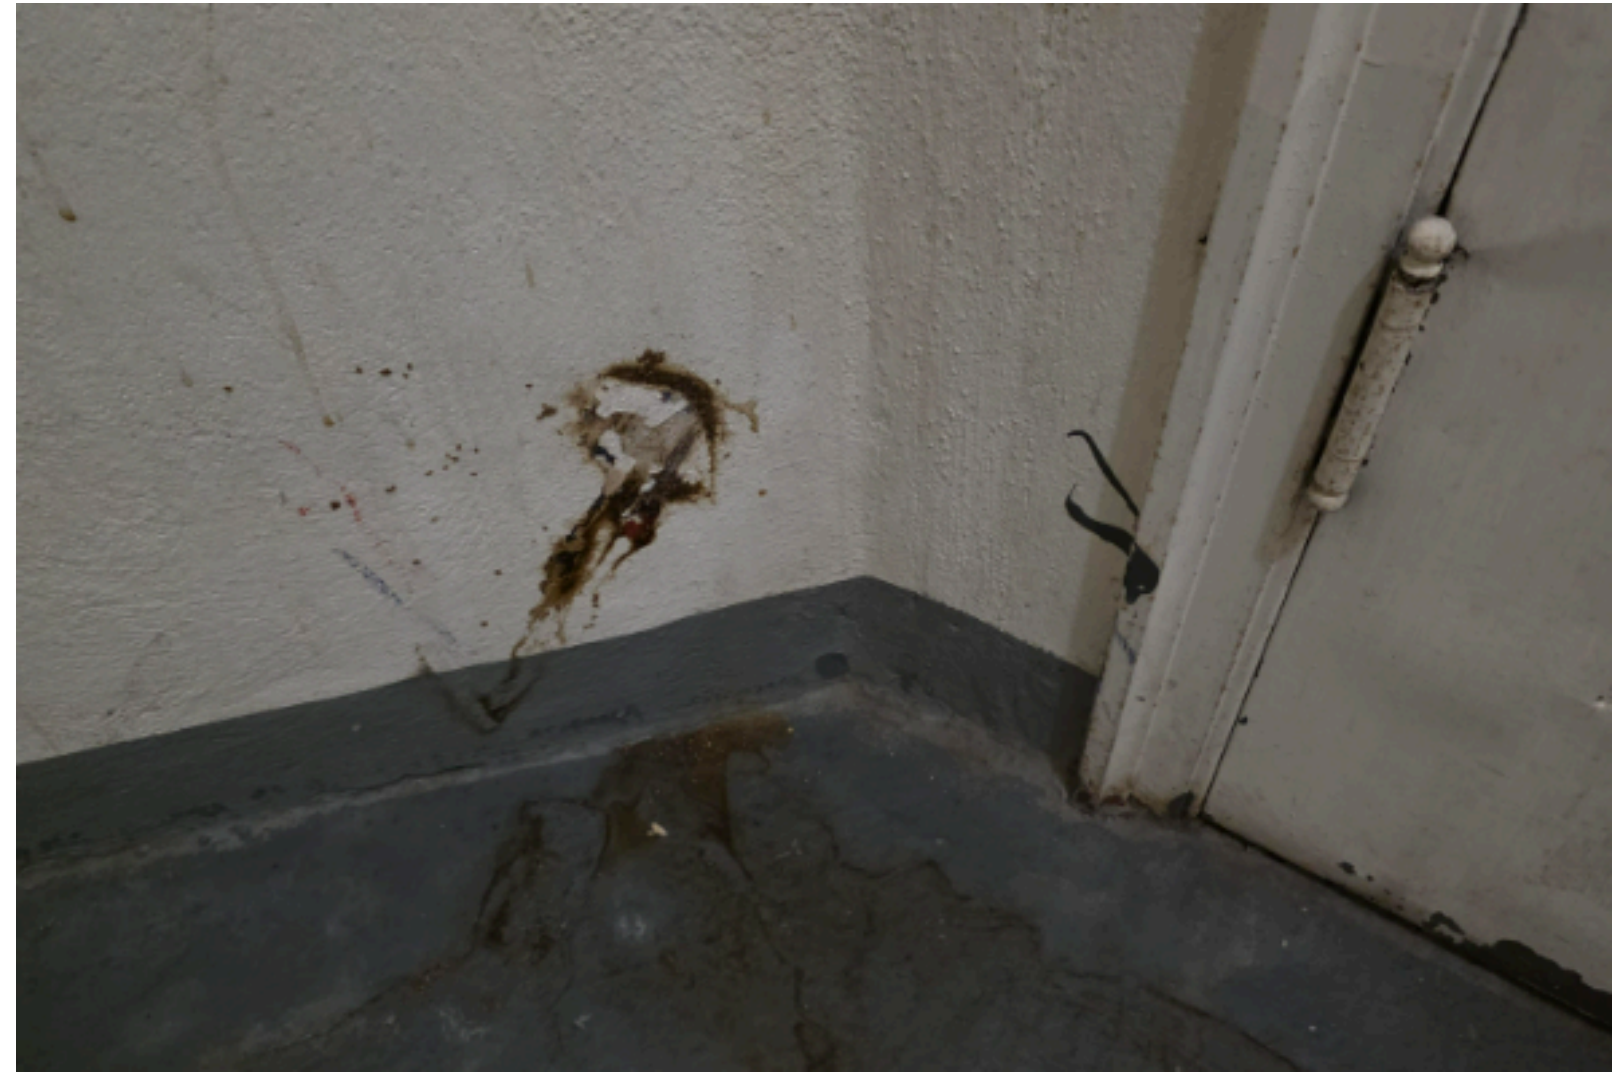
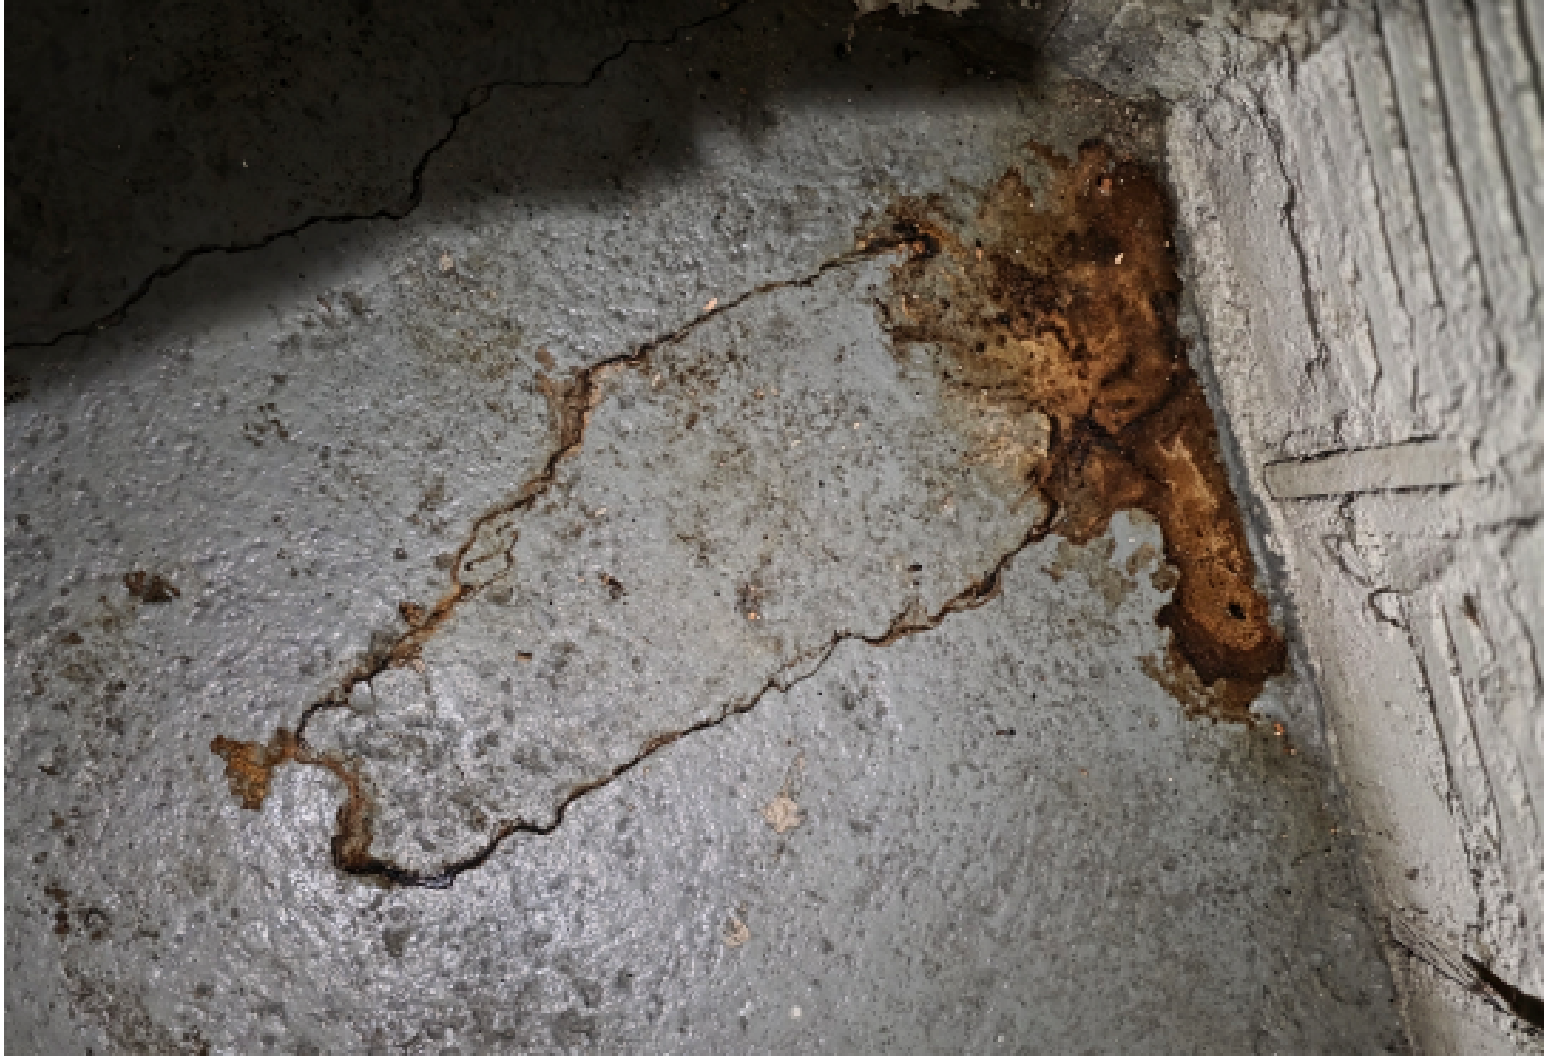
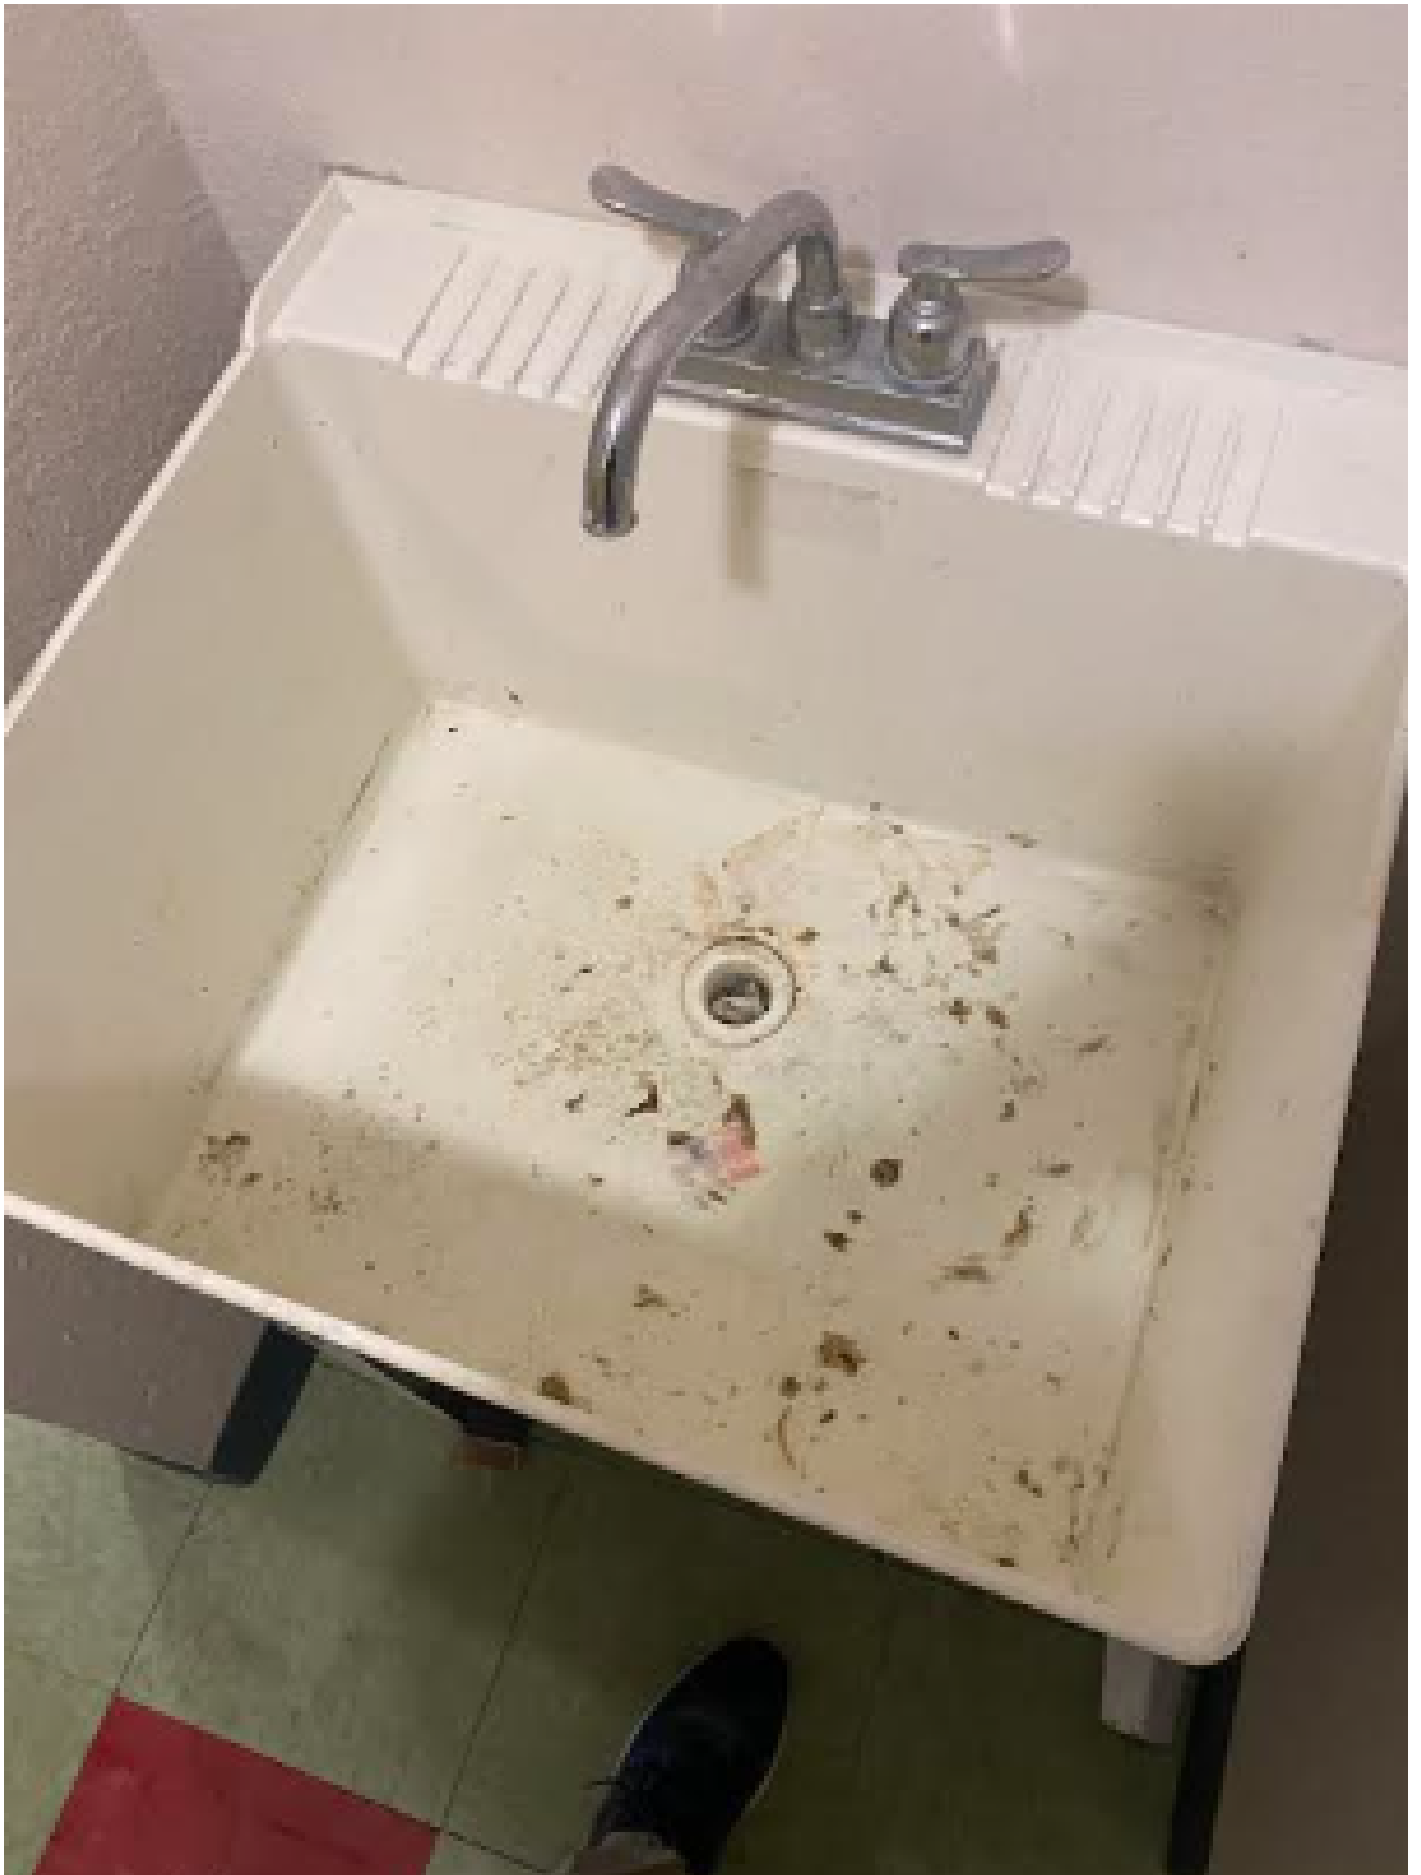
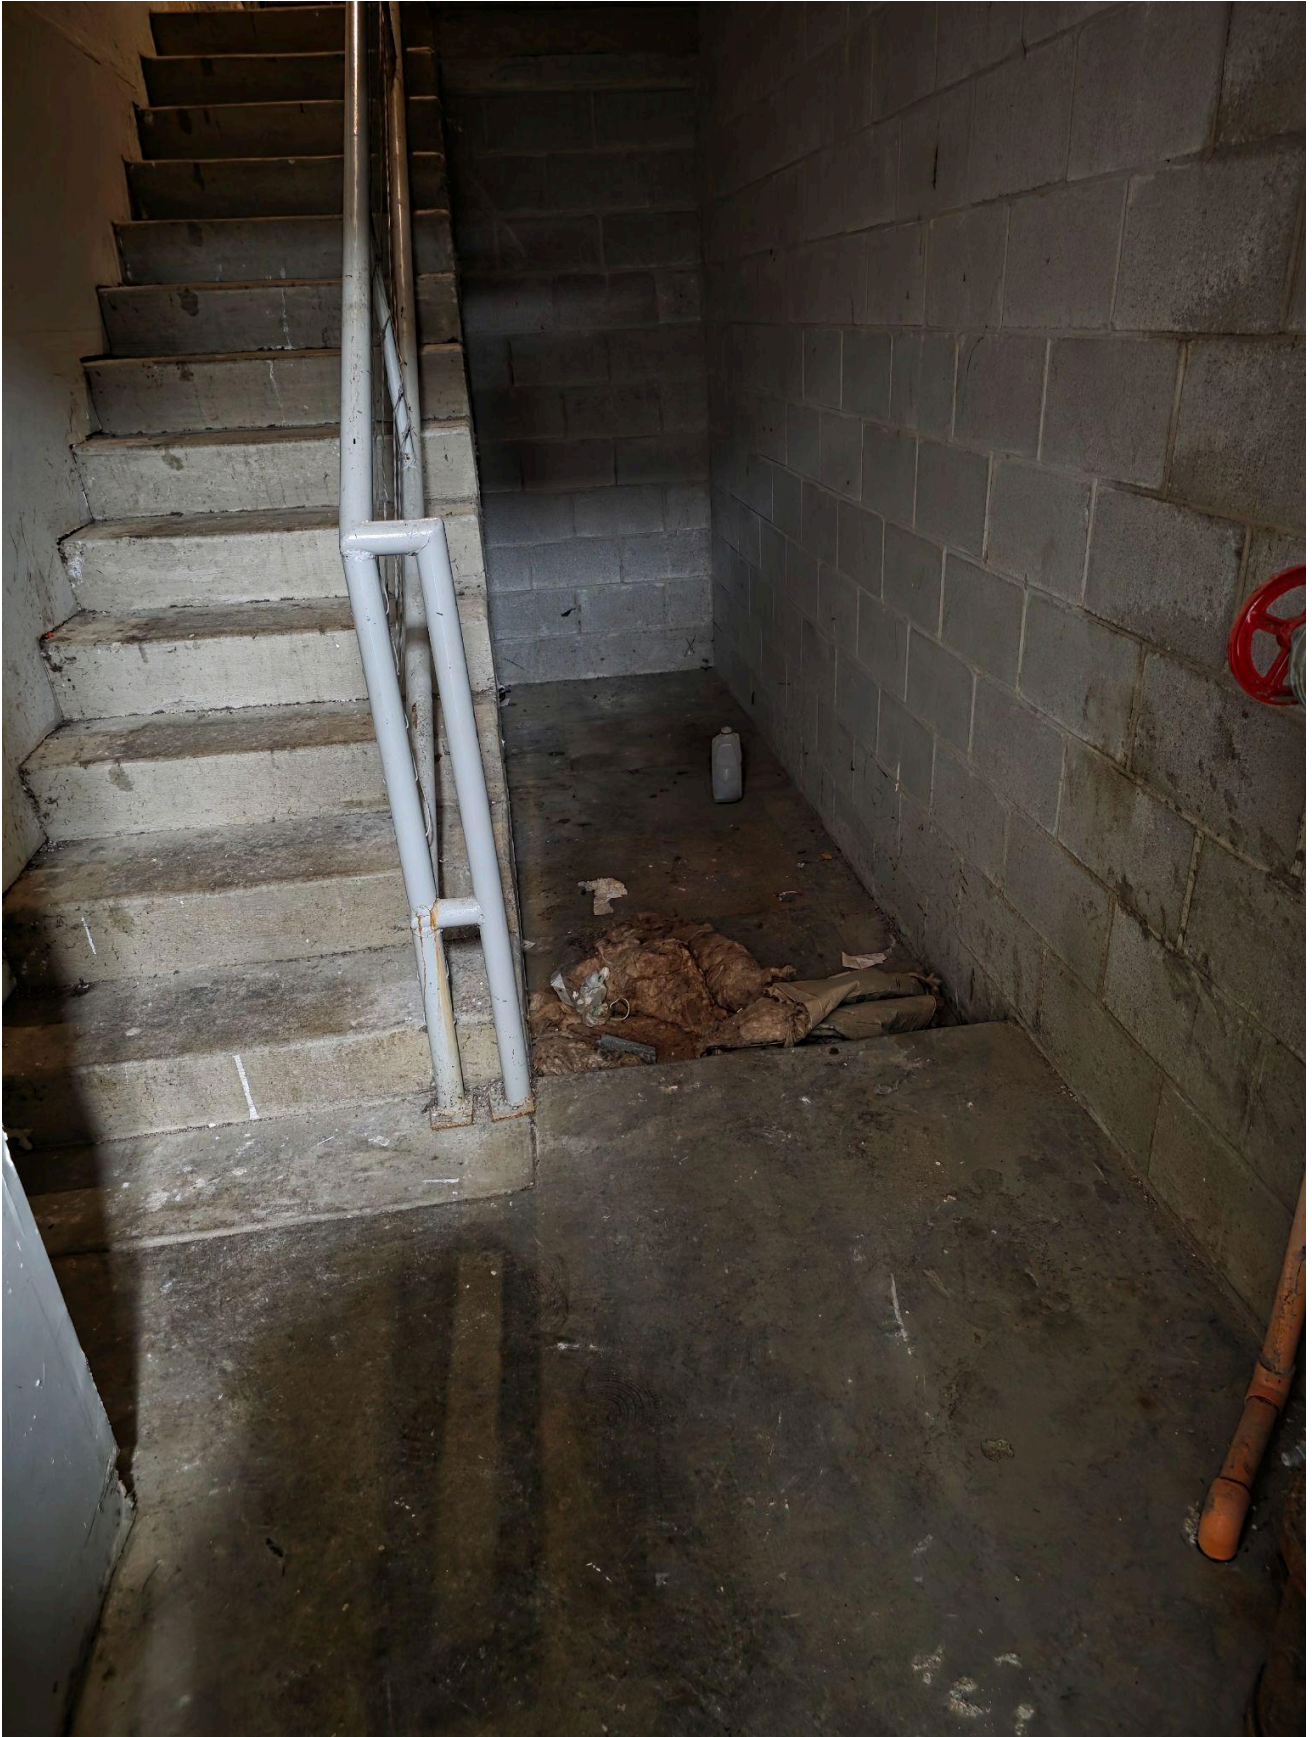
Many of the Common areas mentioned above are littered with trash, as well as the bike room, which smelled like feces or the rotting body of a dead animal. The two pictures below show the bike room, followed by pictures of a trash can and sink in the laundry room, and a loose piece of insulation at the bottom of the stairwell. One resident reported an incident where a bucket of feces remained in the stairwell for weeks until a tenant made their own effort to remove it. One two separate occasions, residents found two different pungent feces stains in the stairwells.
